HURON-CLINTON
metroparks

Kensington Metropark
Stormwater Management Plan

September 2019

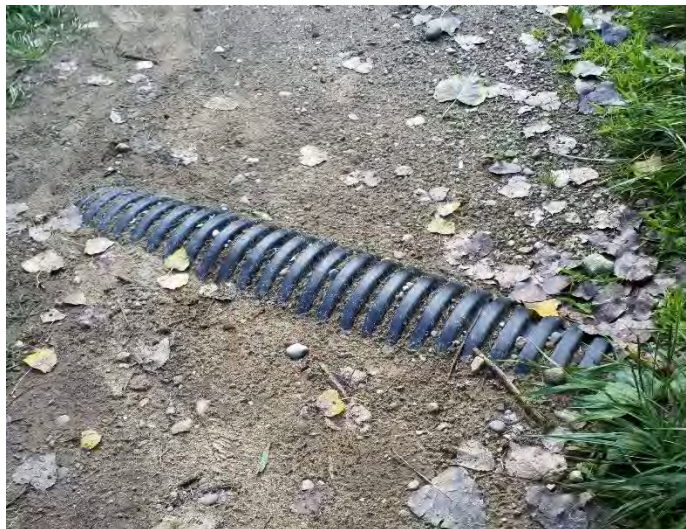
Left: Failing culvert in Kensington Metropark. Right: Proportion of culverts in each condition category.

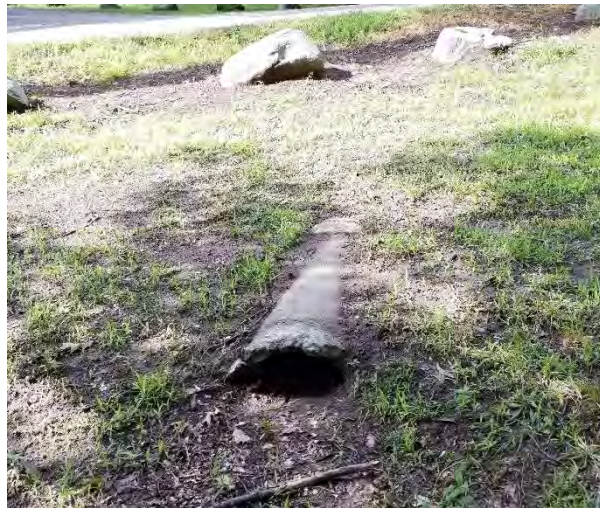
Proportion of outfalls in each condition category. Right: Blocked outfall in failing condition in Kensington Metropark.

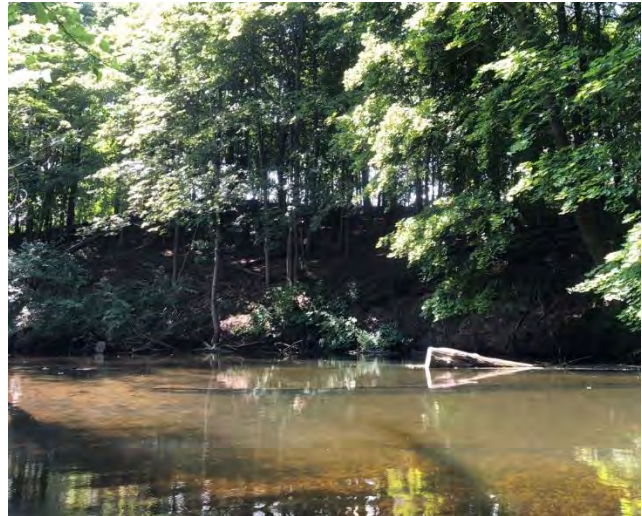
Erosion Condition	Feet of Streambank (miles)	Cost of Restoration
Very High	0.0 (0.0)	
High	2,436 (0.46)	\$598,000
Moderate	5,805 (1.10)	
Low	7,003 (1.33)	
Very Low	802 (0.15)	
Total:	16,047 (3.03)	\$598,000

Left: Proportion of stream bank in each erosion severity category. Right: High erosion on a bank in Kensington Metropark.

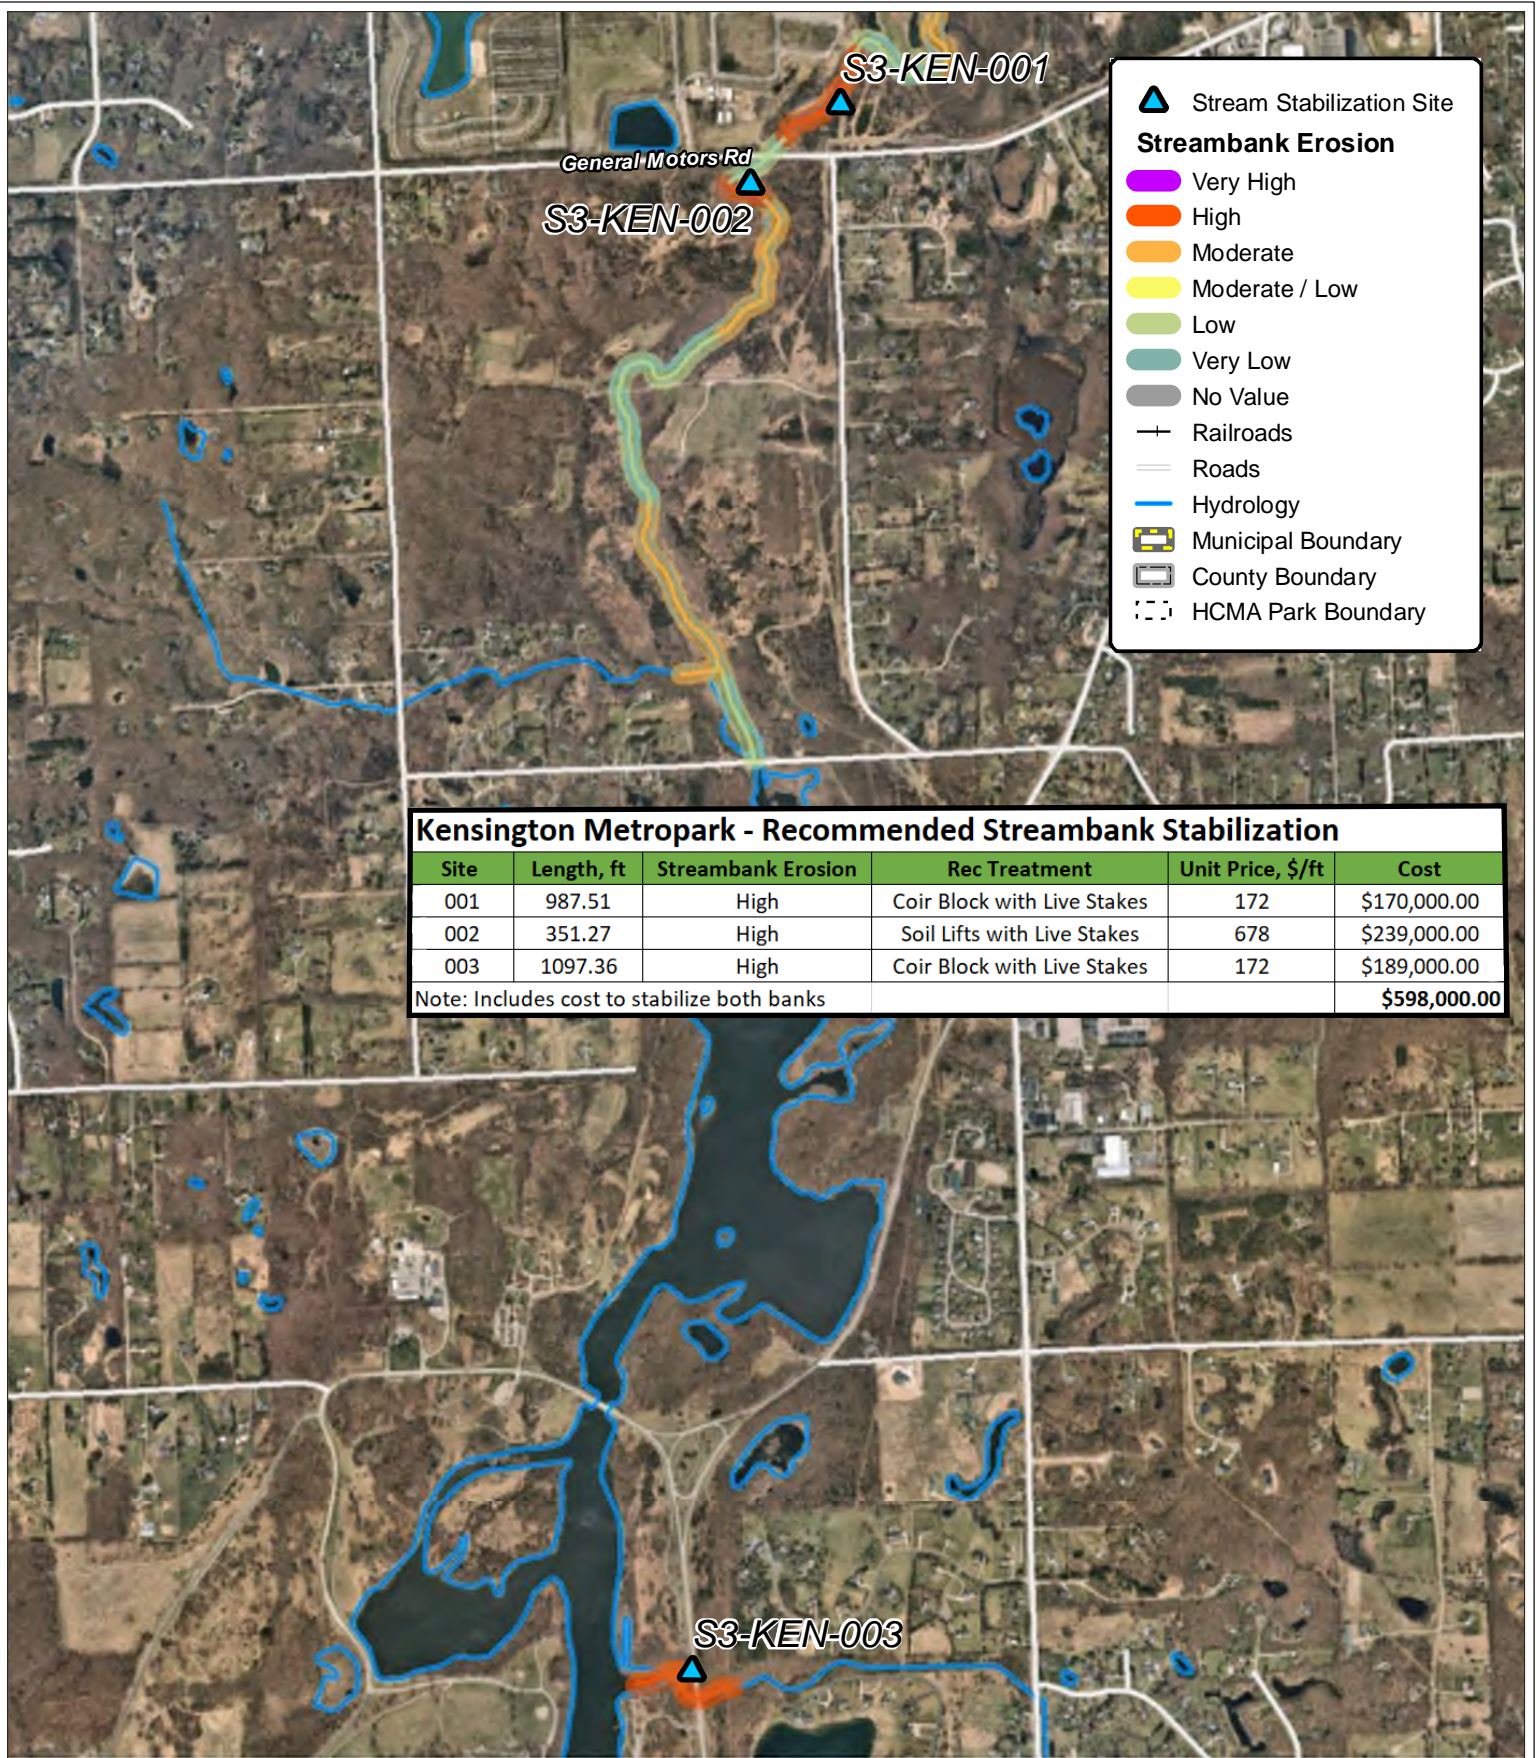
S3-KEN-001

Length: 987.51 ft

Recommended Treatment: Coir Block with Live Stakes

Construction Cost: \$170,000

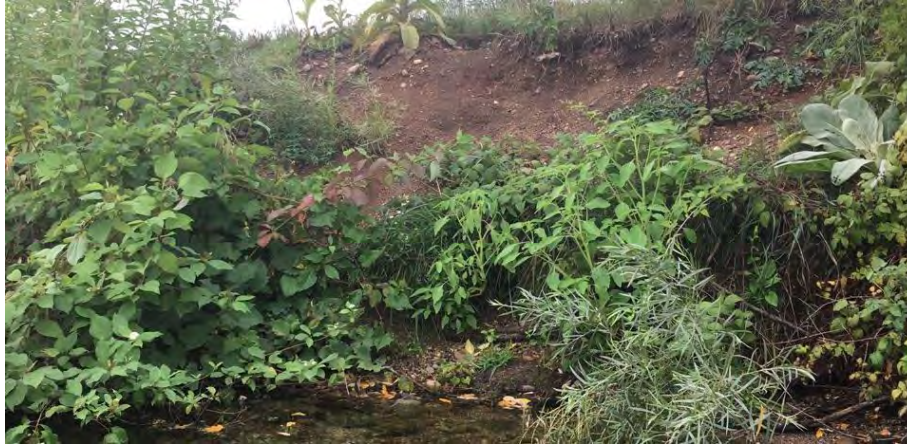
Major slumping in Kensington Metropark.

Erosion Condition	Length of Shoreline (ft)
Major	9,503.1
Minor	86,153.4
None	52,464.2
Total:	148,120.7
Restoration Cost:	\$151,777

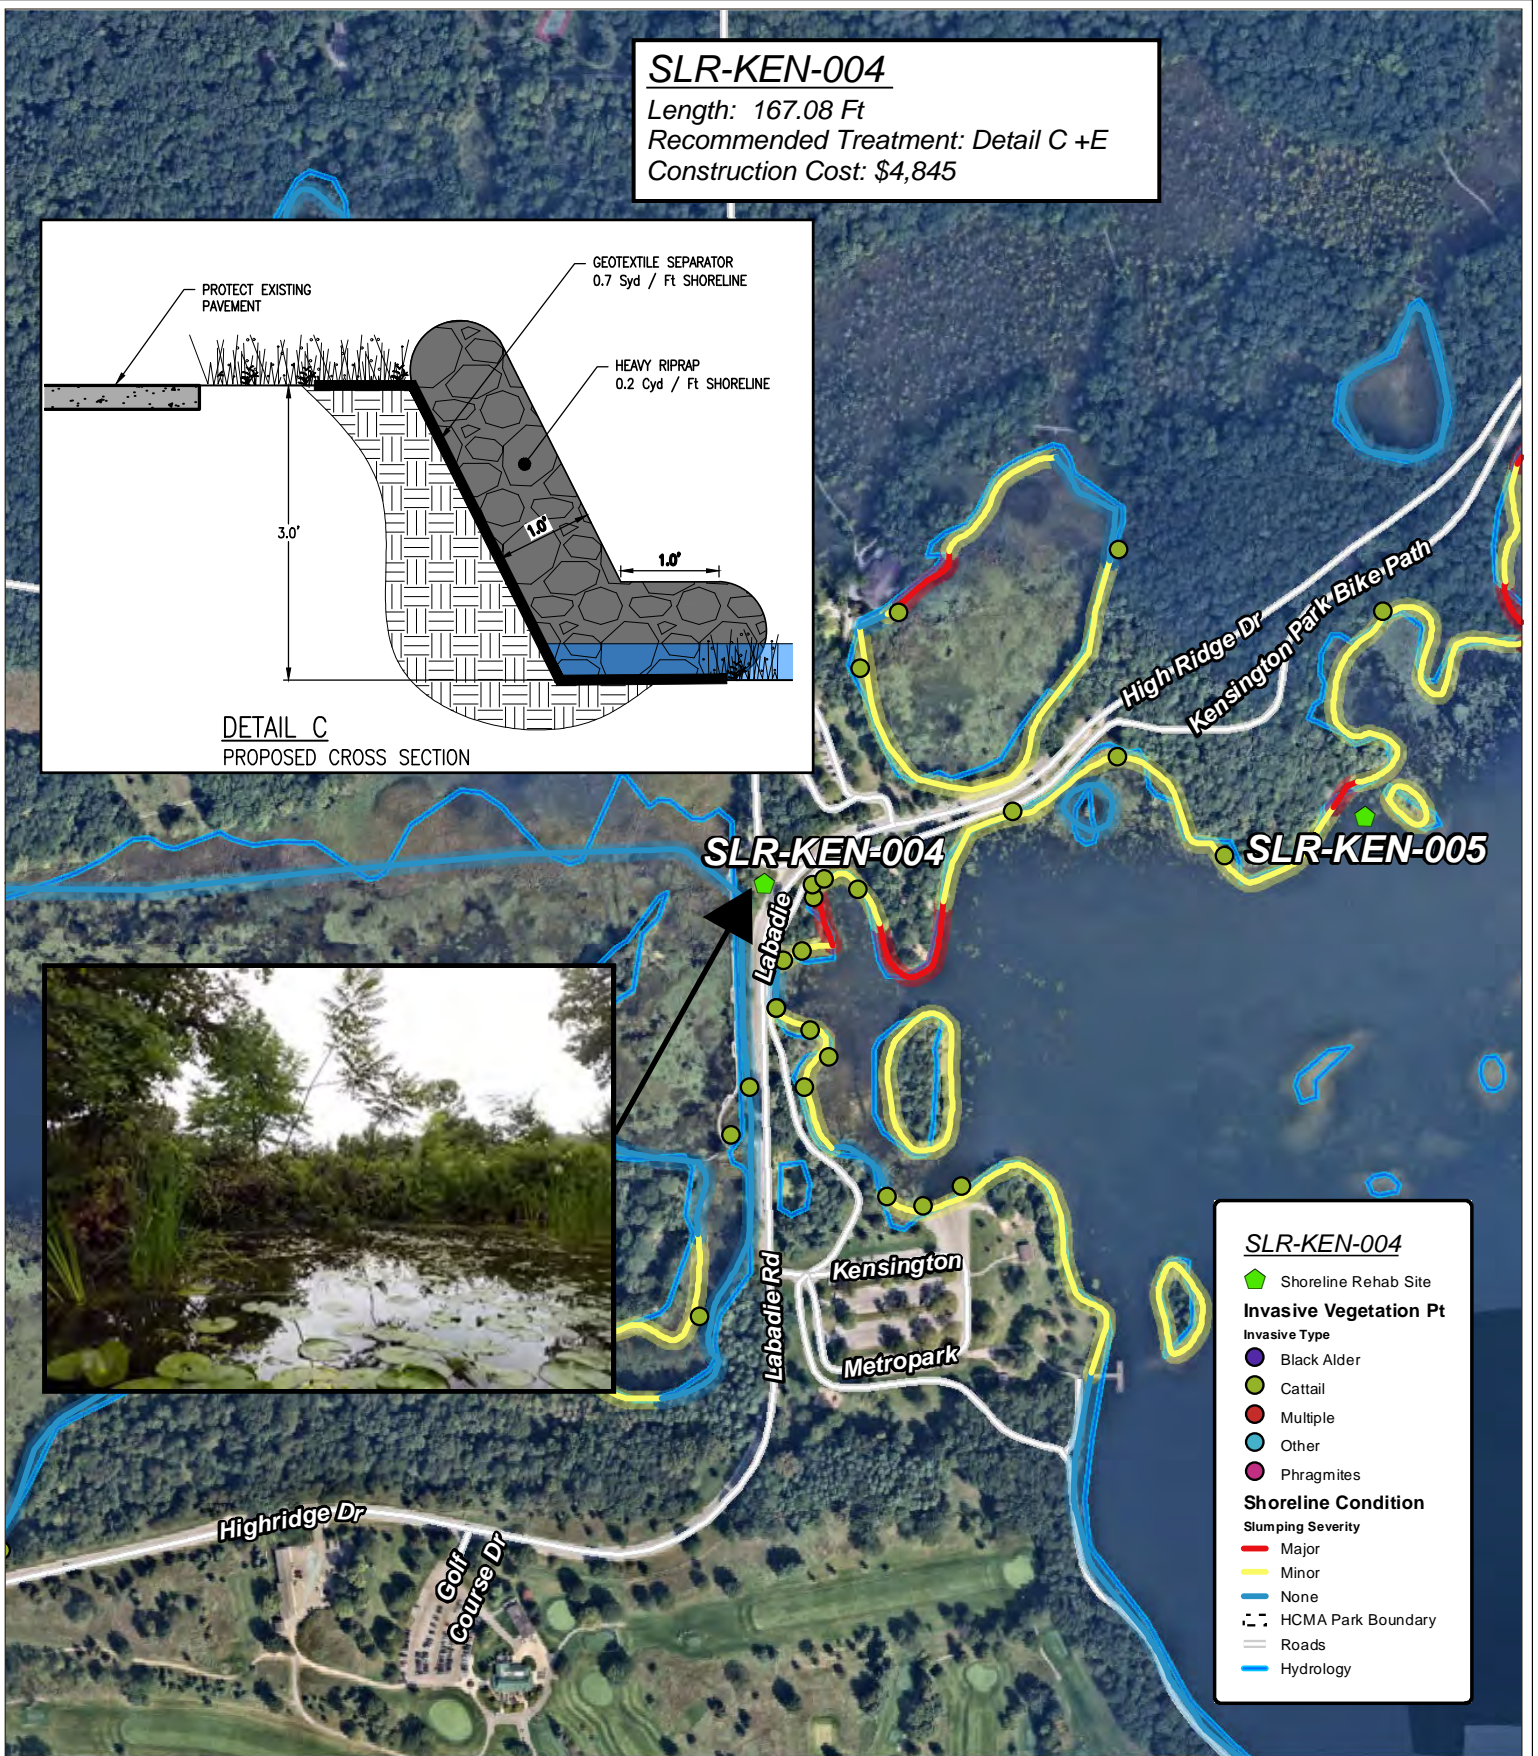
SLR-KEN-004

Length: 167.08 Ft

Recommended Treatment: Detail C +E

Construction Cost: \$4,845

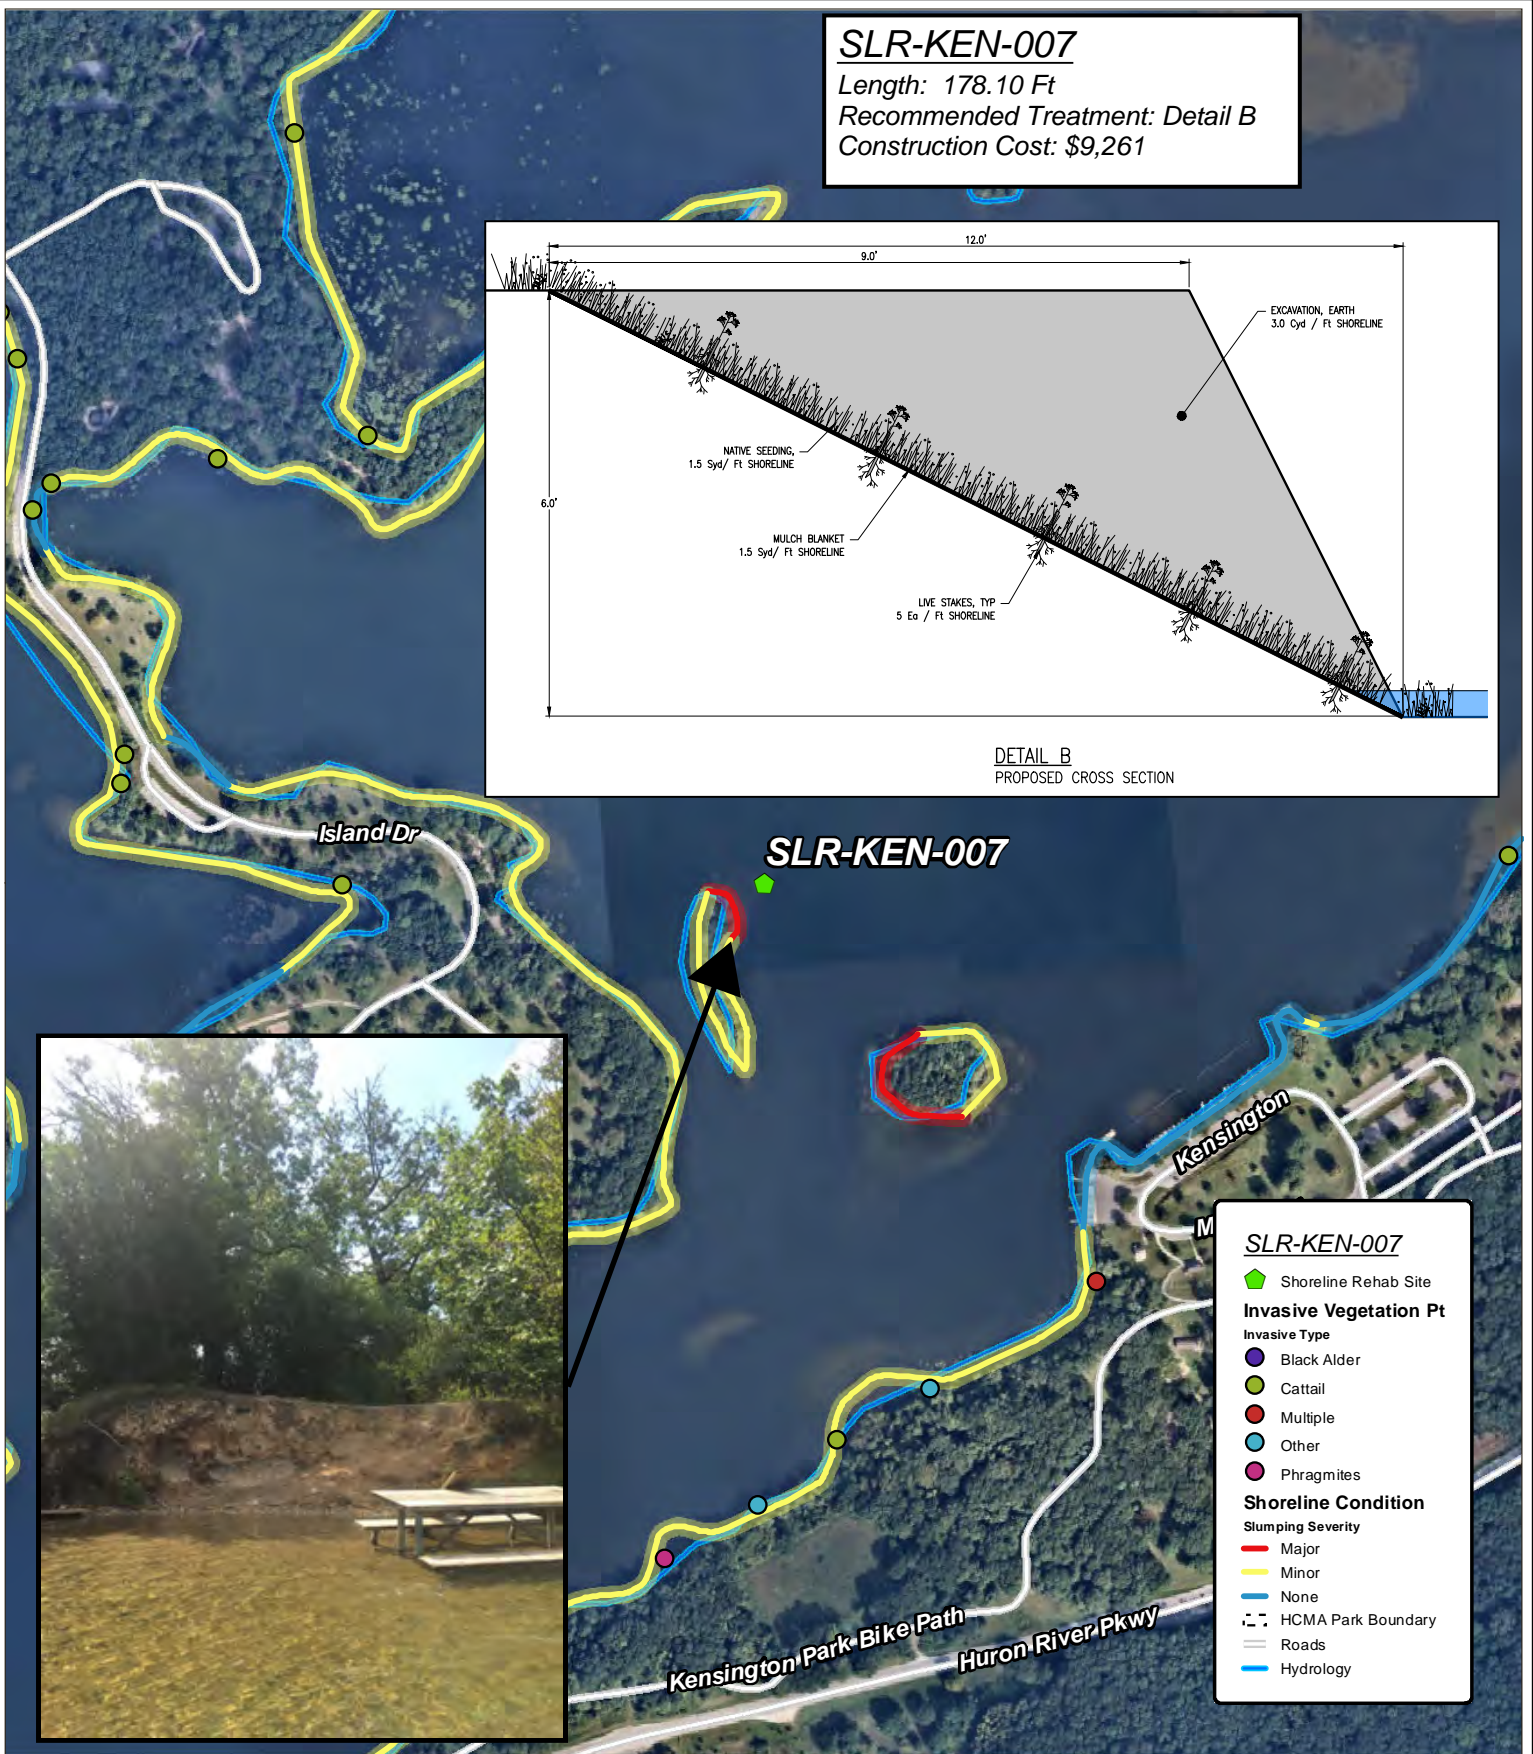
SLR-KEN-007

Length: 178.10 Ft

Recommended Treatment: Detail B

Construction Cost: \$9,261
