SUBJECT: Flat Rock Dam, Dam ID No. 556; Wayne County

**DAM SAFETY INSPECTION REPORT  
FLAT ROCK DAM – DAM ID NO. 556  
HURON RIVER  
WAYNE COUNTY – SW 1/4 SECTION 31, T 04S, R 10E**

APPENDIX B – INSPECTION PHOTOS

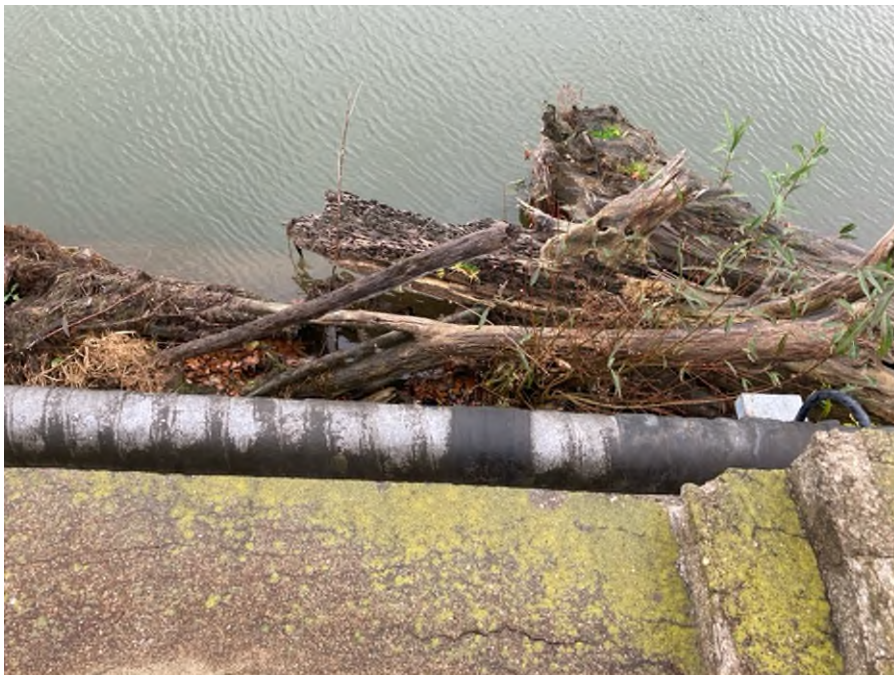
Photo #4: Principal Spillway Weir Wall.  
Issue: Debris, Action: Maintenance.

- 1 **Debris (Action: Maintenance):** Remove debris. Complete action as soon as possible.
  - a Principal Spillway: Weir Wall
- 2 **Deteriorating Material (Action: Maintenance, Material: Concrete):** Remove the deteriorated concrete and install new concrete. Remove all deteriorated concrete, additional concrete may have to be removed to ensure the patch is a minimum of 3 inches thick. Roughen existing concrete surface to improve the patch bond. Install high strength concrete. Complete action by December 31, 2024.

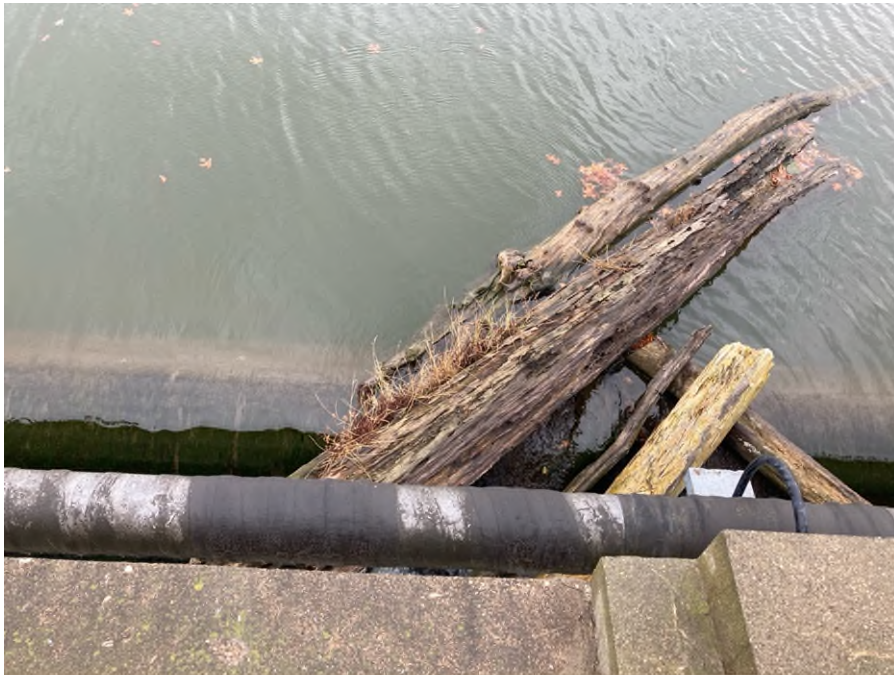
Photo #5: Principal Spillway Weir Wall.  
Issue: Debris, Action: Maintenance.

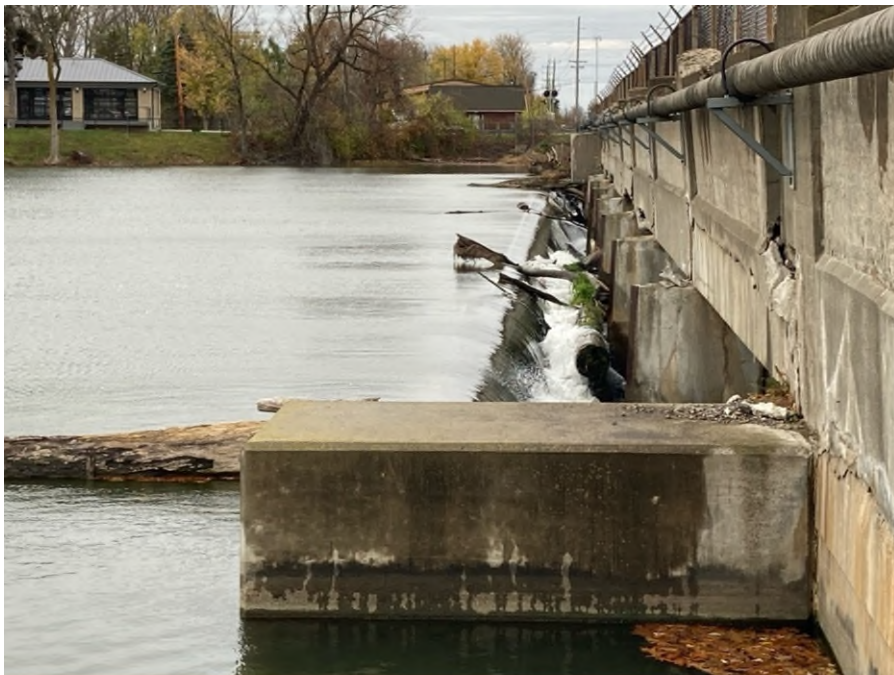
Photo #6: Principal Spillway Weir Wall.  
Issue: Debris, Action: Maintenance.

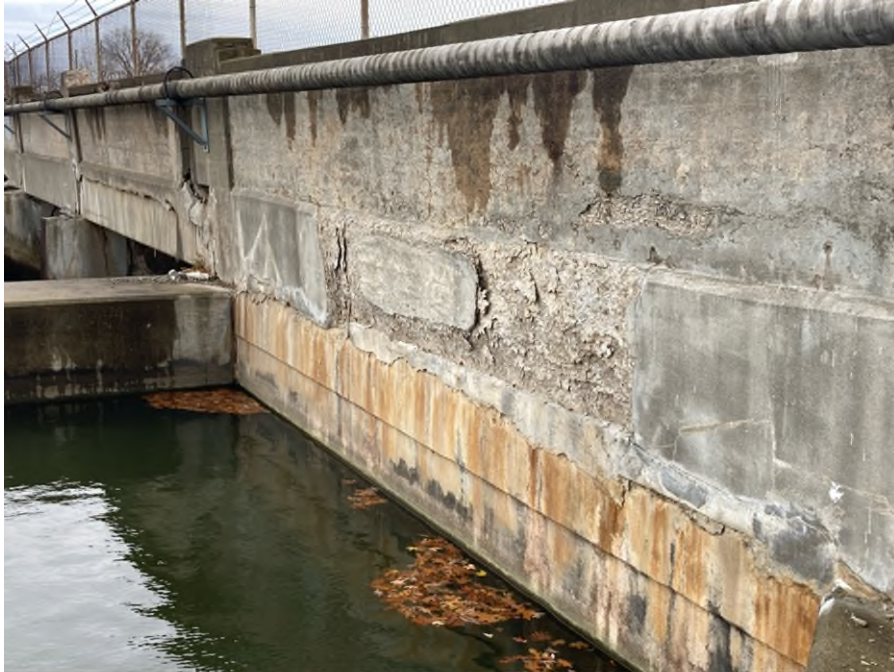
Photo #9: Principal Spillway Abutment Right Wall.  
Issue: Deteriorating Material, Action: Maintenance.  
Material: Concrete.

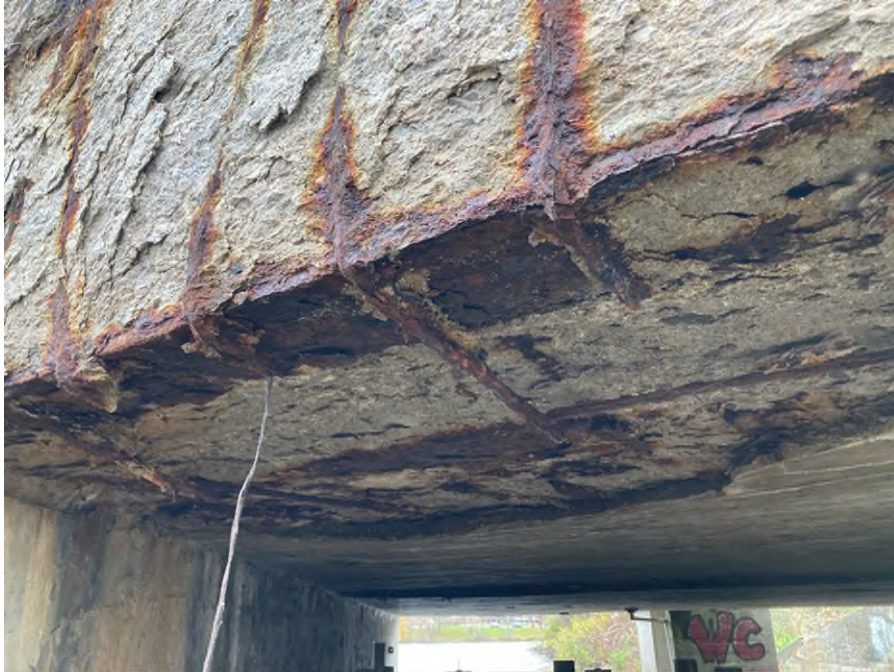
Photo #11: Principal Spillway Bridge.  
Issue: Deteriorating Material, Action: Maintenance.  
Material: Concrete.

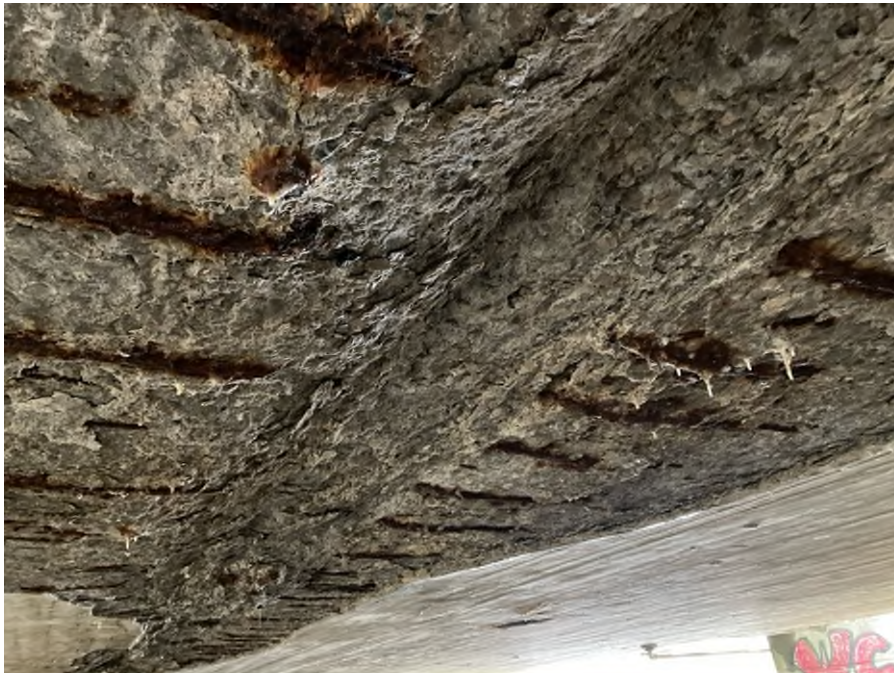
Photo #12: Principal Spillway Bridge.  
Issue: Deteriorating Material, Action: Maintenance.  
Material: Concrete.

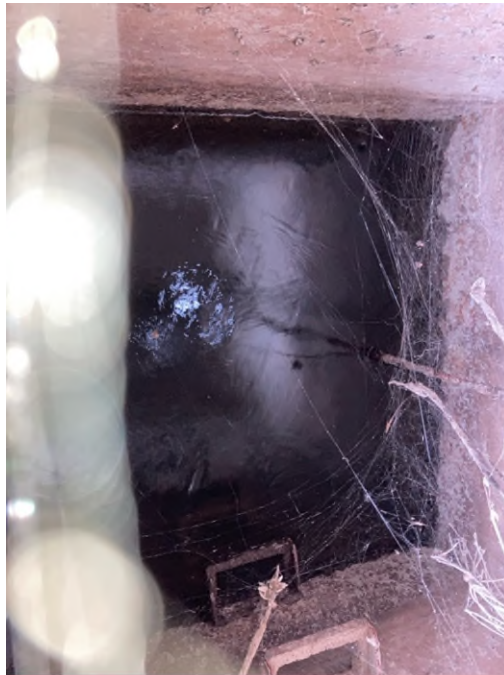
Photo #25: Fish Ladder Abandoned Gate Flow observed through gate.

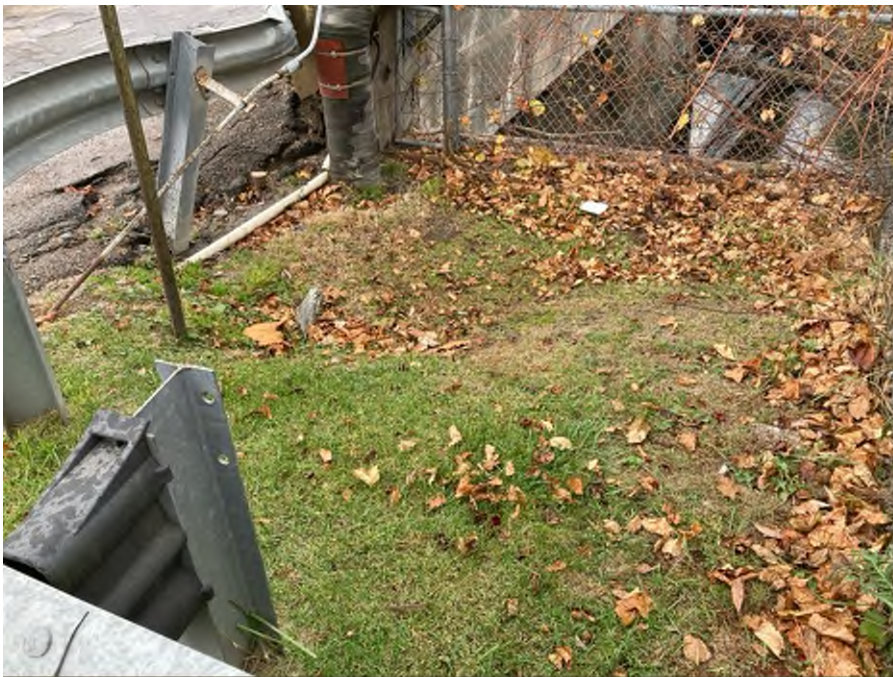
Photo #32: Embankment Upstream Slope.  
Issue: Depression, Action: Maintenance.

- a Principal Spillway: Abutment - Right Wall
  - b Principal Spillway: Bridge
- 3 **Depression (Action: Maintenance):** Reshape and stabilize area affected by depression. Remove vegetation and unsuitable fill material. Regrade the area to the original grade with material that matches the adjacent material. Install surface protection that matches the adjacent surface protection. After the depressions are filled the area should be monitored for another depression. If another depression is observed the Dam Safety Unit should be notified. Complete action by December 31, 2024.

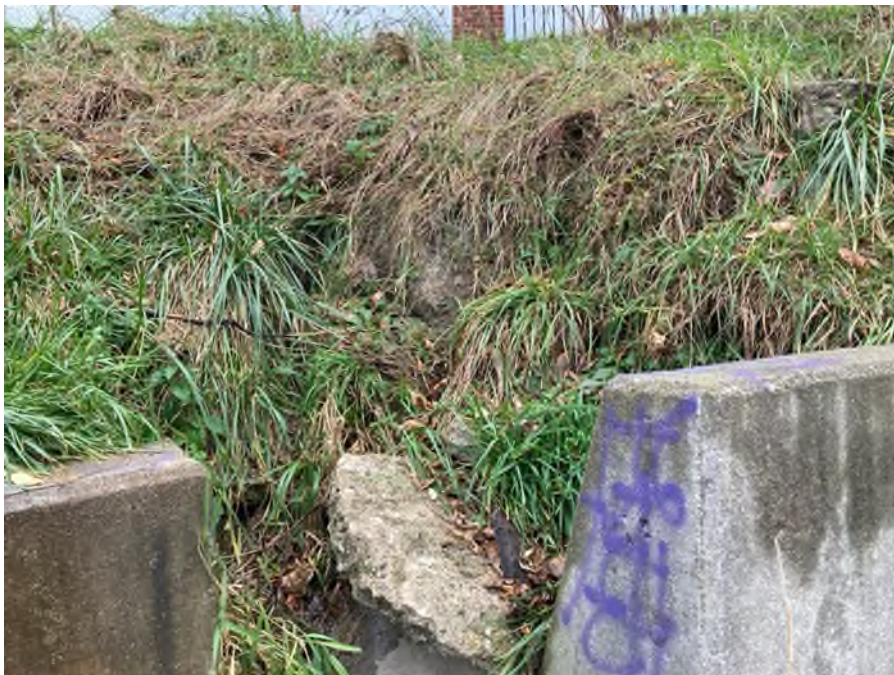
Photo #34: Embankment Downstream Slope. Right above storm sewer from Rhodes.  
likely from seepage observed.  
Issue: Depression, Action: Maintenance.

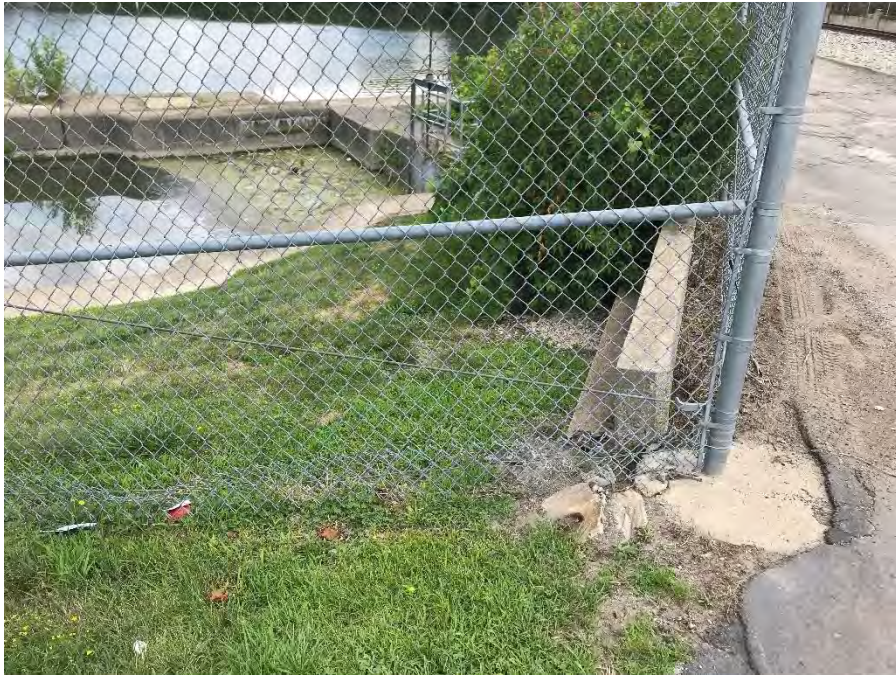
**Photograph 1 – Upstream face of right abutment viewed from right  
Note the brush growth**

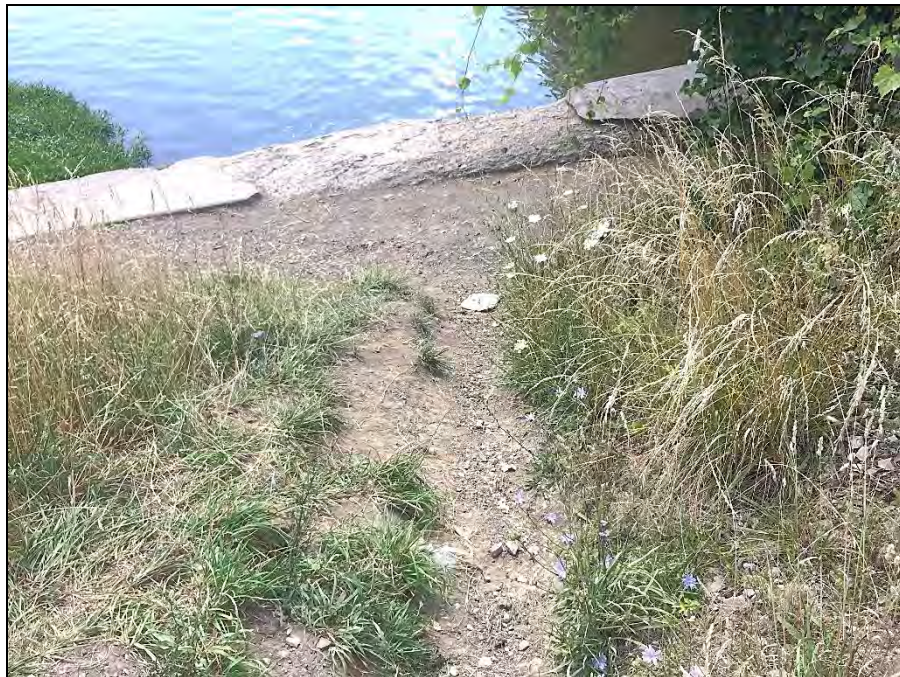
**Photograph 6 – Downstream face of left abutment viewed from left  
Note the foot traffic erosion**

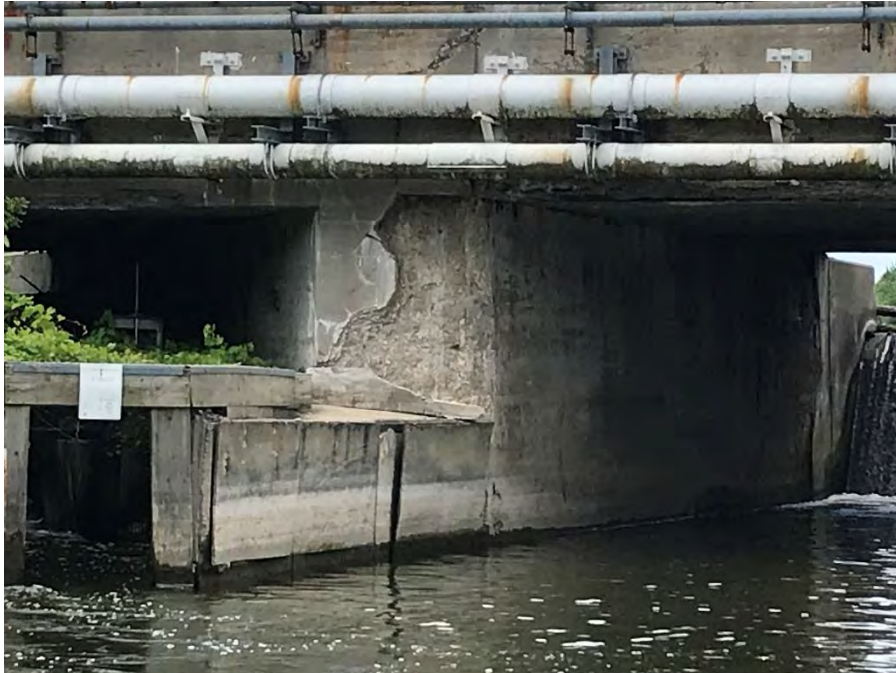
**Photograph 11 – Right downstream abutment wall  
Note the spalling and delamination**

1. Continue to monitor the condition of both downstream concrete abutment walls of the principal spillway structure on a semi-annual basis. Implement repairs as necessary.
2. Remove all trees and brush from both earthen abutments. This recommendation has been repeated since the 2011 inspection report and should be completed as soon as reasonably possible. After clearing, both abutments should be mowed a minimum of two times per year to prevent further establishment of woody vegetation and to facilitate visual inspection.
3. Remove all vegetation from the left wall of the abandoned lock system. This recommendation is repeated from the 2014 and 2017 inspection reports and should be completed as soon as reasonably possible.
4. Backfill, compact, and seed the eroded areas along the downstream face of the left earthen abutment as soon as reasonably possible.

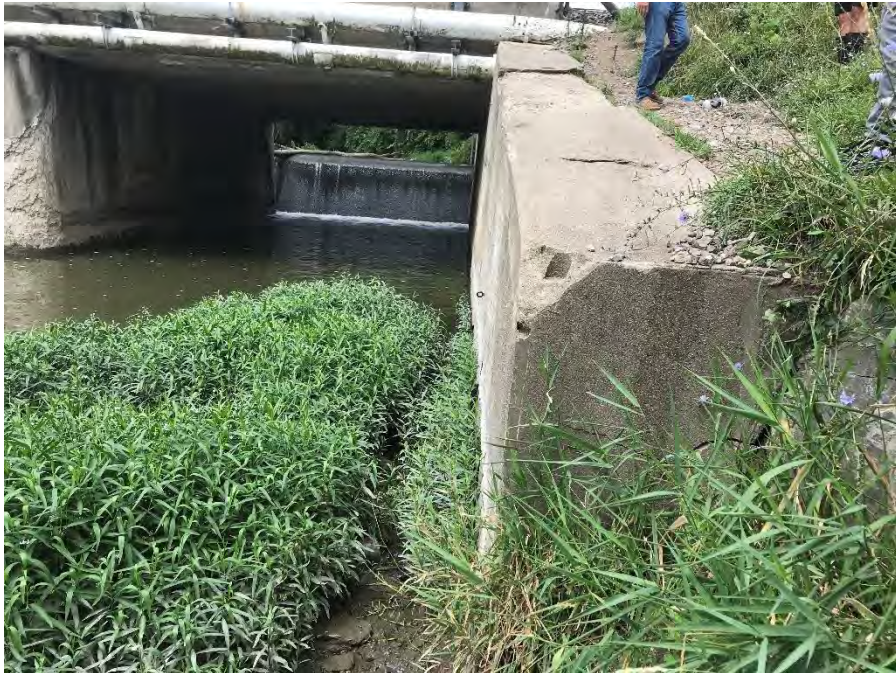
**Photograph 12 – Left downstream abutment wall  
Note the spalling**

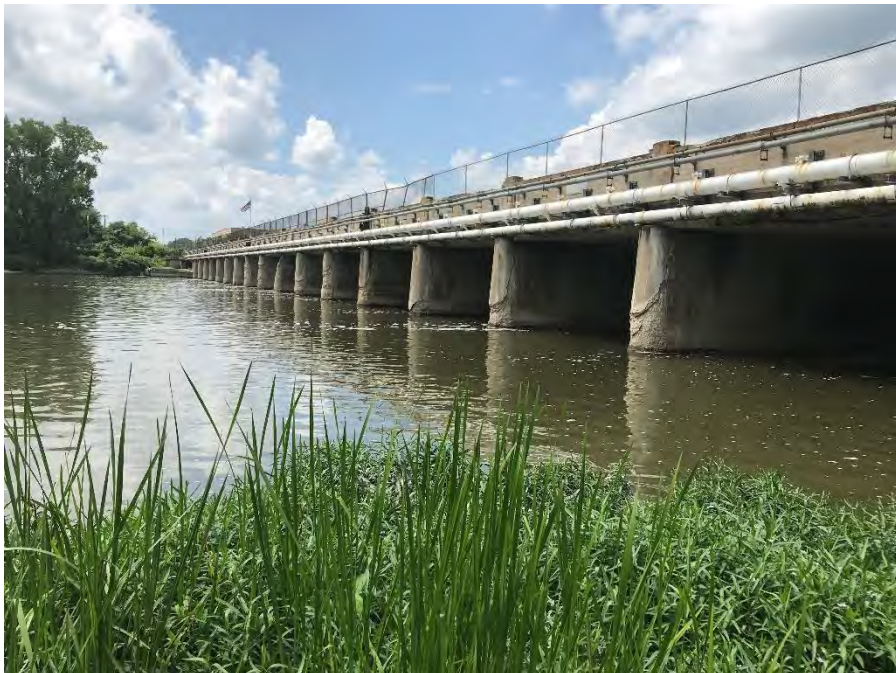
**Photograph 14 – Downstream face of bridge over spillway  
Note the spalling and delamination of piers**

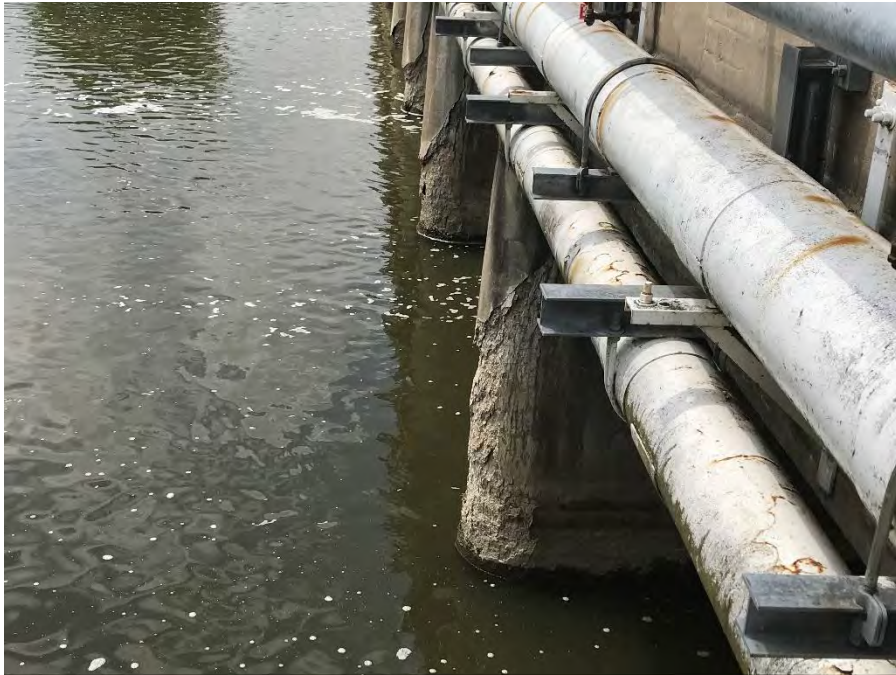
**Photograph 15 – Typical pier spalling and delamination**

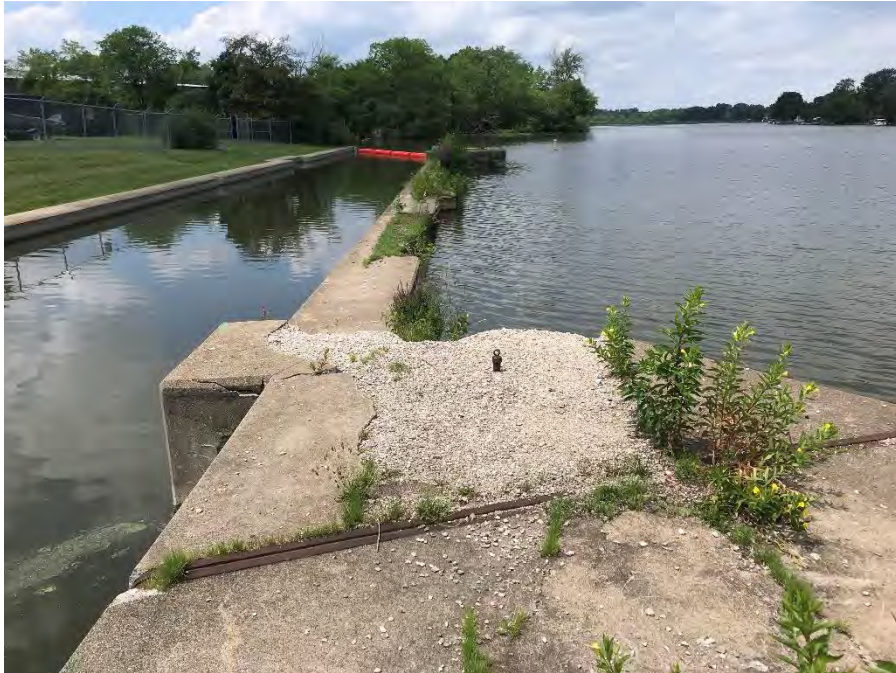
**Photograph 17 – Left abutment wall of abandoned lock  
Note the spalling and cracking**

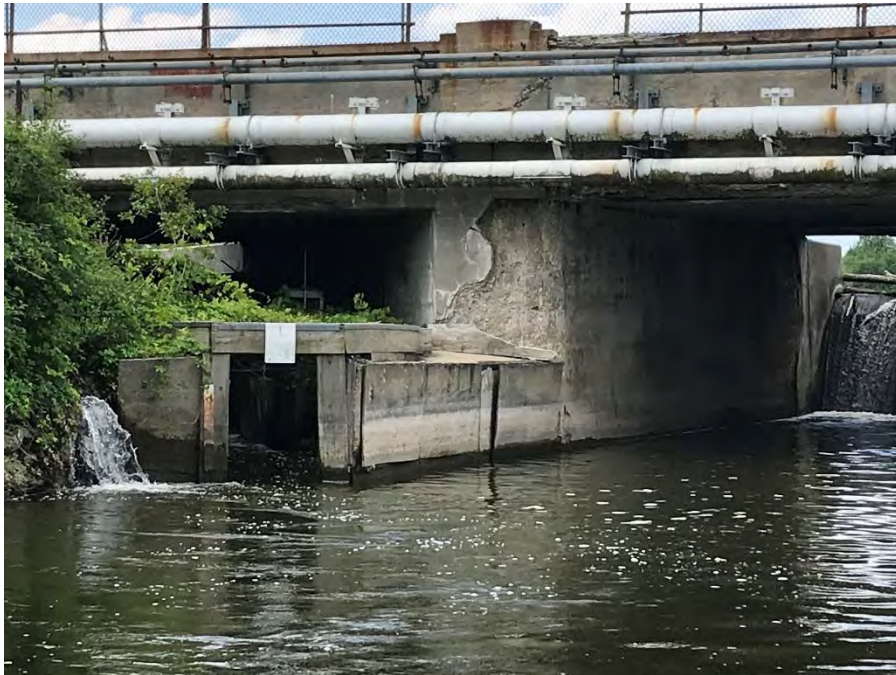
**Photograph 21 – DNR fish ladder outlet  
Note the major leaking at right wall**

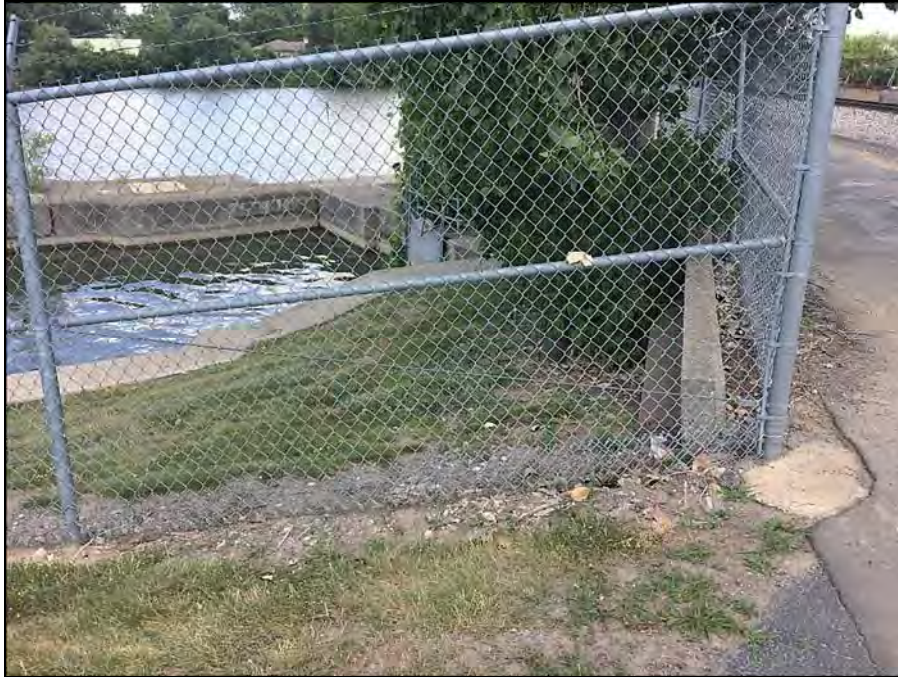
**Photograph 1 – Upstream face of right abutment viewed from right  
Note the small trees and brush near the spillway structure**

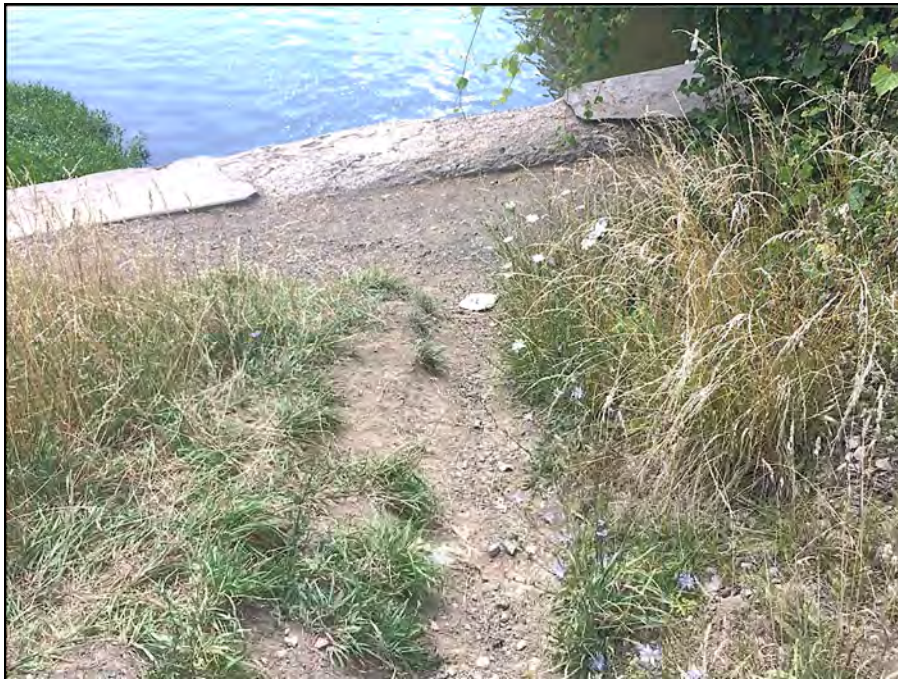
**Photograph 4 – Left abutment viewed from left  
Note the foot traffic erosion**

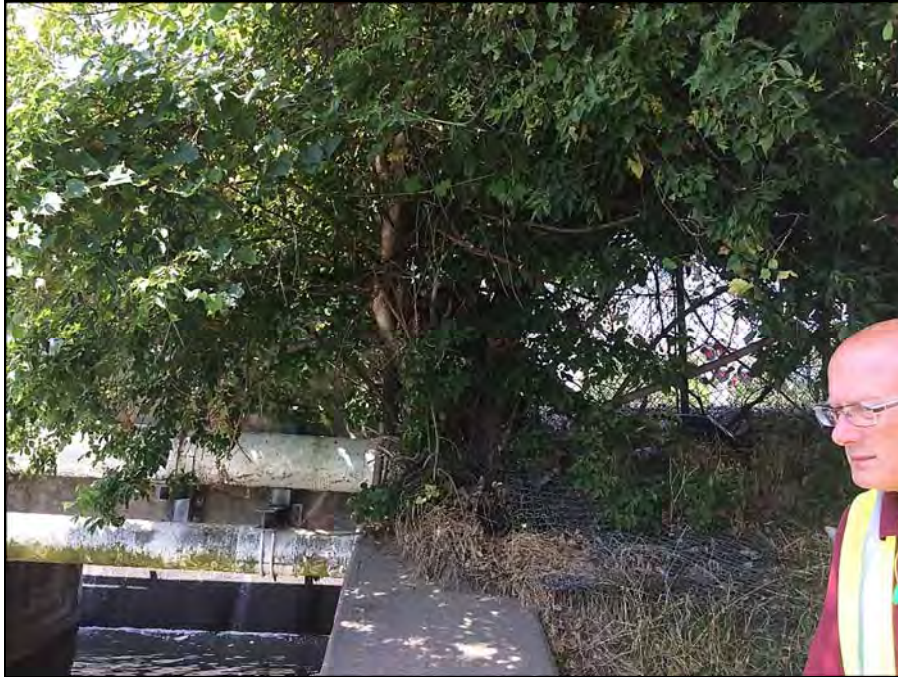
**Photograph 5 – Trees growing from left abutment**

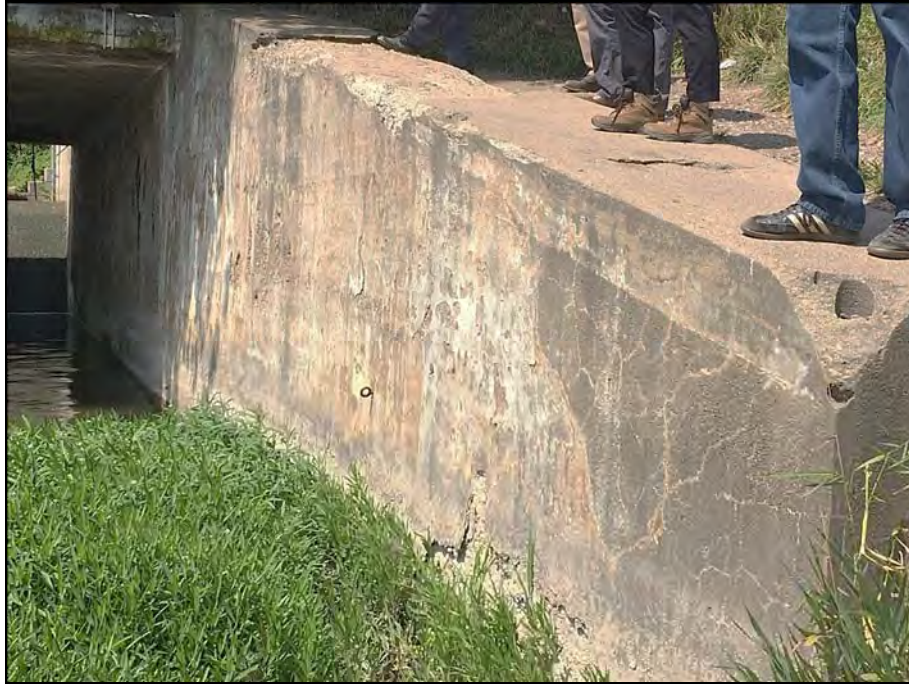
**Photograph 9 – Downstream left spillway abutment wall  
Note the minor spalling and cracking**

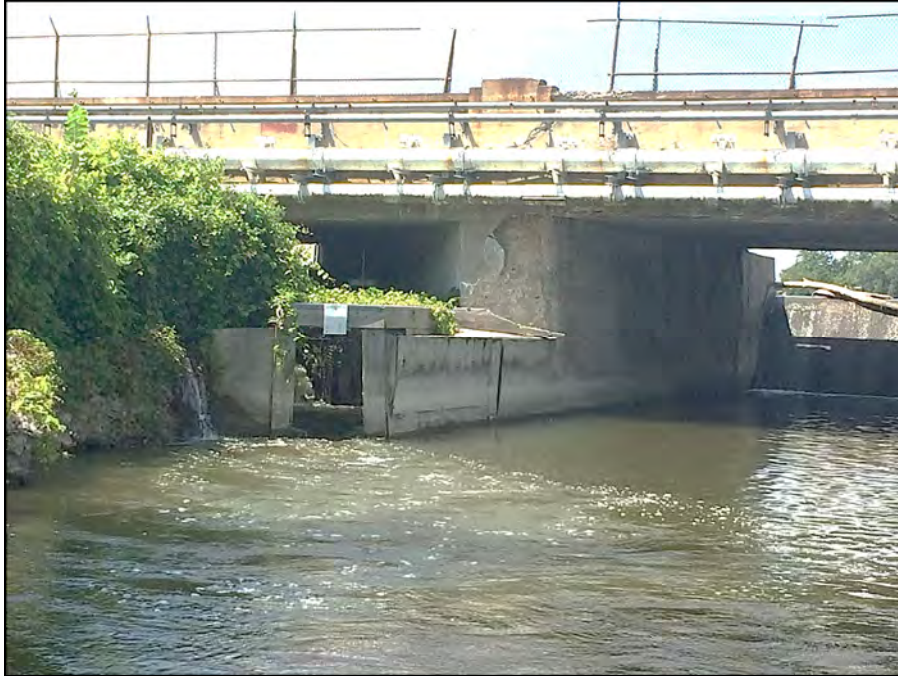
**Photograph 11 – Downstream right spillway abutment wall  
Note the spalling and fish ladder outlet**

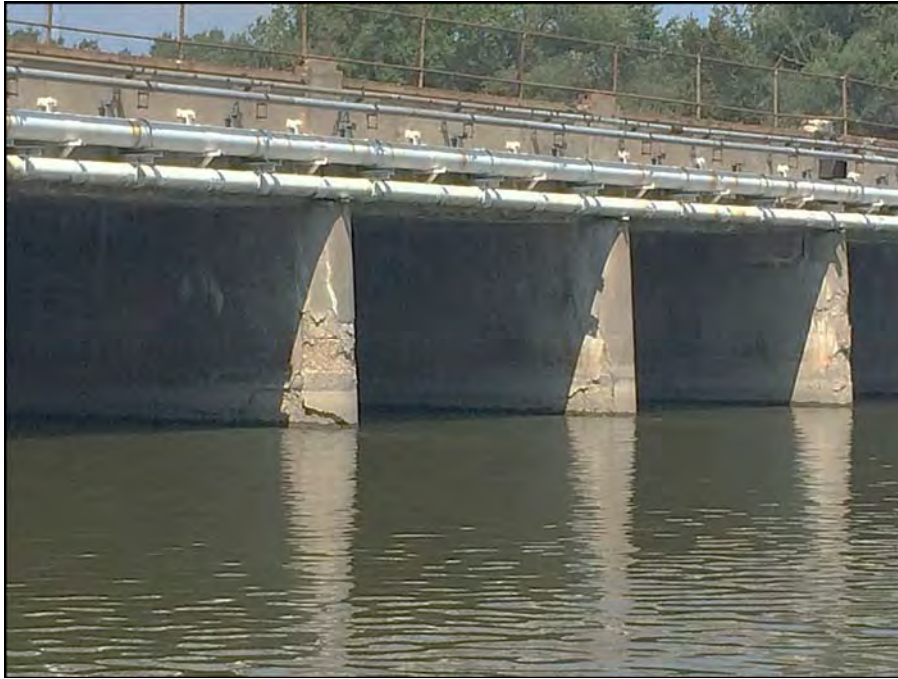
**Photograph 13 – Typical spalling of bridge piers**

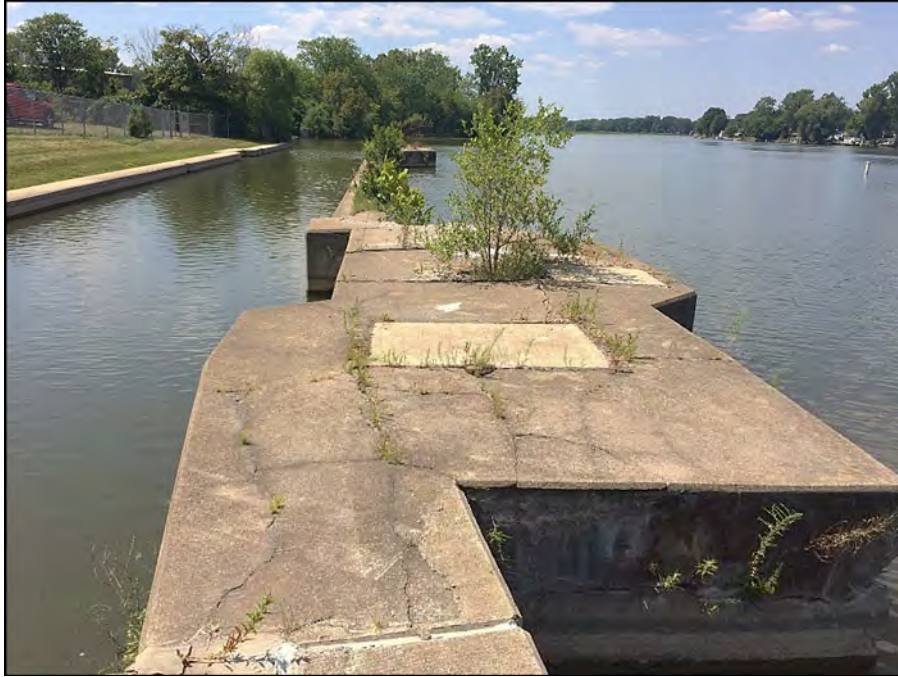
**Photograph 17 – Left wall of abandoned lock  
Note that this is the original wall and shows  
signs of deterioration**

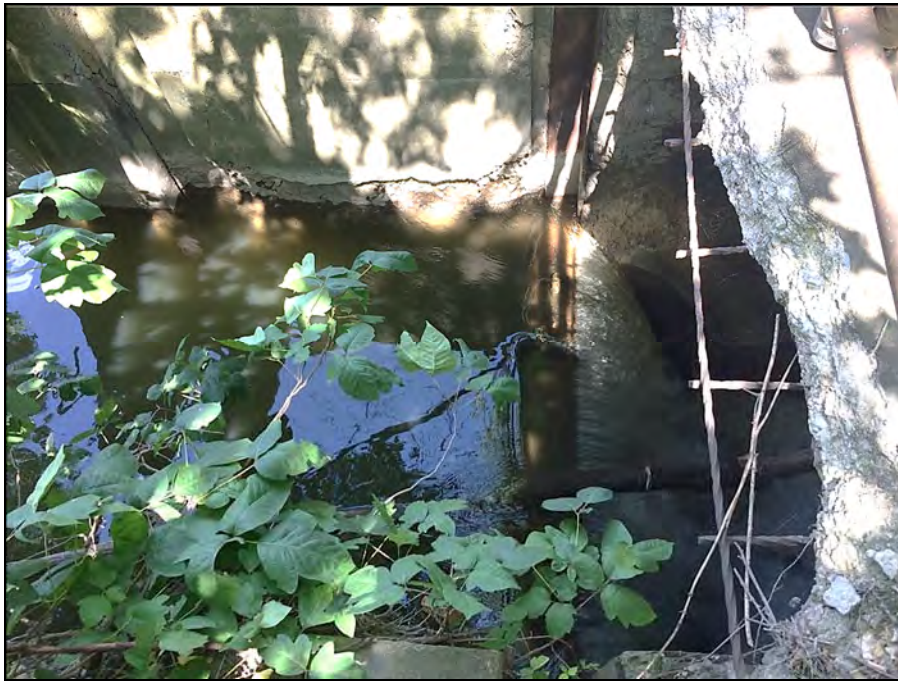
**Photograph 20 – Small powerhouse head gate viewed from right  
Note the deteriorated concrete and exposed reinforcing steel**

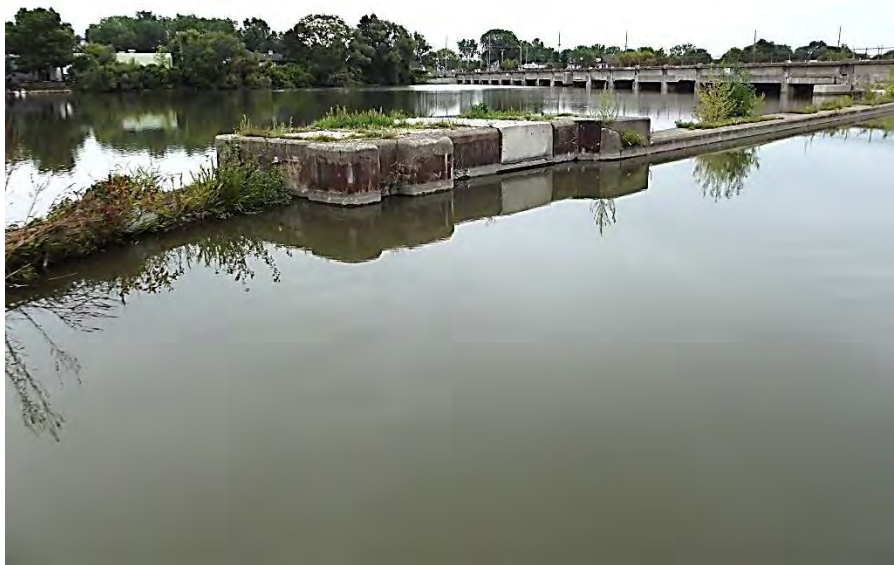
**Photograph 12 – Upstream portion of lock wall viewed from right.  
Note the deteriorated concrete vegetation growing from cracks.**

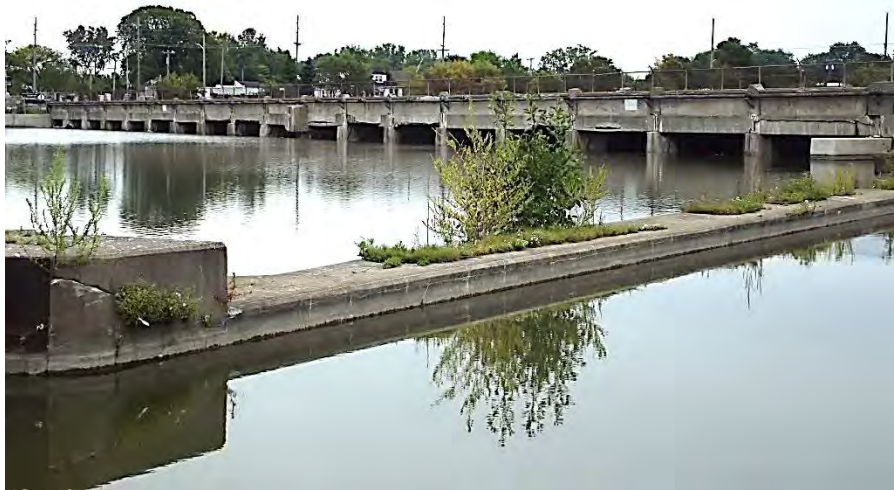
**Photograph 13 – Downstream portion of lock wall viewed from right.  
Note the deteriorated concrete and vegetation growing from cracks.**
