HURON-CLINTON
metroparks

Kensington Metropark
Stormwater Management Plan

September 2019

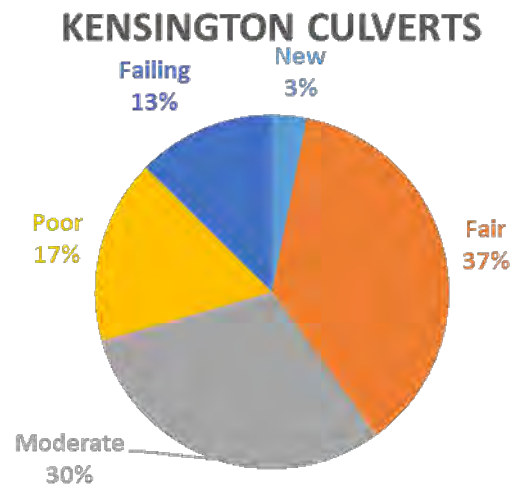
Left: Failing culvert in Kensington Metropark. Right: Proportion of culverts in each condition category.

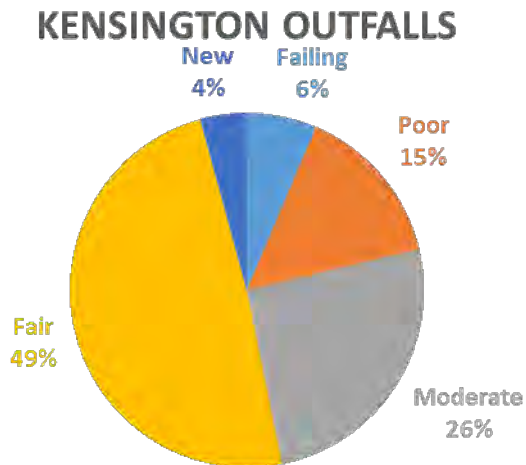
Proportion of outfalls in each condition category. Right: Blocked outfall in failing condition in Kensington Metropark.

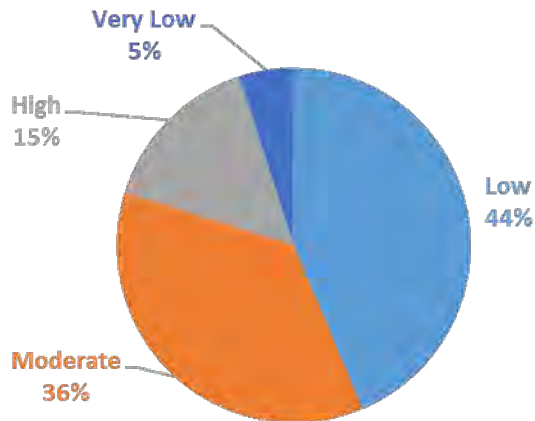
Erosion Condition	Feet of Streambank (miles)	Cost of Restoration
Very High	0.0 (0.0)	
High	2,436 (0.46)	\$598,000
Moderate	5,805 (1.10)	
Low	7,003 (1.33)	
Very Low	802 (0.15)	
Total:	16,047 (3.03)	\$598,000

Left: Proportion of stream bank in each erosion severity category. Right: High erosion on a bank in Kensington Metropark.

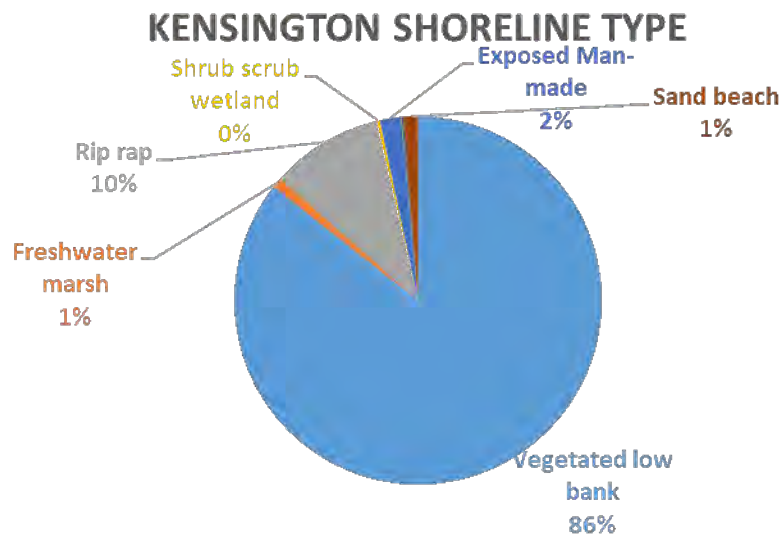
Most of the shoreline in Kensington Metropark is part of Kent Lake. The rest is occasional small ponds which don't require restoration.

Proportion of each shoreline type present in Kensington Metropark.
