SUBJECT: Flat Rock Dam, Dam ID No. 556; Wayne County

**DAM SAFETY INSPECTION REPORT  
FLAT ROCK DAM – DAM ID NO. 556  
HURON RIVER  
WAYNE COUNTY – SW 1/4 SECTION 31, T 04S, R 10E**

APPENDIX B – INSPECTION PHOTOS

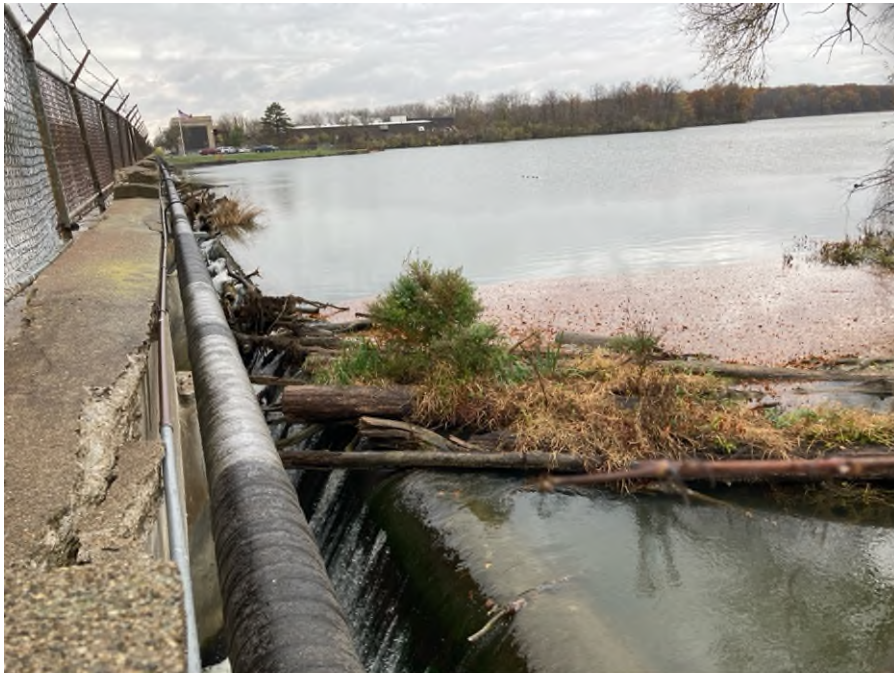
Photo #3: Principal Spillway Weir Wall.  
Issue: Debris, Action: Maintenance.

- 1 **Debris (Action: Maintenance):** Remove debris. Complete action as soon as possible.
  - a Principal Spillway: Weir Wall
- 2 **Deteriorating Material (Action: Maintenance, Material: Concrete):** Remove the deteriorated concrete and install new concrete. Remove all deteriorated concrete, additional concrete may have to be removed to ensure the patch is a minimum of 3 inches thick. Roughen existing concrete surface to improve the patch bond. Install high strength concrete. Complete action by December 31, 2024.

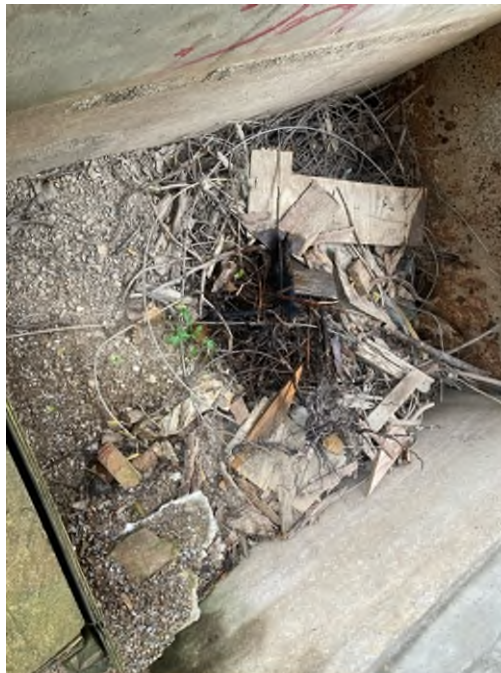
Photo #16: Fish Ladder Abandoned Conduit.  
Issue: Depression, Action: Maintenance.

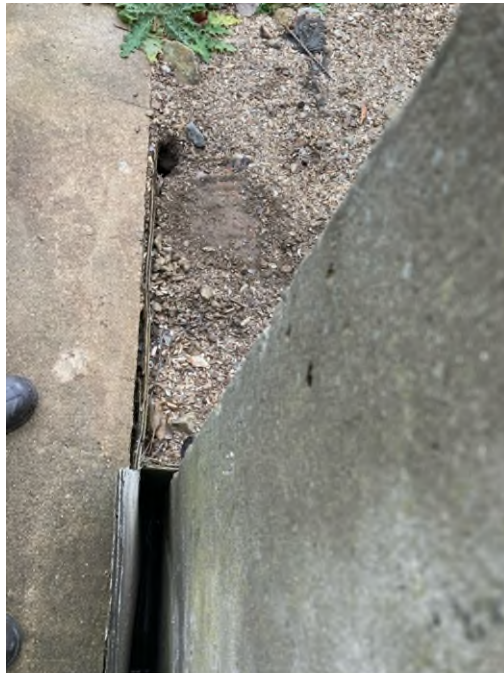
Photo #17: Fish Ladder Abandoned Conduit.  
Issue: Sink Hole, Action: Maintenance.

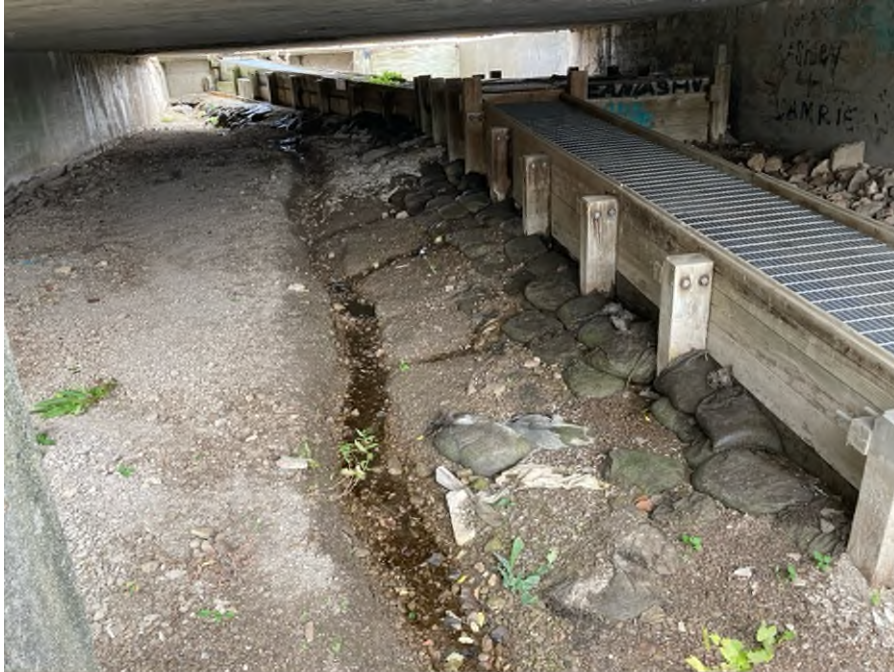
Photo #27: Fish Ladder Chute.  
Issue: Seepage, Action: Monitor.  
Type: Flow.

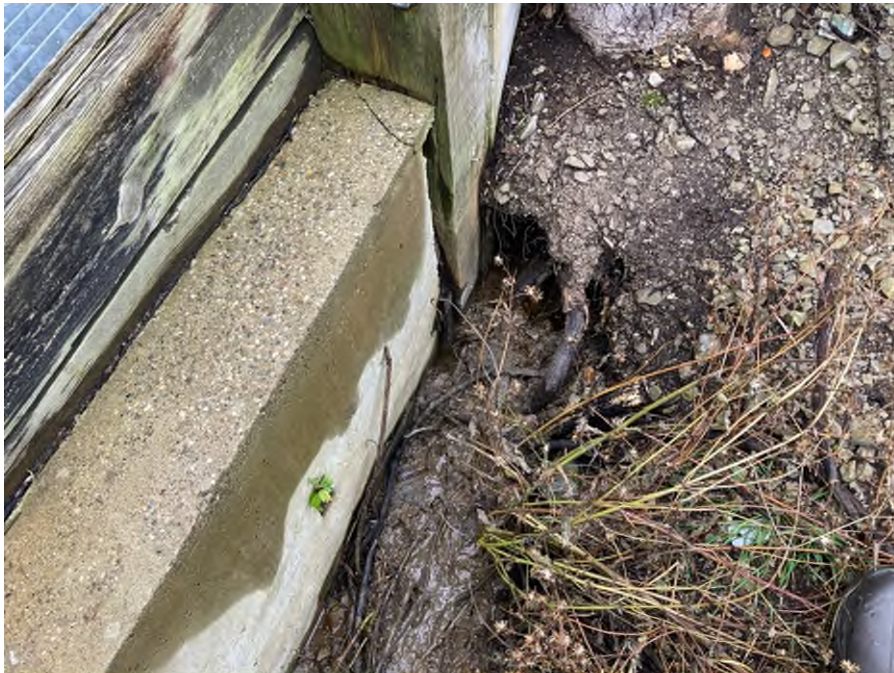
Photo #28: Fish Ladder Chute.  
Issue: Seepage, Action: Monitor.  
Type: Flow.

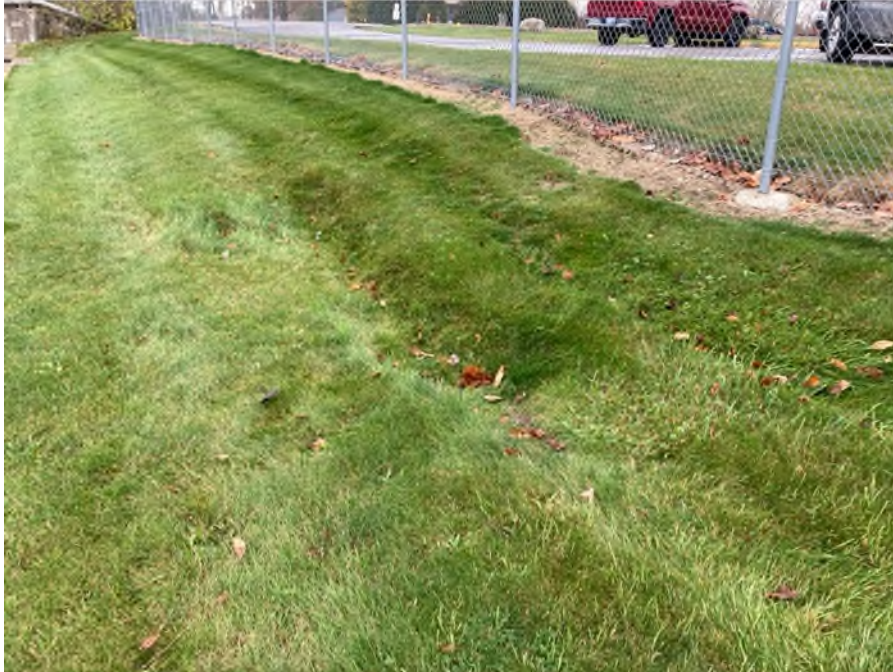
Photo #31: Embankment Upstream Slope.  
Issue: Depression, Action: Maintenance.

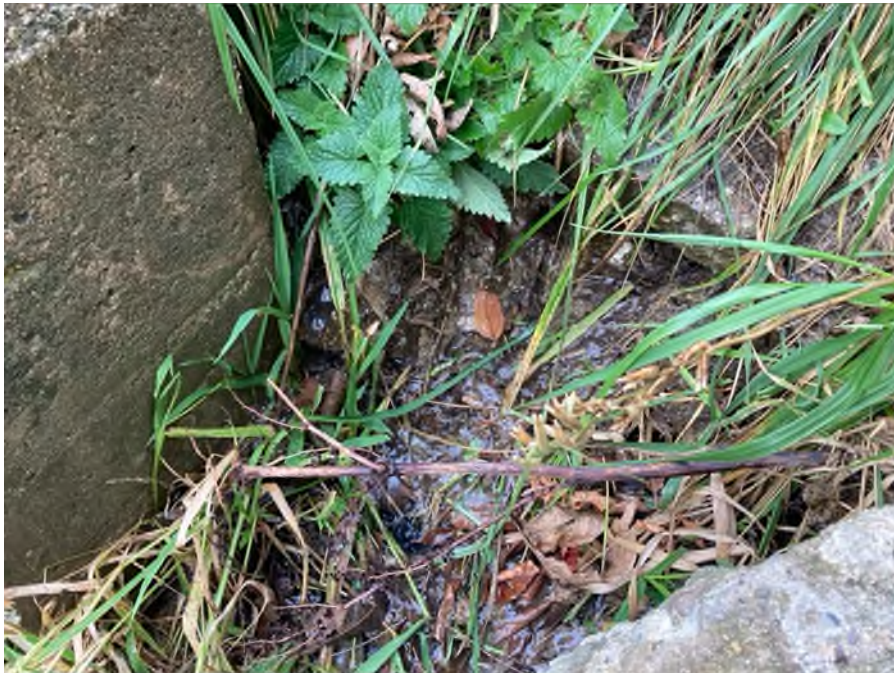
Photo #33: Embankment Downstream Slope. Might be from storm sewer.  
Issue: Seepage, Action: Monitor.  
Type: Flow.

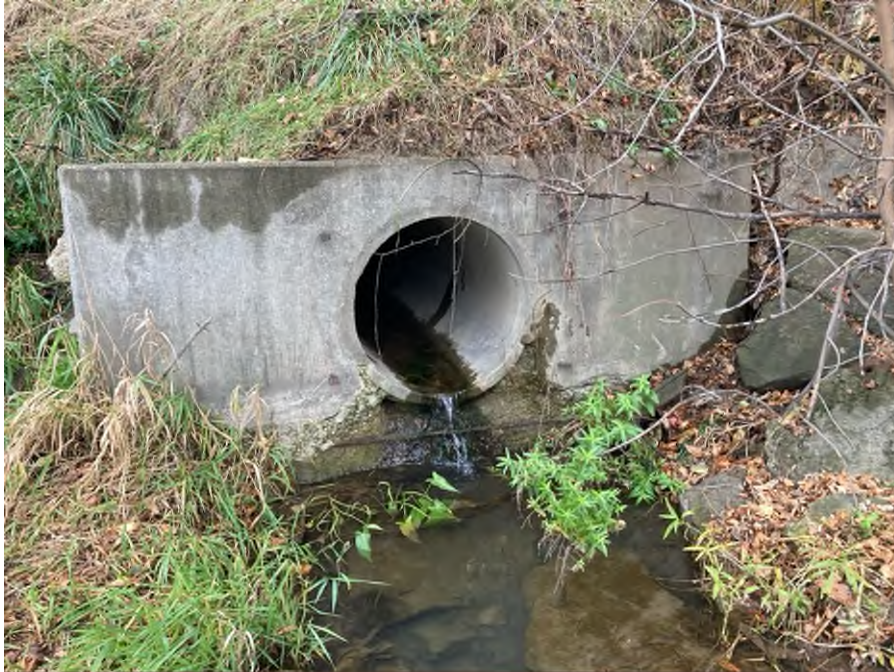
Photo #35: Embankment Downstream Slope. Drainage pipe for roads.

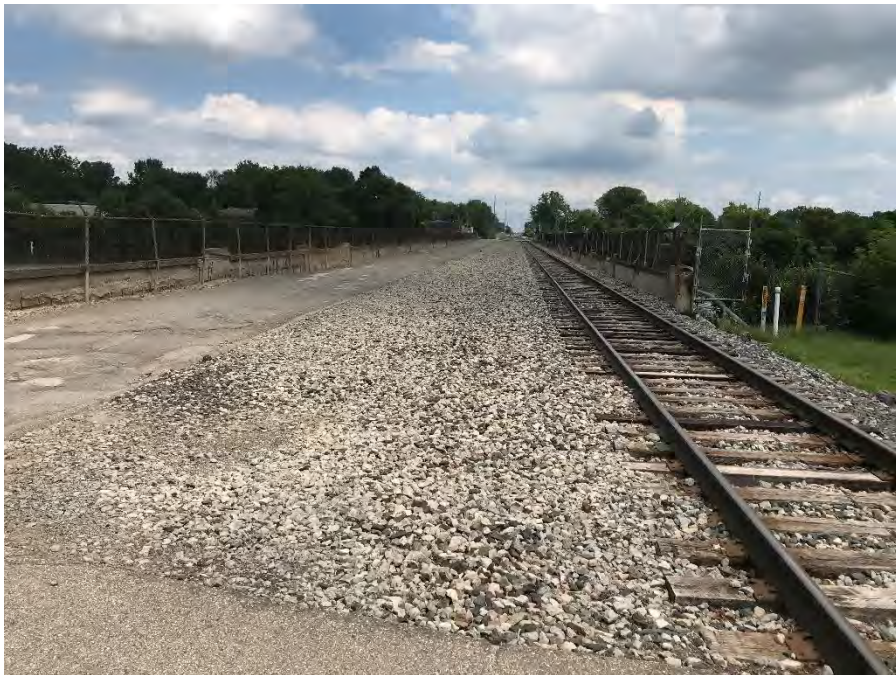
**Photograph 2 – Abutment crest viewed from right**

The dam's earthen abutments, shown in Photographs 1 through 6, are in fair condition. No sloughs, slumps, differential settlement, cracking, or major erosion was observed. However, both abutments have small trees and brush growing near the spillway structure walls, as shown in Photographs 1, 3, and 4. Trees and brush can provide shortened seepage pathways along their root systems that can lead to internal erosion (piping) of abutment fill material, cause large section loss in the event of a blow down, provide a haven for burrowing animals, and obscure underlying deficiencies. Therefore, all trees and brush should be removed from the earthen abutments. This recommendation has been repeated since the 2011 inspection report and should be completed as soon as reasonably possible. After clearing, both abutments should be mowed a minimum of two times per year to prevent further establishment of woody vegetation and to facilitate visual inspection.

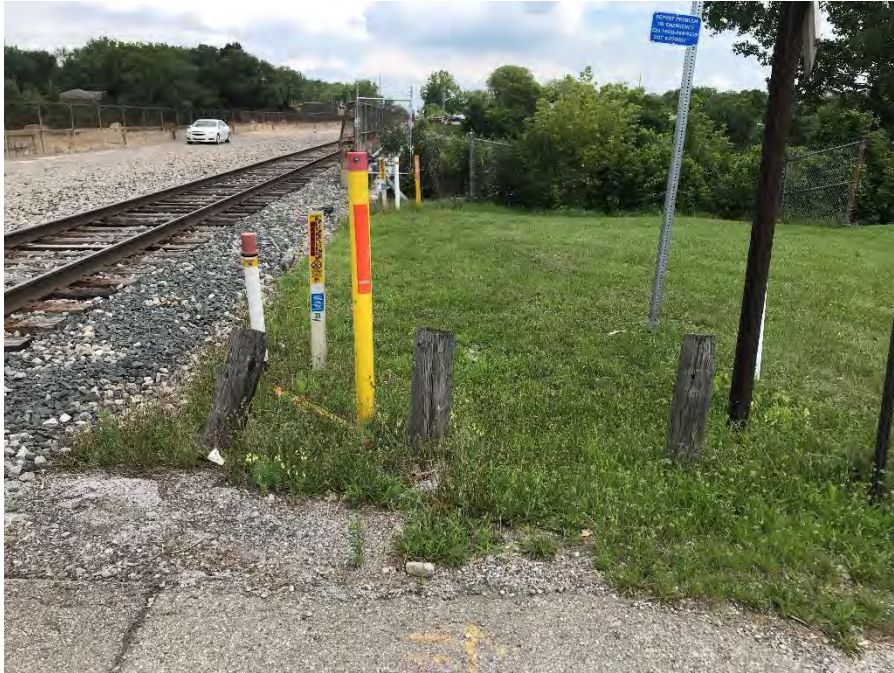
**Photograph 3 – Downstream face of right abutment viewed from right  
Note the trees and brush**

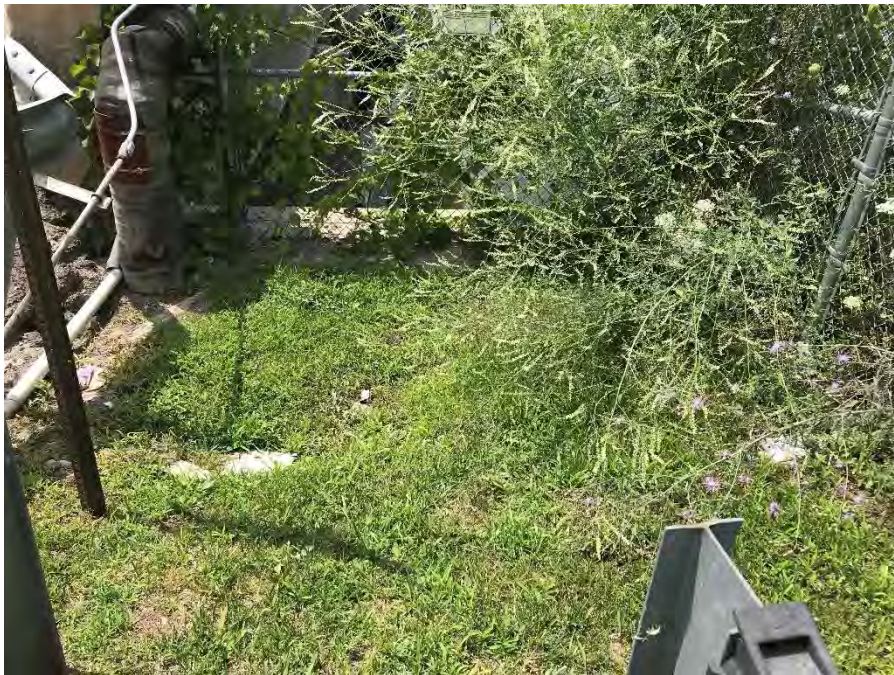
**Photograph 4 – Upstream face of left abutment viewed from left  
Note the tall weeds and brush**

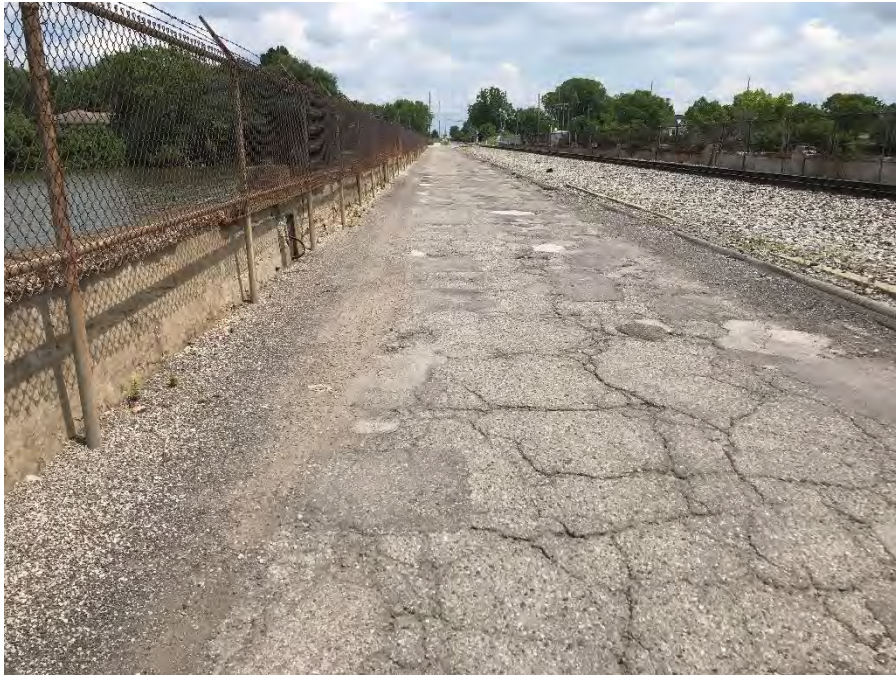
**Photograph 5 – Left abutment crest viewed from left**

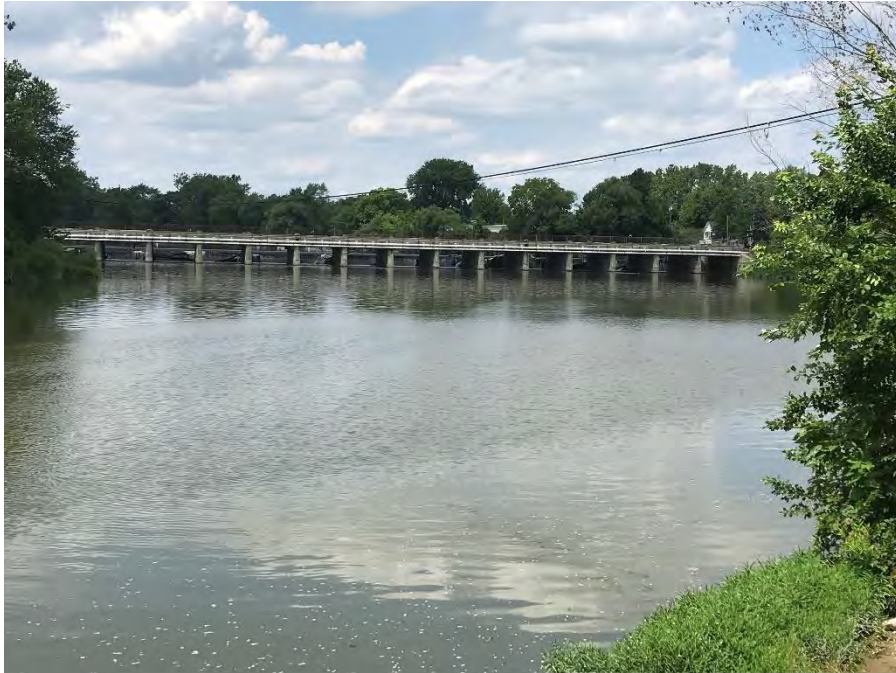
**Photograph 7 – Principal spillway viewed from downstream**

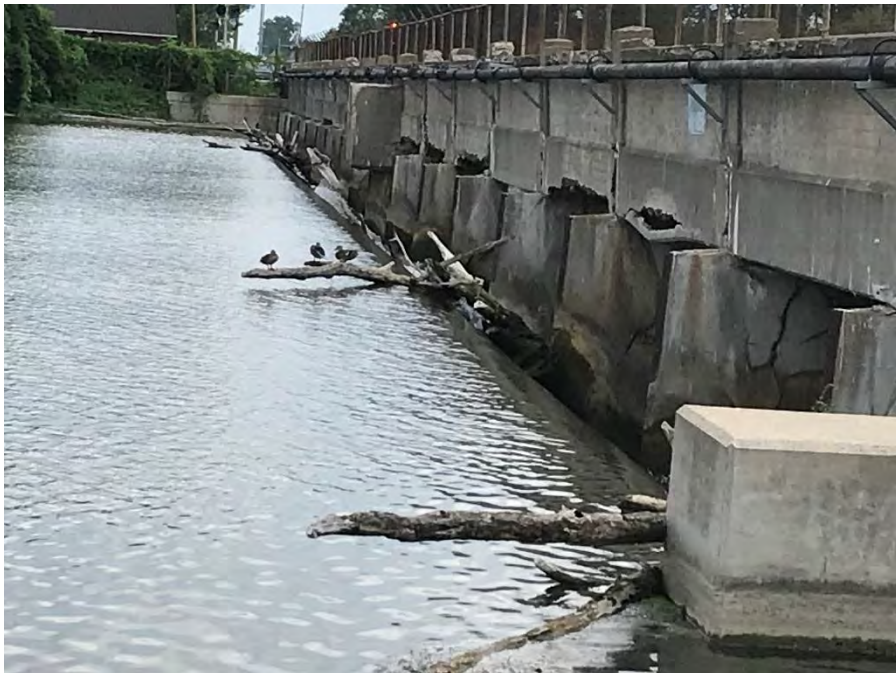
**Photograph 8 – Spillway crest viewed from right  
Note the minor debris build up and delamination of bridge beams**

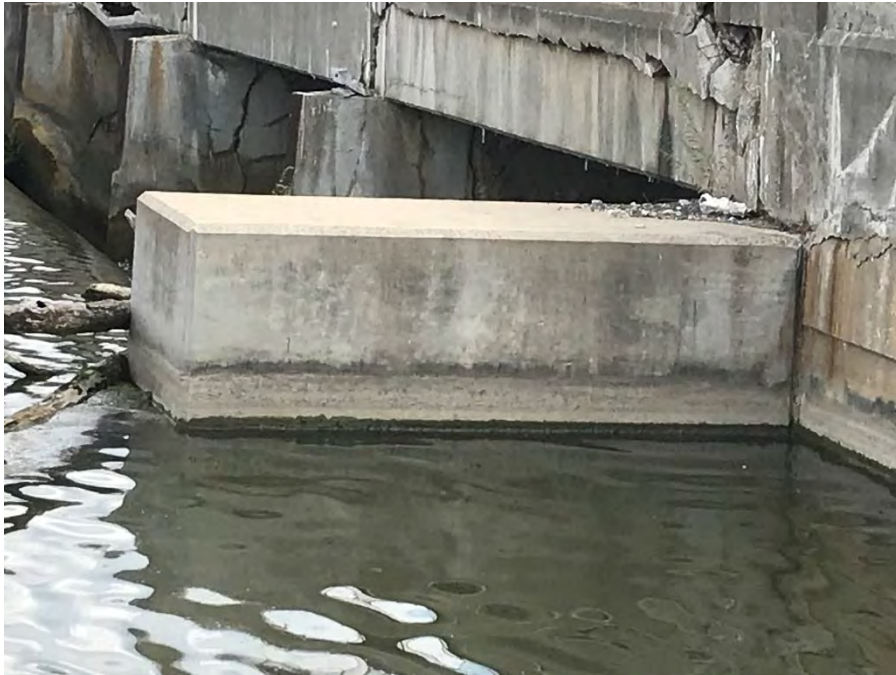
**Photograph 9 – Right upstream abutment wall**

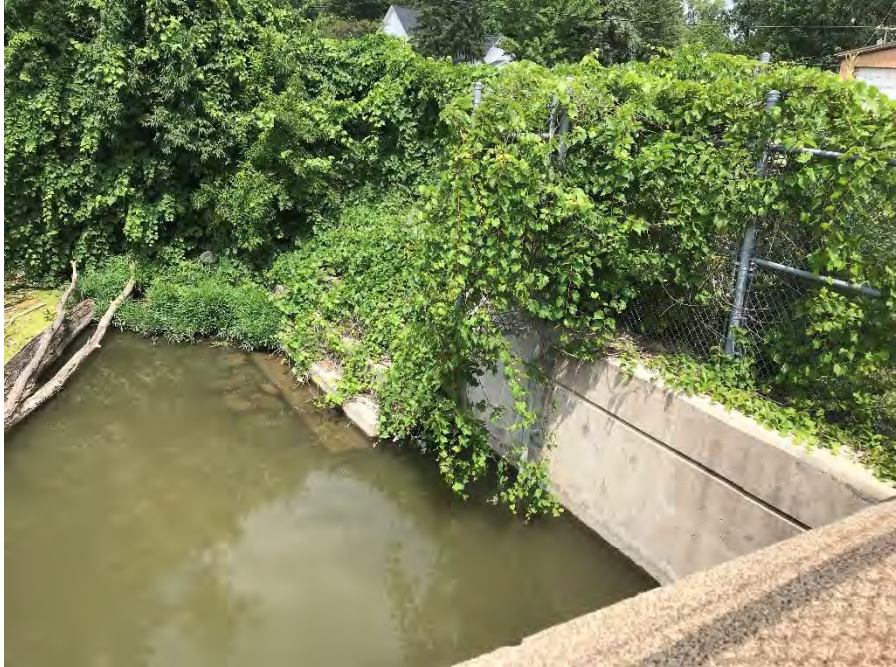
**Photograph 10 – Left upstream abutment wall  
Note the overgrowth of vegetation**

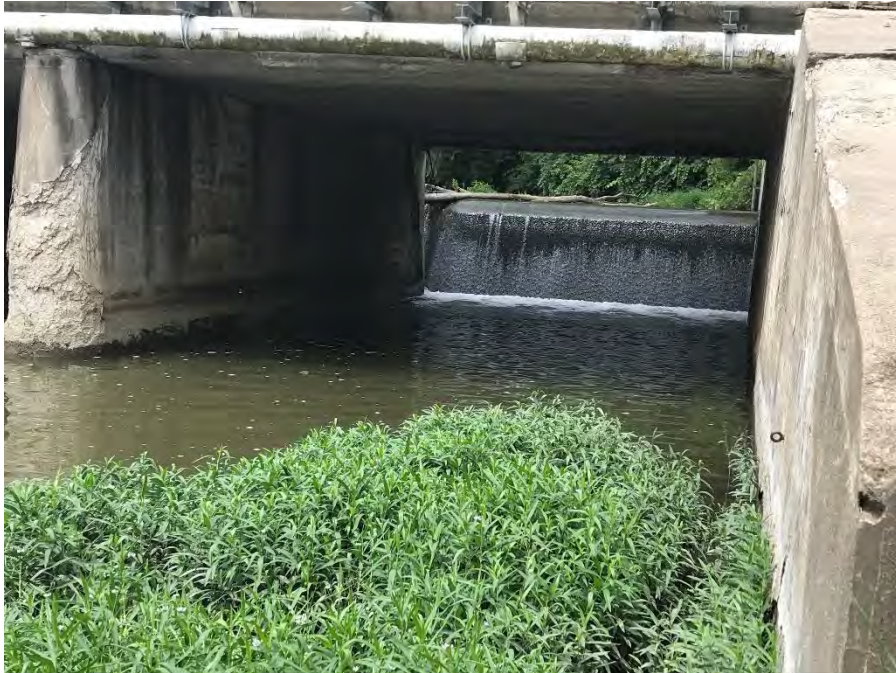
**Photograph 13 – Typical spillway bay**

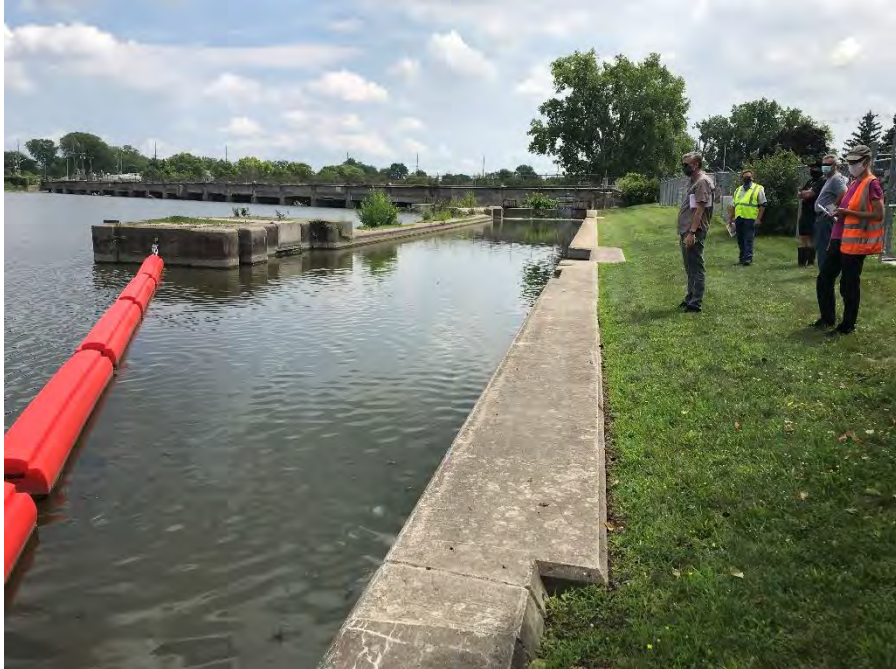
**Photograph 16 – Right abutment wall of abandoned lock**

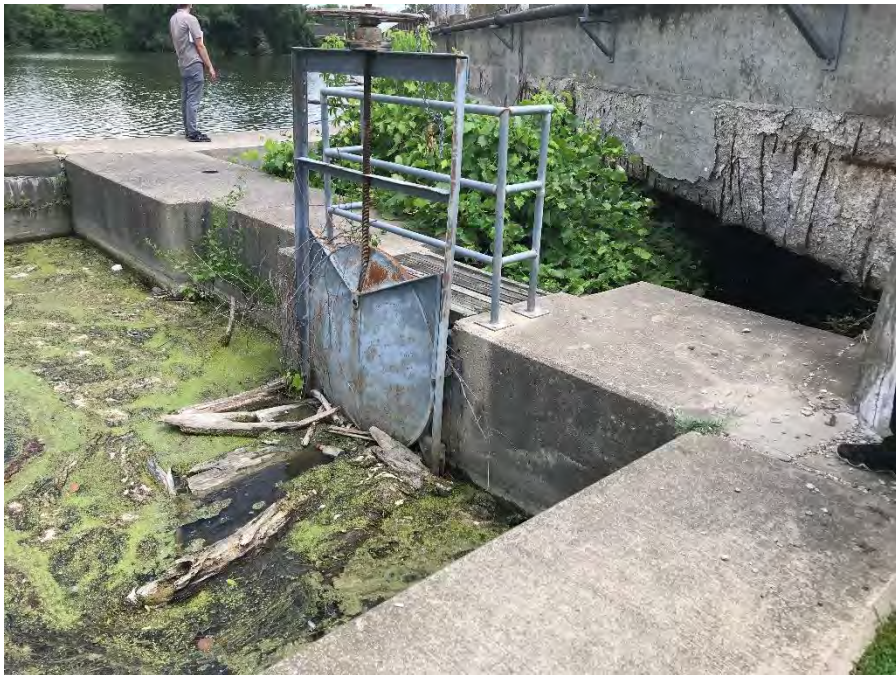
**Photograph 18 – Right lock gate and operator  
Note that this gate acts as the inlet to the DNR fish ladder**

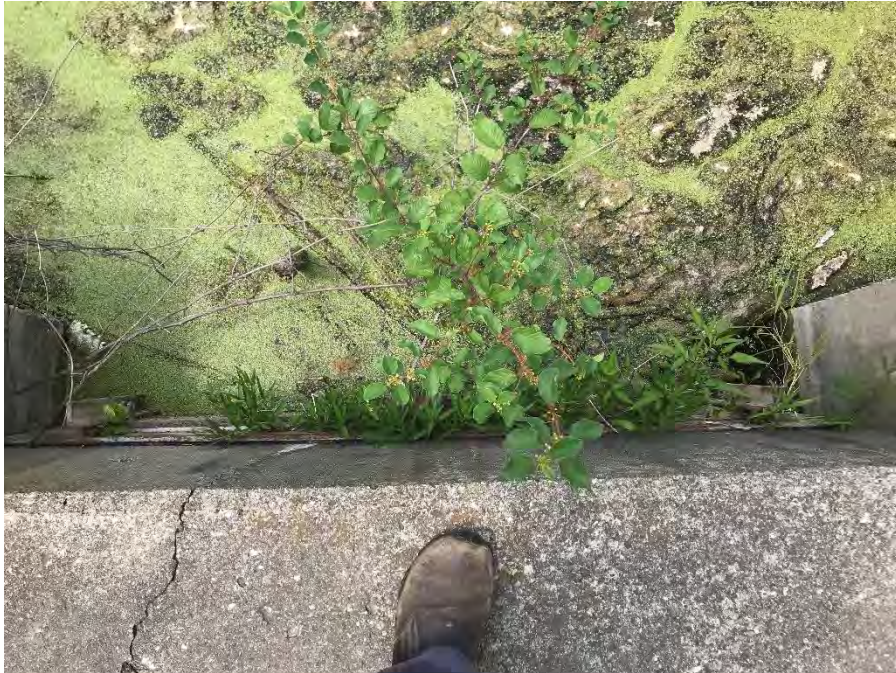
**Photograph 19 – Left lock gate**

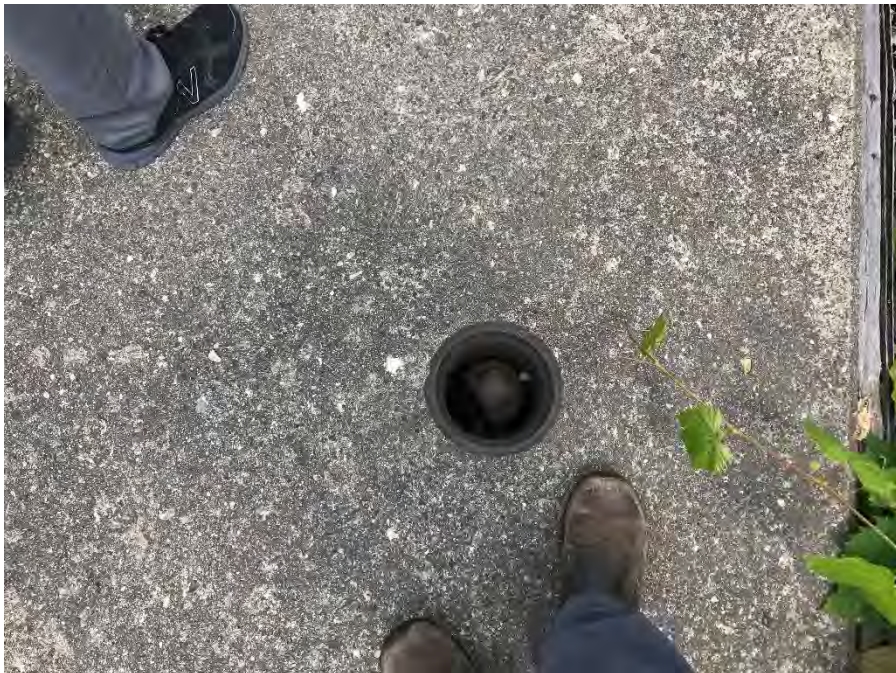
**Photograph 20 – Left gate operator**

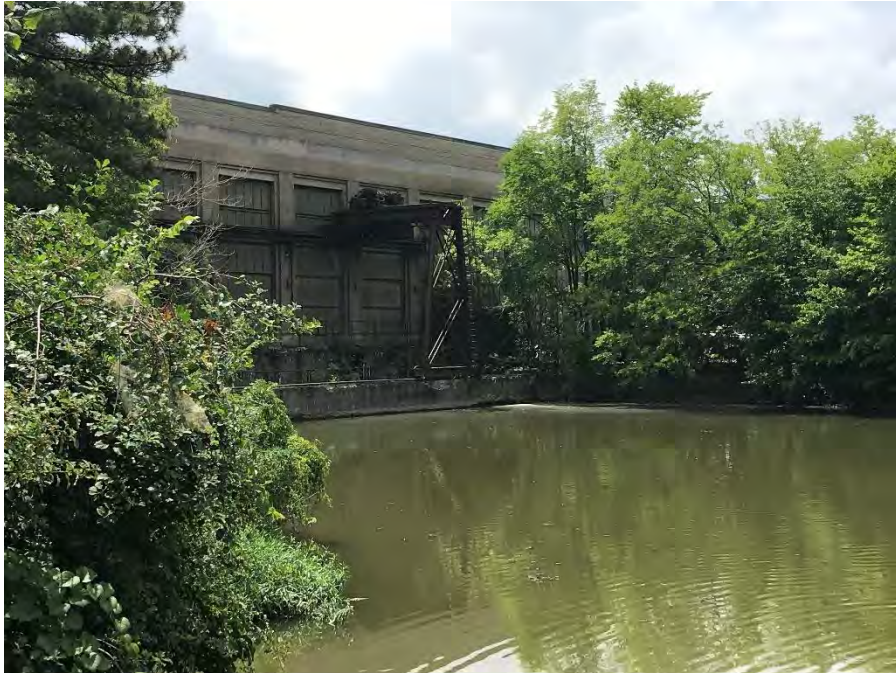
**Photograph 23 – Former powerhouse inlet viewed from upstream**

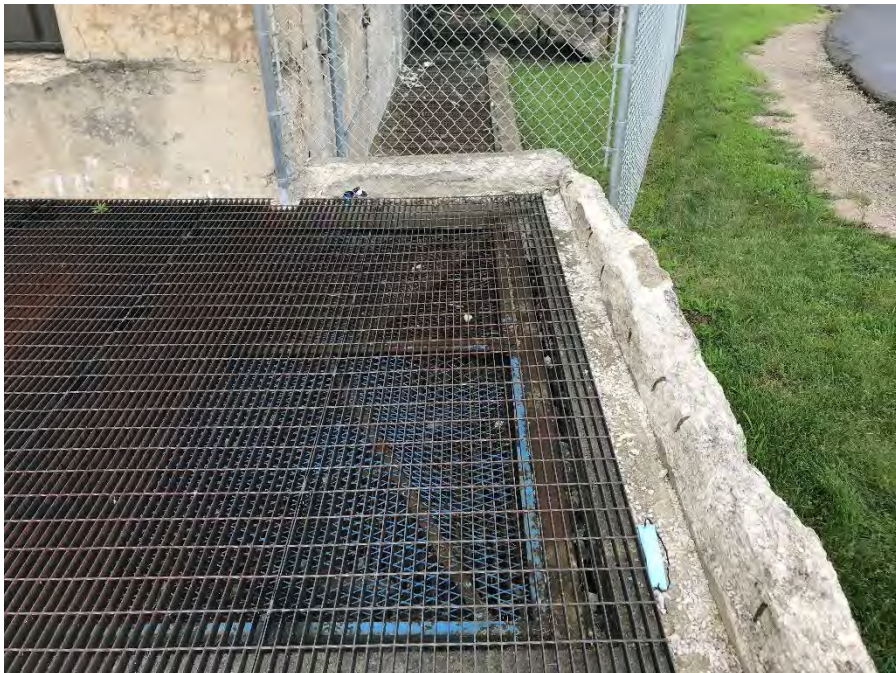
**Photograph 24 – Bypass channel at left of powerhouse  
Note that there was flow through this channel during this inspection**

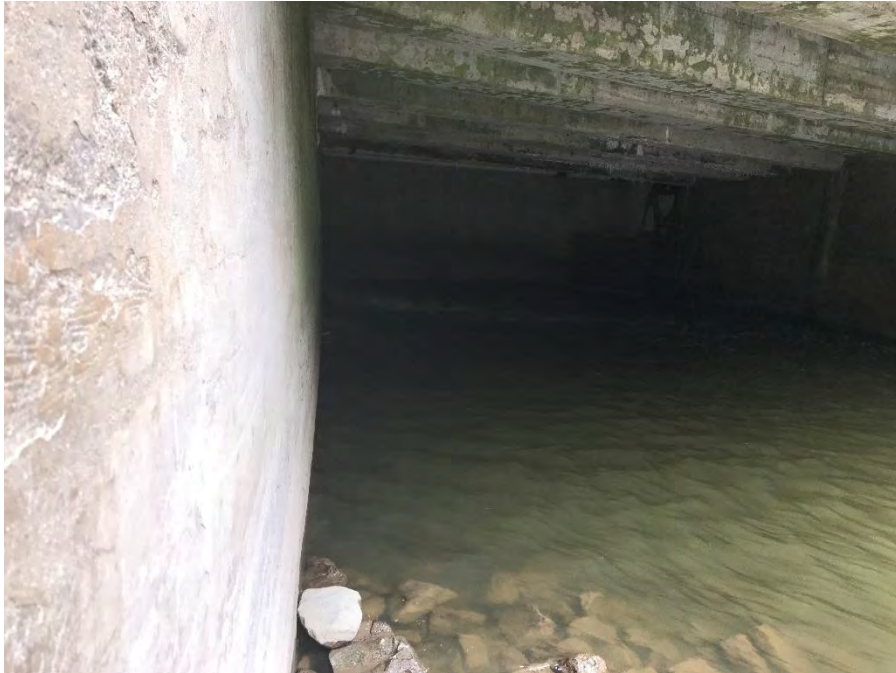
**Photograph 25 – Powerhouse outlet viewed from downstream  
Note the flow from the right**

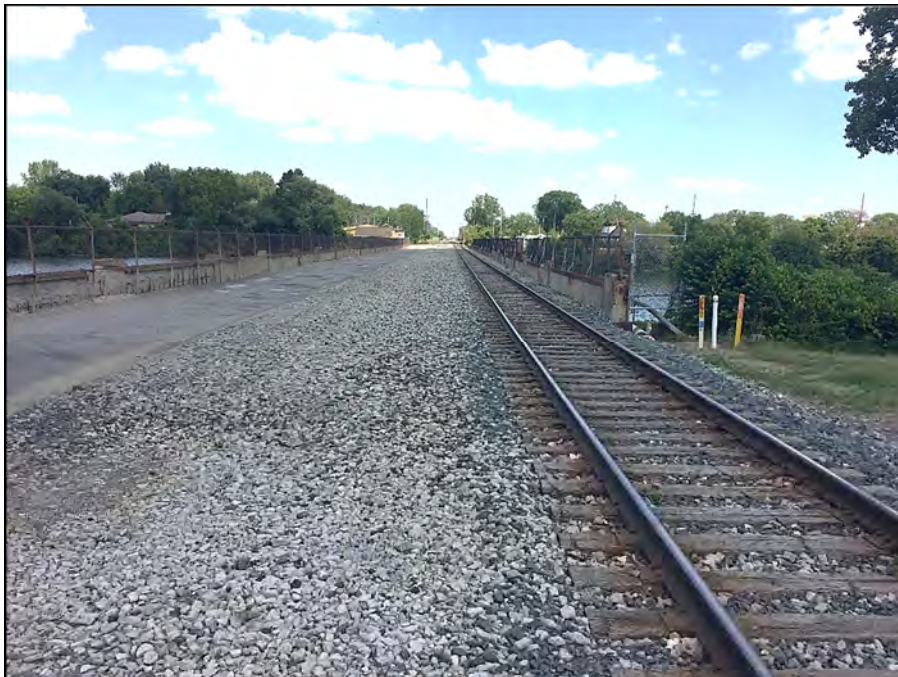
**Photograph 2 – Abutment crest viewed from right**

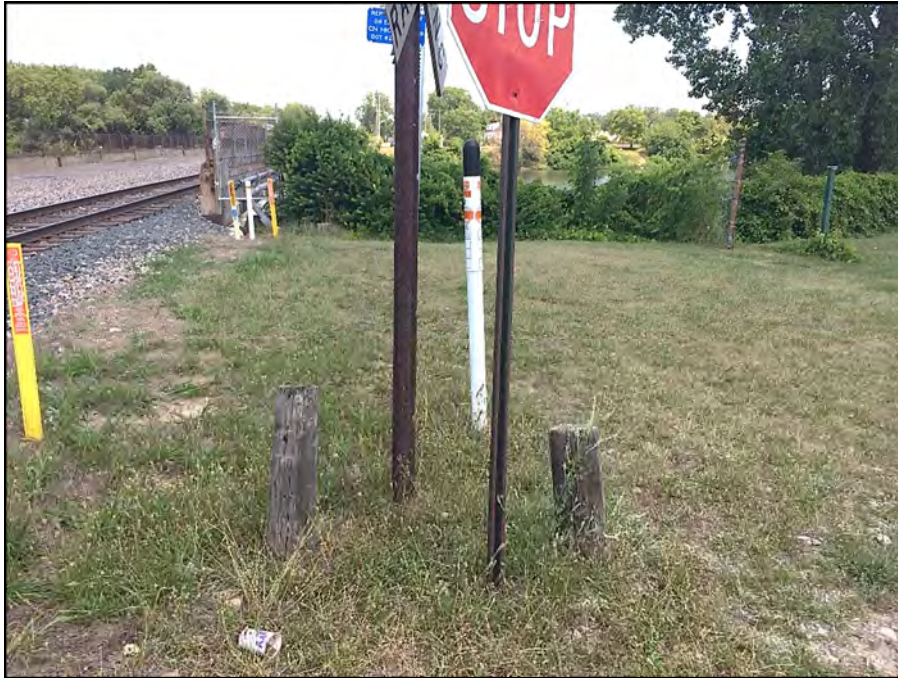
**Photograph 3 – Downstream face of right abutment viewed from right**

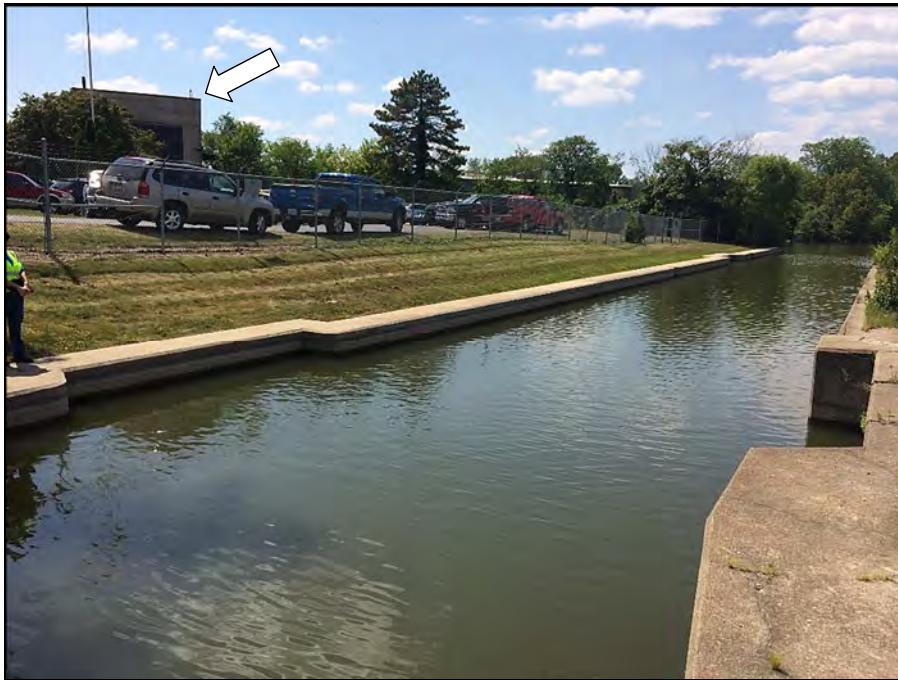
**Photograph 6 – Earthen needle section located between lock and powerhouse  
Note the arrow indicating the location of the former powerhouse**

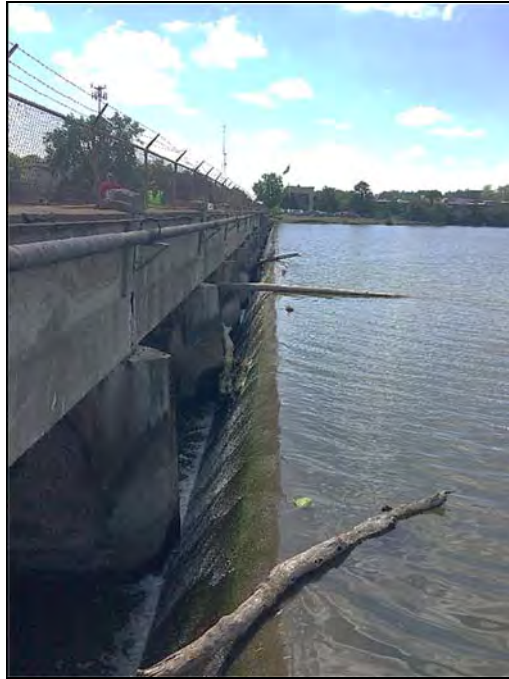
The principal spillway, shown in Photographs 7 through 11 and 14, is also in fair condition. No misalignment, differential settlement, or severe cracking or deterioration was observed. Both upstream abutment walls were reconstructed in 2007 and are in excellent condition. Moderate spalling is present at both downstream abutment walls, as shown in Photographs 9 and 11. This condition does not currently pose a threat to the stability of the spillway structure, but should continue to be monitored on a semi-annual basis and repaired as necessary.

**Photograph 7 – Principal spillway crest viewed from left  
Note the minor buildup of woody debris**

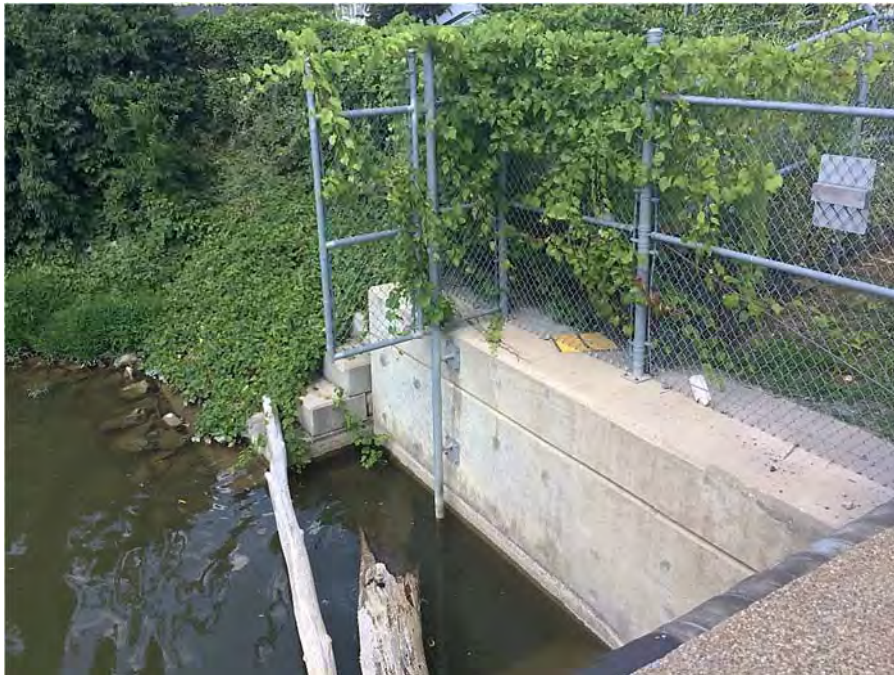
**Photograph 8 – Upstream left spillway abutment wall**

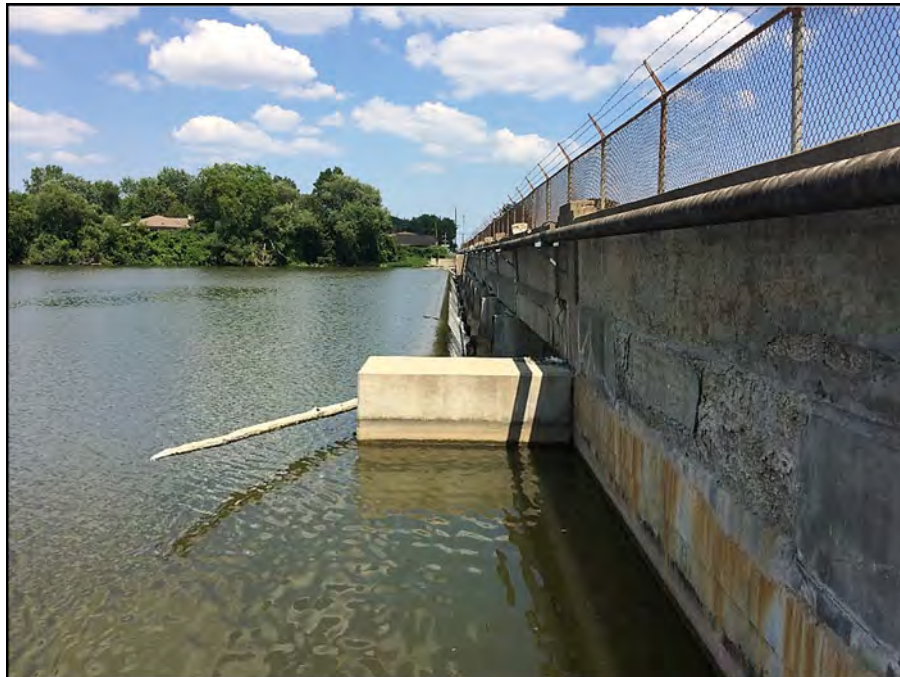
**Photograph 10 – Upstream right spillway abutment wall  
Note that a portion of this wall was recently  
reconstructed**

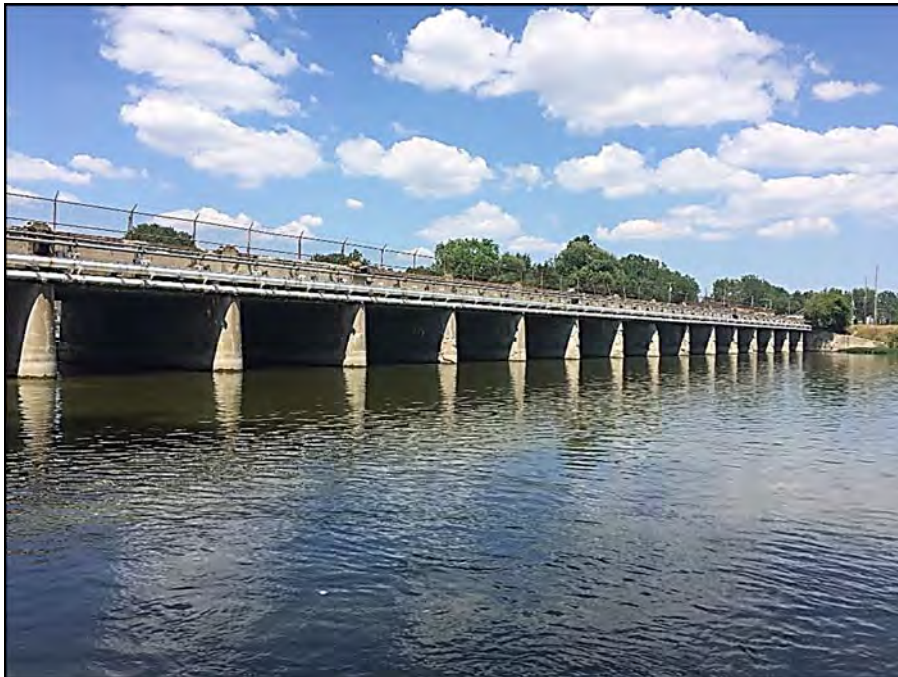
**Photograph 12 – Downstream bridge viewed from right**

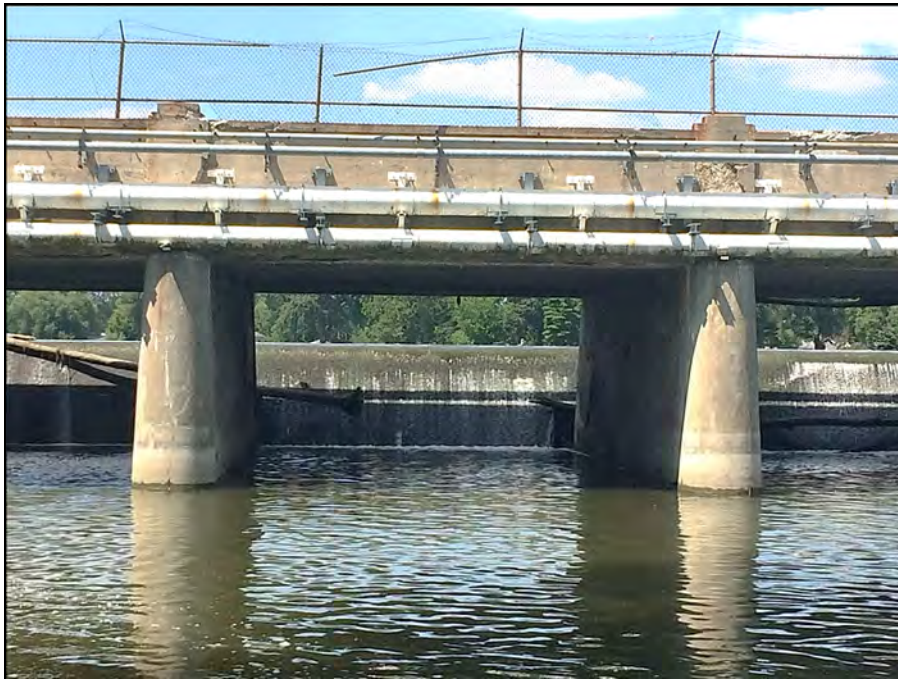
**Photograph 14 – Typical spillway bay viewed from downstream**

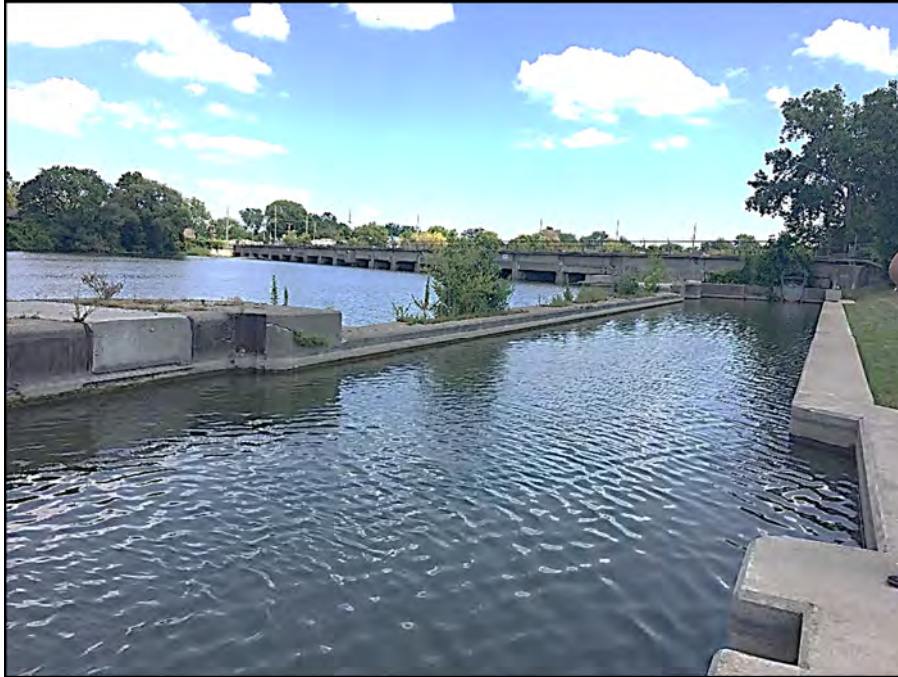
The abandoned lock system, shown in Photographs 15 through 17, is also in fair condition. The right channel wall of the lock system was reconstructed in 2007 and remains in excellent condition. The left channel wall is original to the dam, and is in poor condition. Moderate spalling and cracking are evident along the entire length of the wall. Additionally, vegetation was observed to be growing from cracks in the concrete. A log boom system that was present at the inlet to the lock system during the 2014 inspection report was damaged and removed. The 2014 inspection report recommended that all vegetation be removed from the left lock wall by October 1, 2015. This action should be completed as soon as reasonably possible in order to prevent accelerated deterioration of the structural concrete.

**Photograph 15 – Abandoned lock viewed from upstream  
Note that the right wall was recently reconstructed**

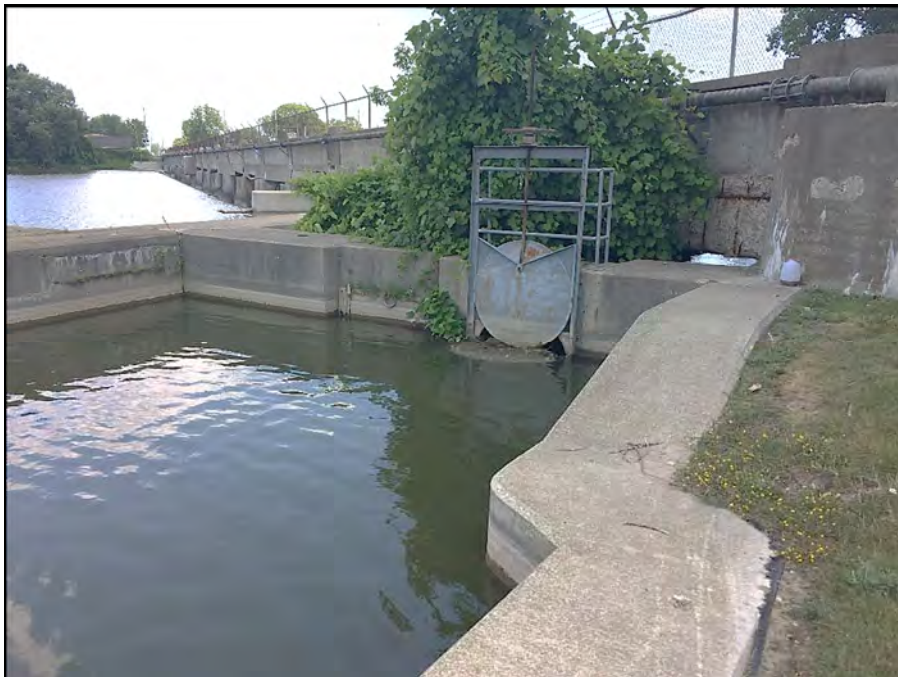
The fish ladder, shown in Photographs 11 and 16, is in poor condition. Significant deformation of the wooden panel and leakage throughout the structure was observed. Though not critical to the stability or function of the dam, continued deterioration or failure of the fish ladder could impede the passage of fish and cause localized erosion downstream of the lock gate structure. It is understood that the MDNR Fisheries Division maintains and operates the fish ladder. As such, the MDNR should consider repairing or replacing the structure.

**Photograph 16 – Abandoned lock gates  
Note that the right sluice gate feeds the  
fish ladder**

5. Begin conversations with Michigan Department of Natural Resources (MDNR) Fisheries Division, who maintain a fish ladder at the dam, to consider repair or replacement of the fish ladder structure.
6. Prepare and keep current an operation and maintenance (O&M) plan for the dam. Provide a copy of the plan to the Dam Safety Program.

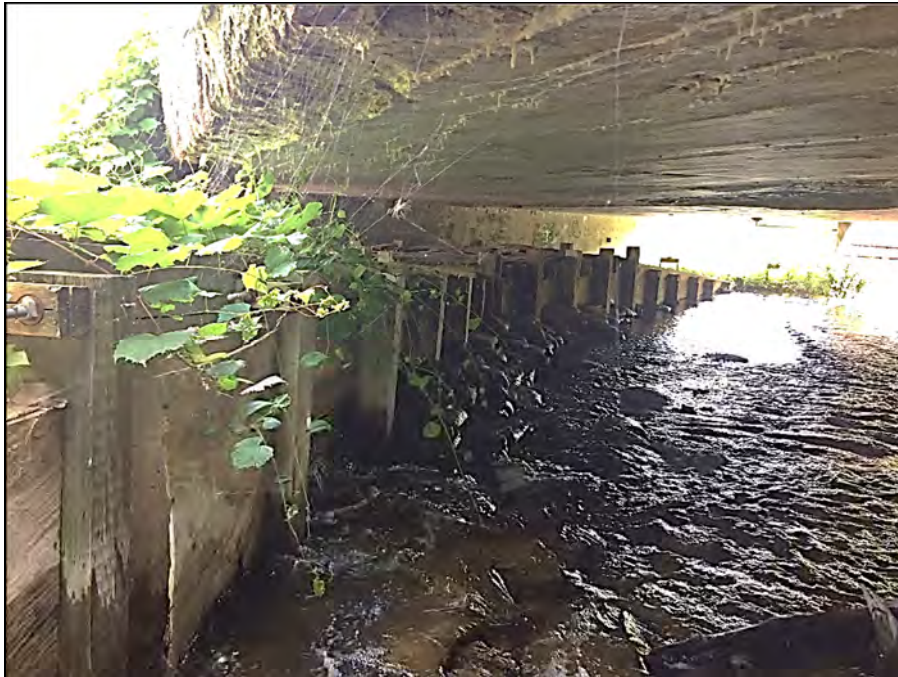
**Photograph 18 – Wooden fish ladder viewed from upstream**

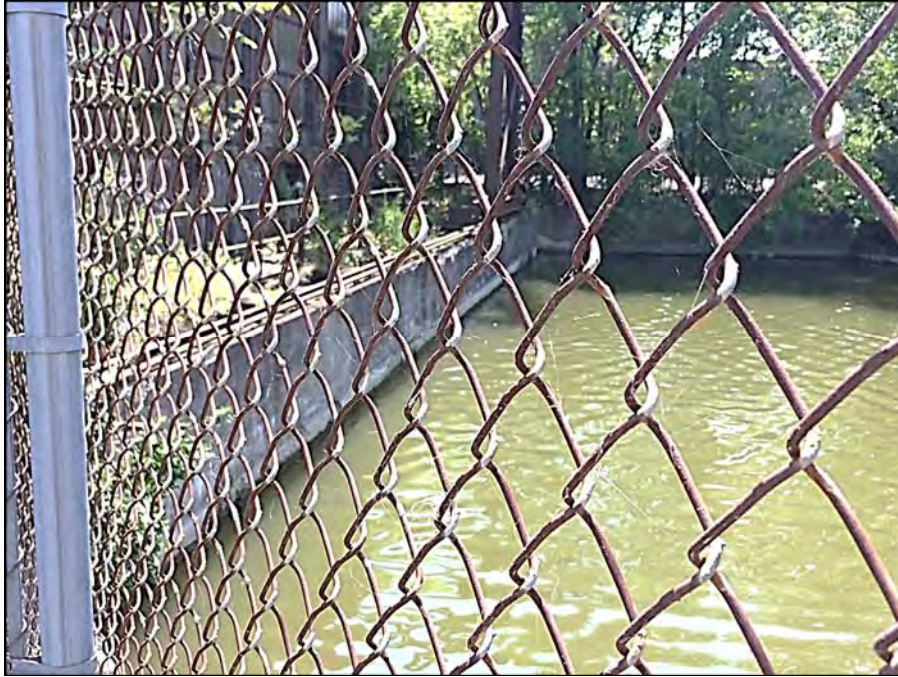
**Photograph 19 – Powerhouse inlet viewed from left**
