SUBJECT: Flat Rock Dam, Dam ID No. 556; Wayne County

**DAM SAFETY INSPECTION REPORT  
FLAT ROCK DAM – DAM ID NO. 556  
HURON RIVER  
WAYNE COUNTY – SW 1/4 SECTION 31, T 04S, R 10E**

APPENDIX B – INSPECTION PHOTOS

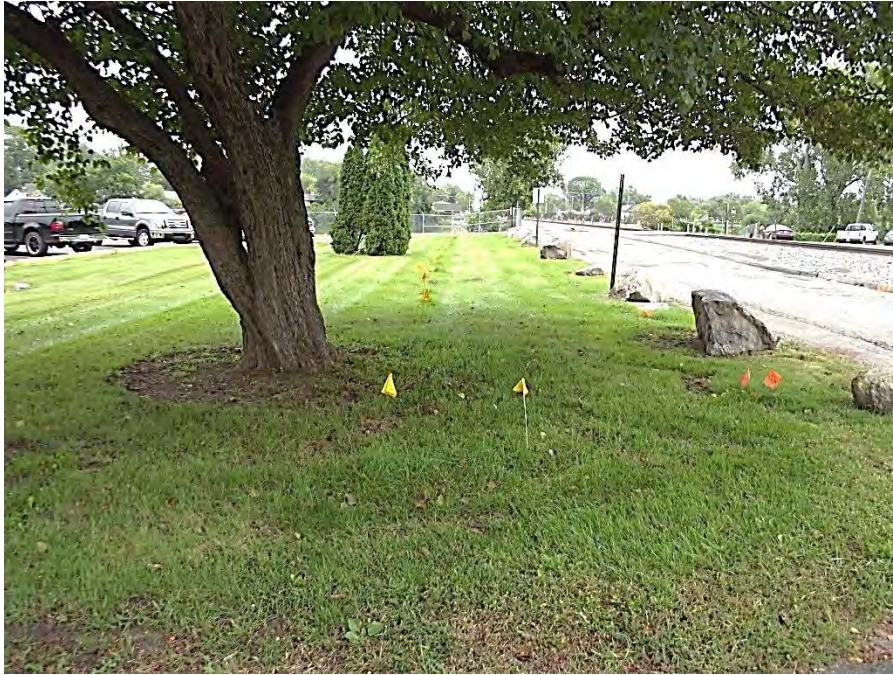
The short earthen embankments, shown in Photographs 1 through 5, are in fair conditions. No sloughs, slumps, differential settlement, cracking, or major erosion was observed. However, both embankments were overgrown with small trees and brush. [Trees and brush](#) can provide shortened seepage pathways along their root systems that can lead to [internal erosion \(piping\)](#) of embankment materials, cause large section loss in the event of a blow down, provide a haven for burrowing animals, and obscure underlying deficiencies. Therefore, all trees and brush should be removed from the earthen embankments. This recommendation is repeated from the 2011 inspection report and should be completed as soon as reasonably possible. The entire embankment should be mowed a minimum of two times per year to prevent further establishment of woody vegetation.

**Photograph 1 – Upstream face of right embankment viewed from right.**

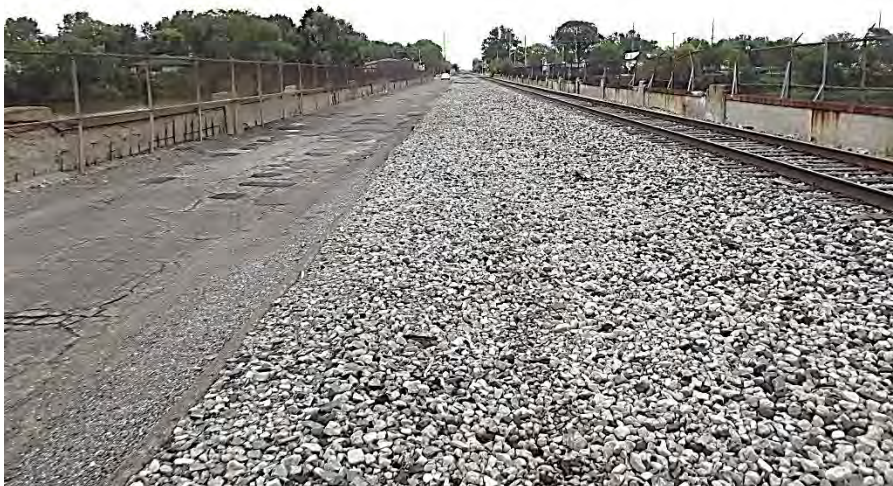
**Photograph 2 – Embankment crest viewed from right.**

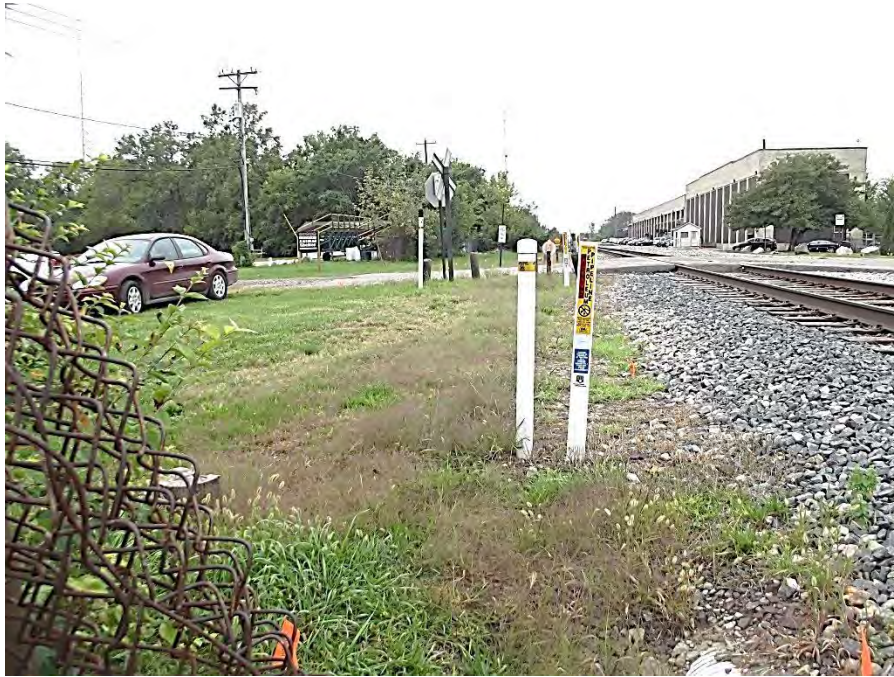
**Photograph 3 – Downstream face of right embankment viewed from left.**

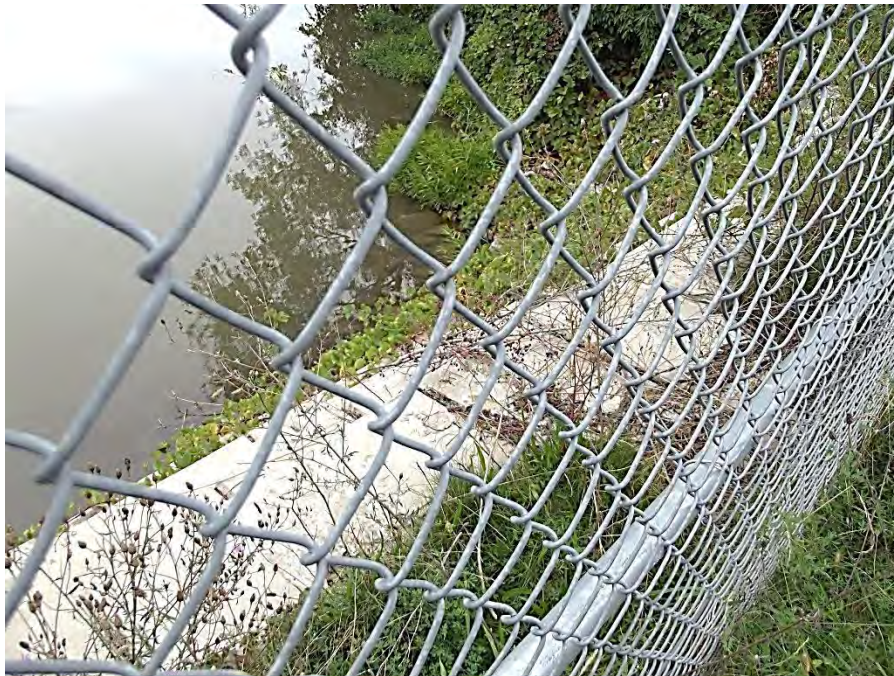
**Photograph 4 – Upstream face of left embankment viewed from left.**

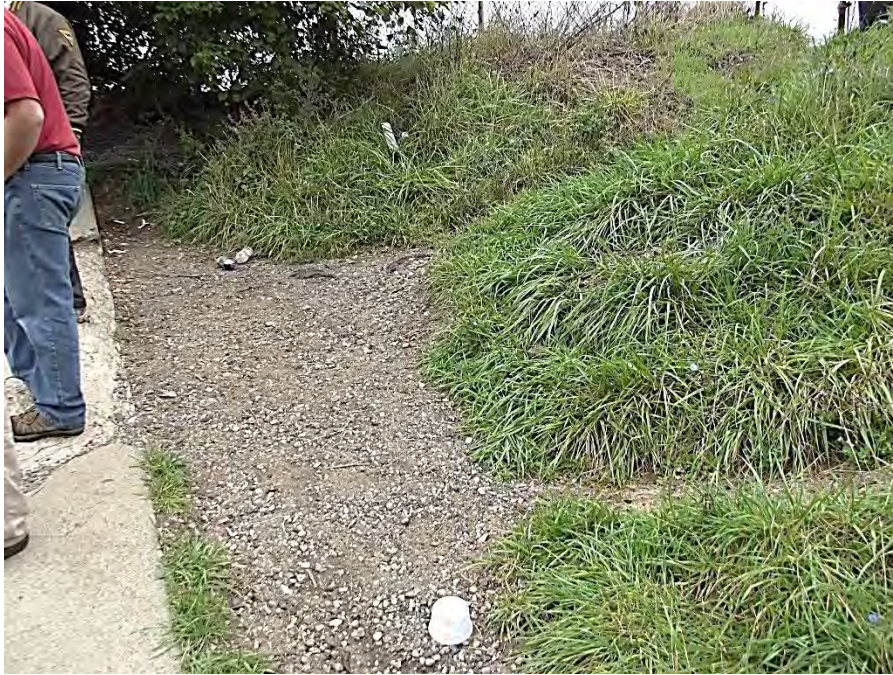
Additionally, some minor foot traffic erosion is present along the downstream face of the left embankment, as shown in Photograph 5. This condition does not currently pose a threat to the stability of the embankment, but was noted in the 2011 inspection report and should be backfilled, compacted, and seeded as soon as reasonably possible to prevent further erosion from developing.

**Photograph 5 – Downstream face of left embankment viewed from left.  
Note the foot traffic erosion.**

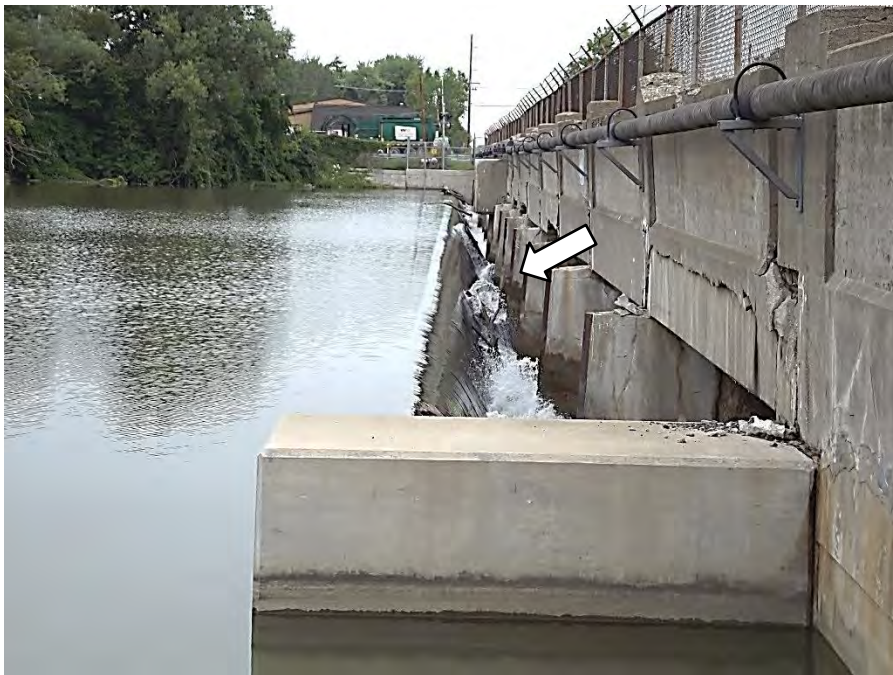
Additionally, large woody continues to become lodged between the principal spillway and the downstream bridge piers. This condition, shown in Photograph 6, does not currently pose a threat to the safety of the dam, but if enough debris built up below the spillway; its ability to convey flood flows would be compromised. Clogging of the spillway bays could result in premature overtopping of the earthen portions of the dam, potentially resulting in severe erosion damage or even breaching failure of the embankment. Therefore, the principal spillway should be monitored on a quarterly basis and during high flow events for buildup of debris. Debris should be removed as necessary to prevent clogging of the spillway bays.

**Photograph 6 – Principal spillway crest viewed from right.  
Note the minor debris build up.**

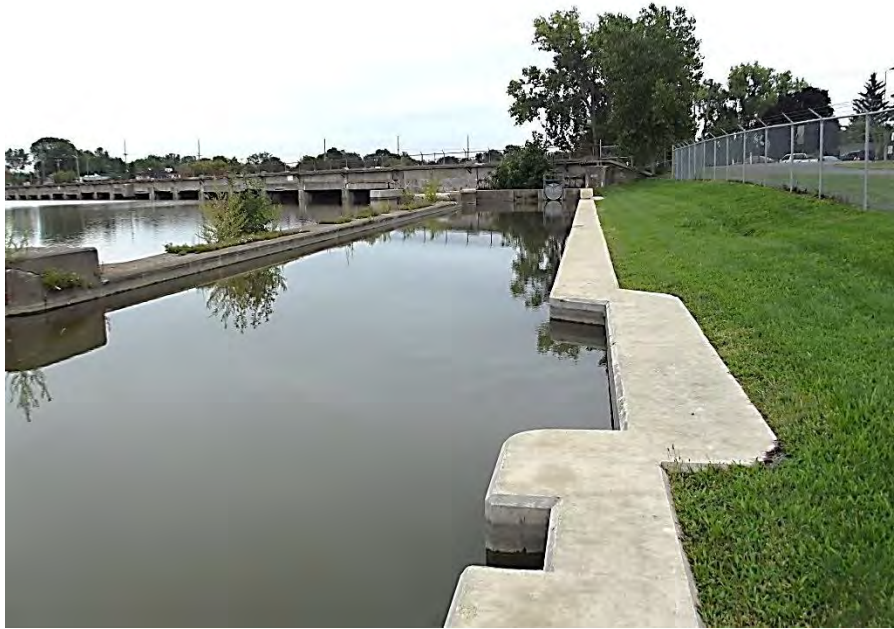
The principal spillway, shown in Photographs 6 through 10, is also in fair condition. No misalignment, differential settlement, or severe cracking or deterioration was observed. Moderate spalling is evident in all spillway bays, but does not currently pose a threat to the structural integrity of the dam. The spalled areas should be monitored on a semi-annual basis. Any major deterioration should be further analyzed by a qualified engineer and repaired as appropriate.

**Photograph 7 – Upstream right principal spillway abutment wall viewed from upstream.**

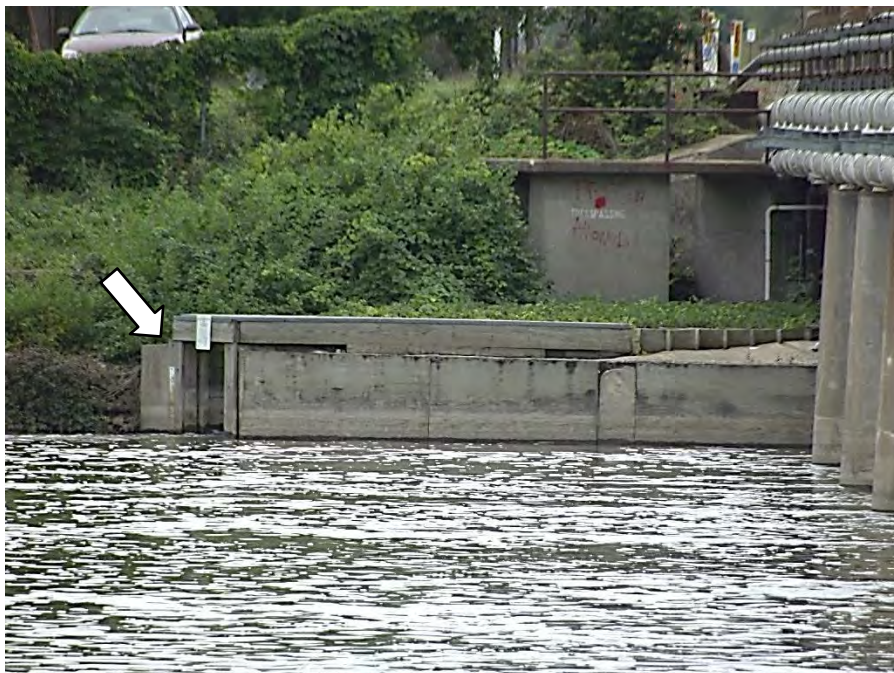
**Photograph 8 – Downstream right principal spillway abutment wall. Note the outlet of the fish ladder.**

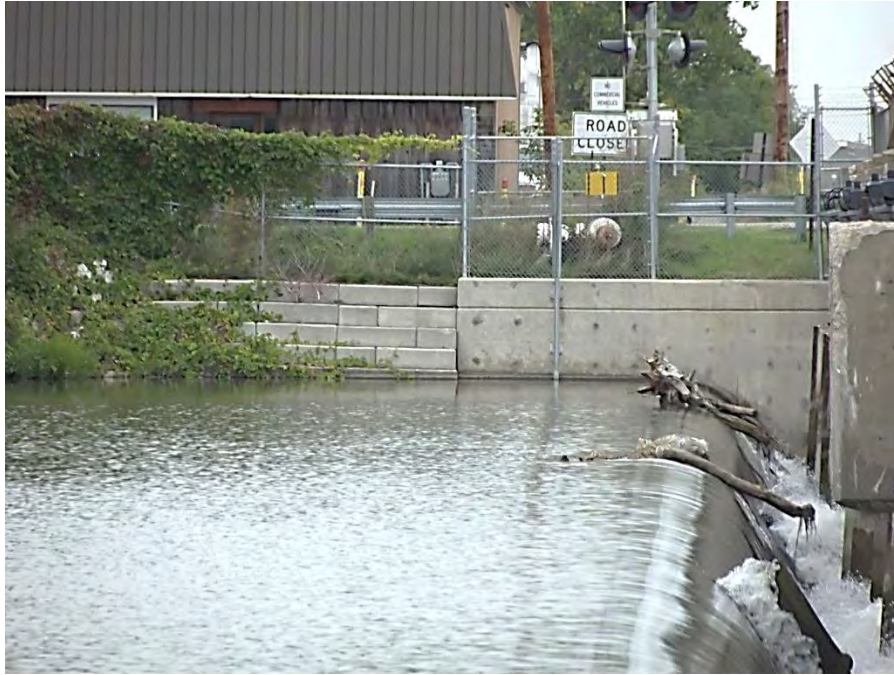
**Photograph 9 – Upstream left principal spillway abutment wall viewed from right.**

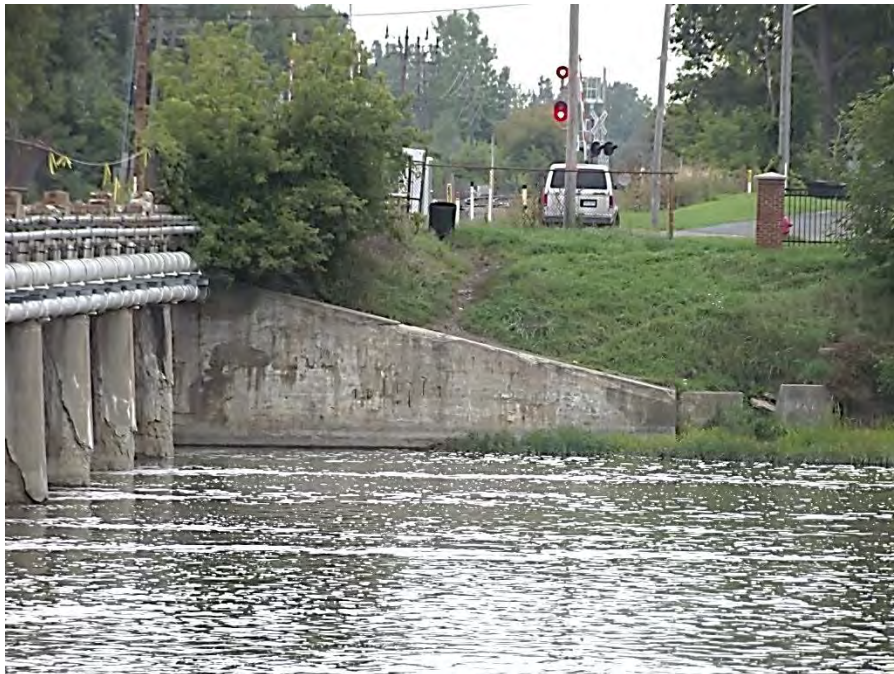
**Photograph 10 – Downstream left principal spillway abutment wall viewed from right.**

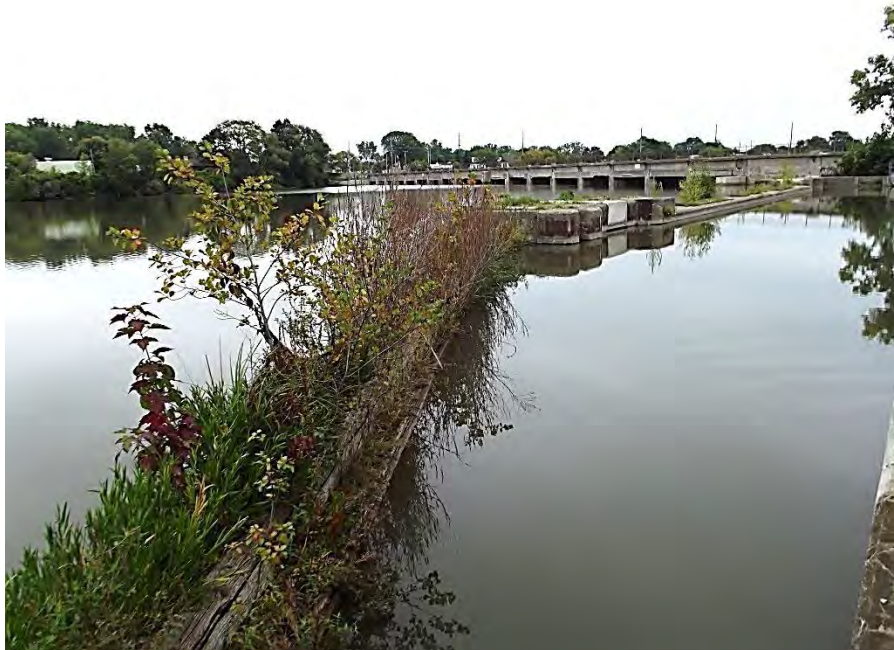
Photographs 11 through 14 show the abandoned lock system which exists immediately right of the principal overflow spillway. This structure is in fair overall condition. The right channel wall of the lock system serves as the right abutment of the principal spillway structure. This wall was repaired in 2007, under the authority of DEQ Permit No. 07-82-0168-P, and remains in excellent condition. The left channel wall was not repaired in 2007, and is in considerably worse condition. Moderate spalling and cracking are evident along the entire length of the left wall. Additionally, vegetation was observed to be growing from cracks in the concrete wall as well as from the log boom system at the inlet of the lock channel. This condition, shown in photographs 11 through 13, does not currently impact the stability of the structure; however if left uncorrected will accelerate the deterioration of the concrete and boom logs. Therefore, all vegetation should be removed from the left lock wall and log boom by October 1, 2015.

**Photograph 11 – Inlet to abandoned lock system viewed from upstream.  
Note the overgrowth of vegetation at the log boom.**

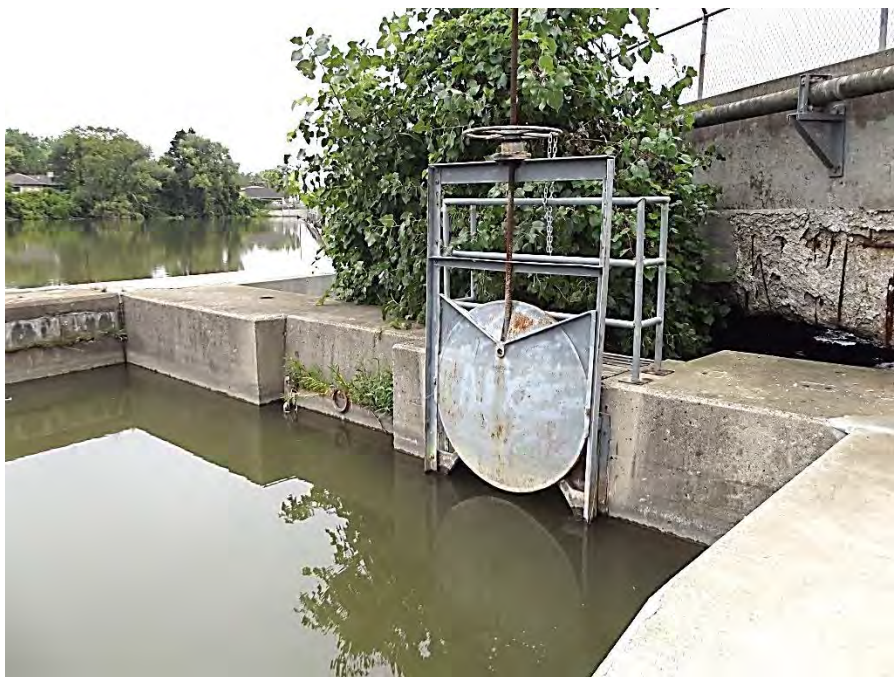
**Photograph 14 – Gate system for abandoned locks.  
Note the raised gate now provides water for a downstream fish ladder.**

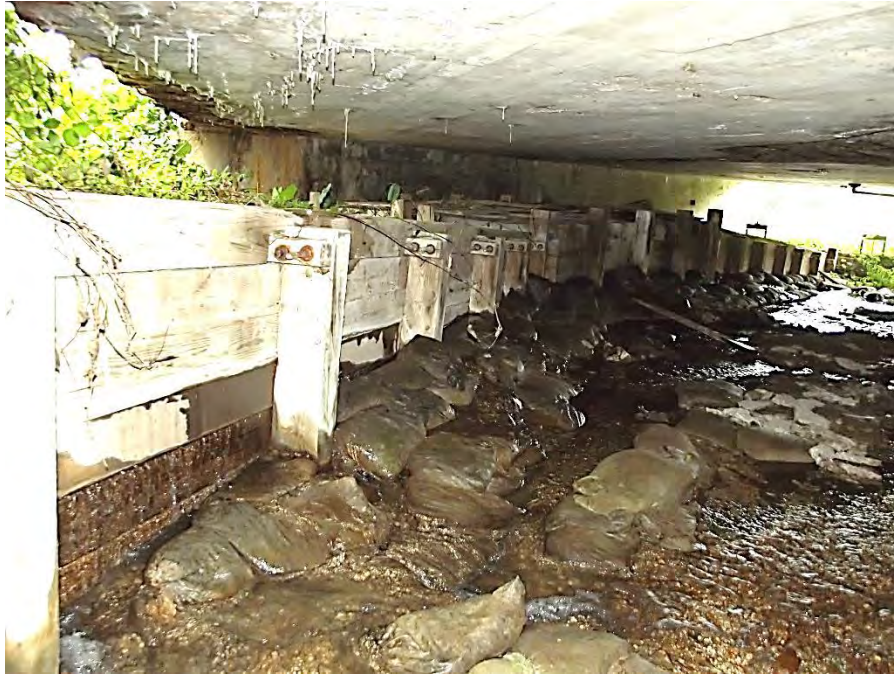
The fish ladder, shown in Photographs 15 through 17, is also in fair condition. No major deterioration was observed. However, leakage between the boards of the wooden structure continues to be an issue. This leakage is not currently causing concern for erosion adjacent to the structure, but as the boards deteriorate; leakage will increase, potentially causing erosion concerns. Therefore, the wooden fish ladder structure should be observed quarterly for significant deterioration and increased leakage. Repairs should be implemented as needed.

**Photograph 15 – Fish ladder as it passes under bridge downstream of dam.**

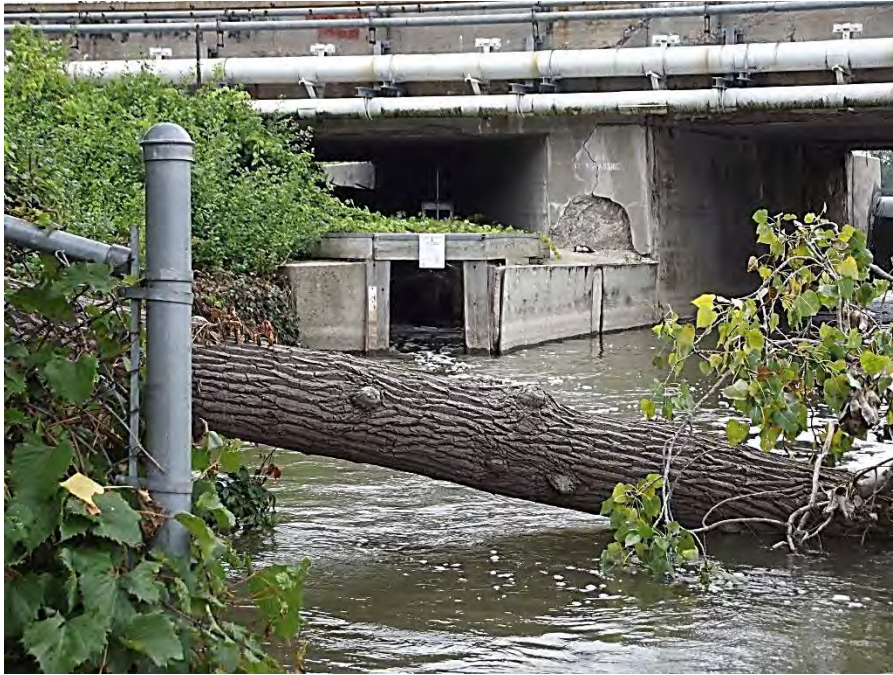
**Photograph 17 – Fish ladder outlet viewed from downstream.  
Note the overgrowth of vegetation.**

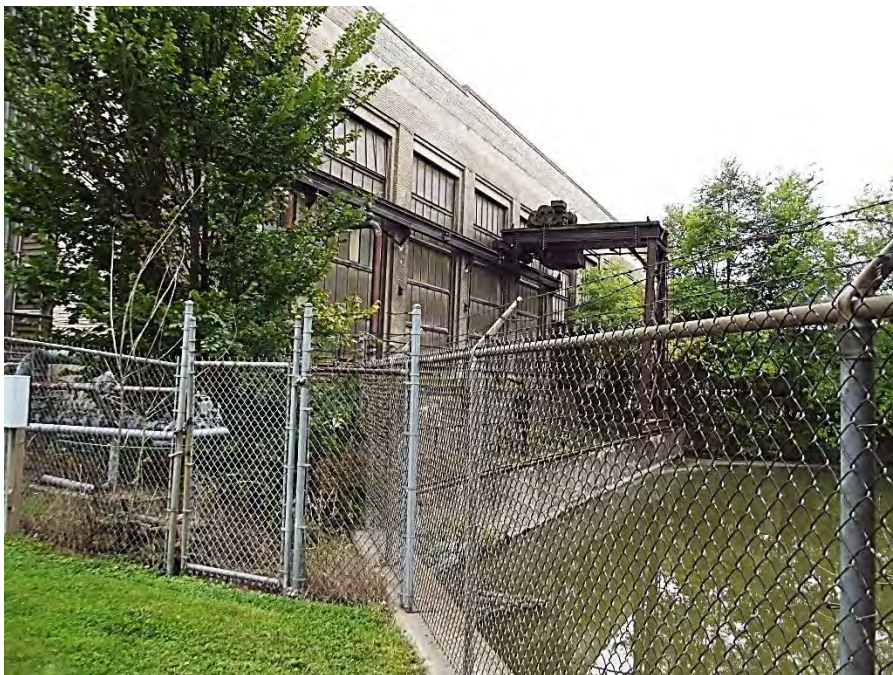
The former powerhouse, located approximately 250 feet right of the principal spillway, is owned by Flat Rock Metal, Incorporated and was not entered as part of this inspection. Photographs 18 and 19 were taken from the exterior of the structure and show significant deterioration of the concrete foundation. Additionally, flow was observed in the channel adjacent to the left wall of the powerhouse building, indicating open or deteriorated gates at the powerhouse inlet. To our knowledge, the powerhouse structure has not recently been inspected by a licensed professional engineer. As part of the regulated dam, an engineering inspection of the structure should be completed as soon as reasonably possible. The responsibility for completing this inspection lies with the owner of the structure, per [Section 324.31518](#) of Part 315.

**Photograph 18 – Abandoned powerhouse (now Flat Rock Steel) viewed from left.**

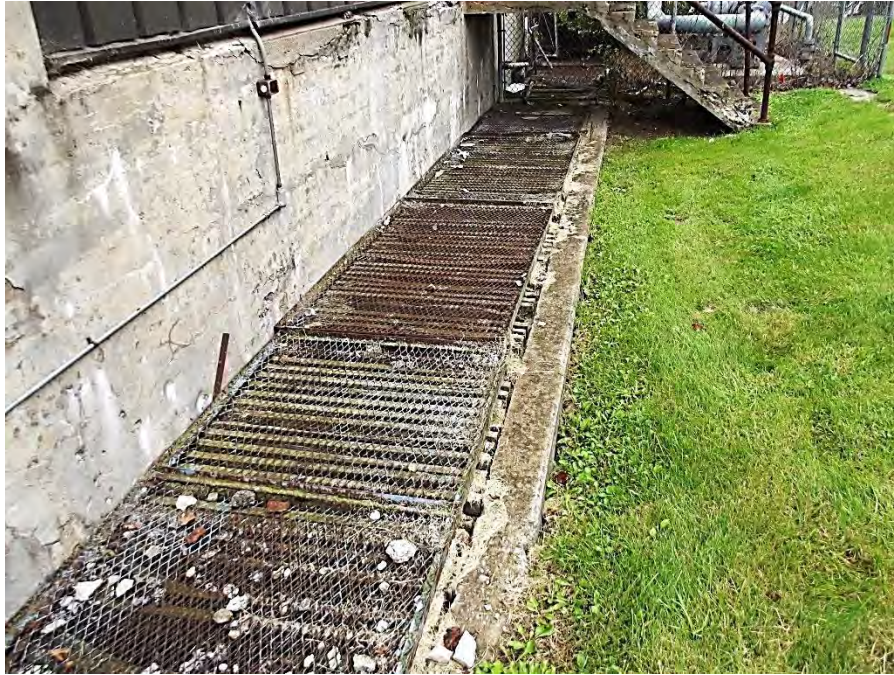
**Photograph 19 – Channel along right powerhouse wall.  
Note that there was flow through this channel on the date of the inspection.**
