APPENDIX 3: PICNIC FACILITIES MAP

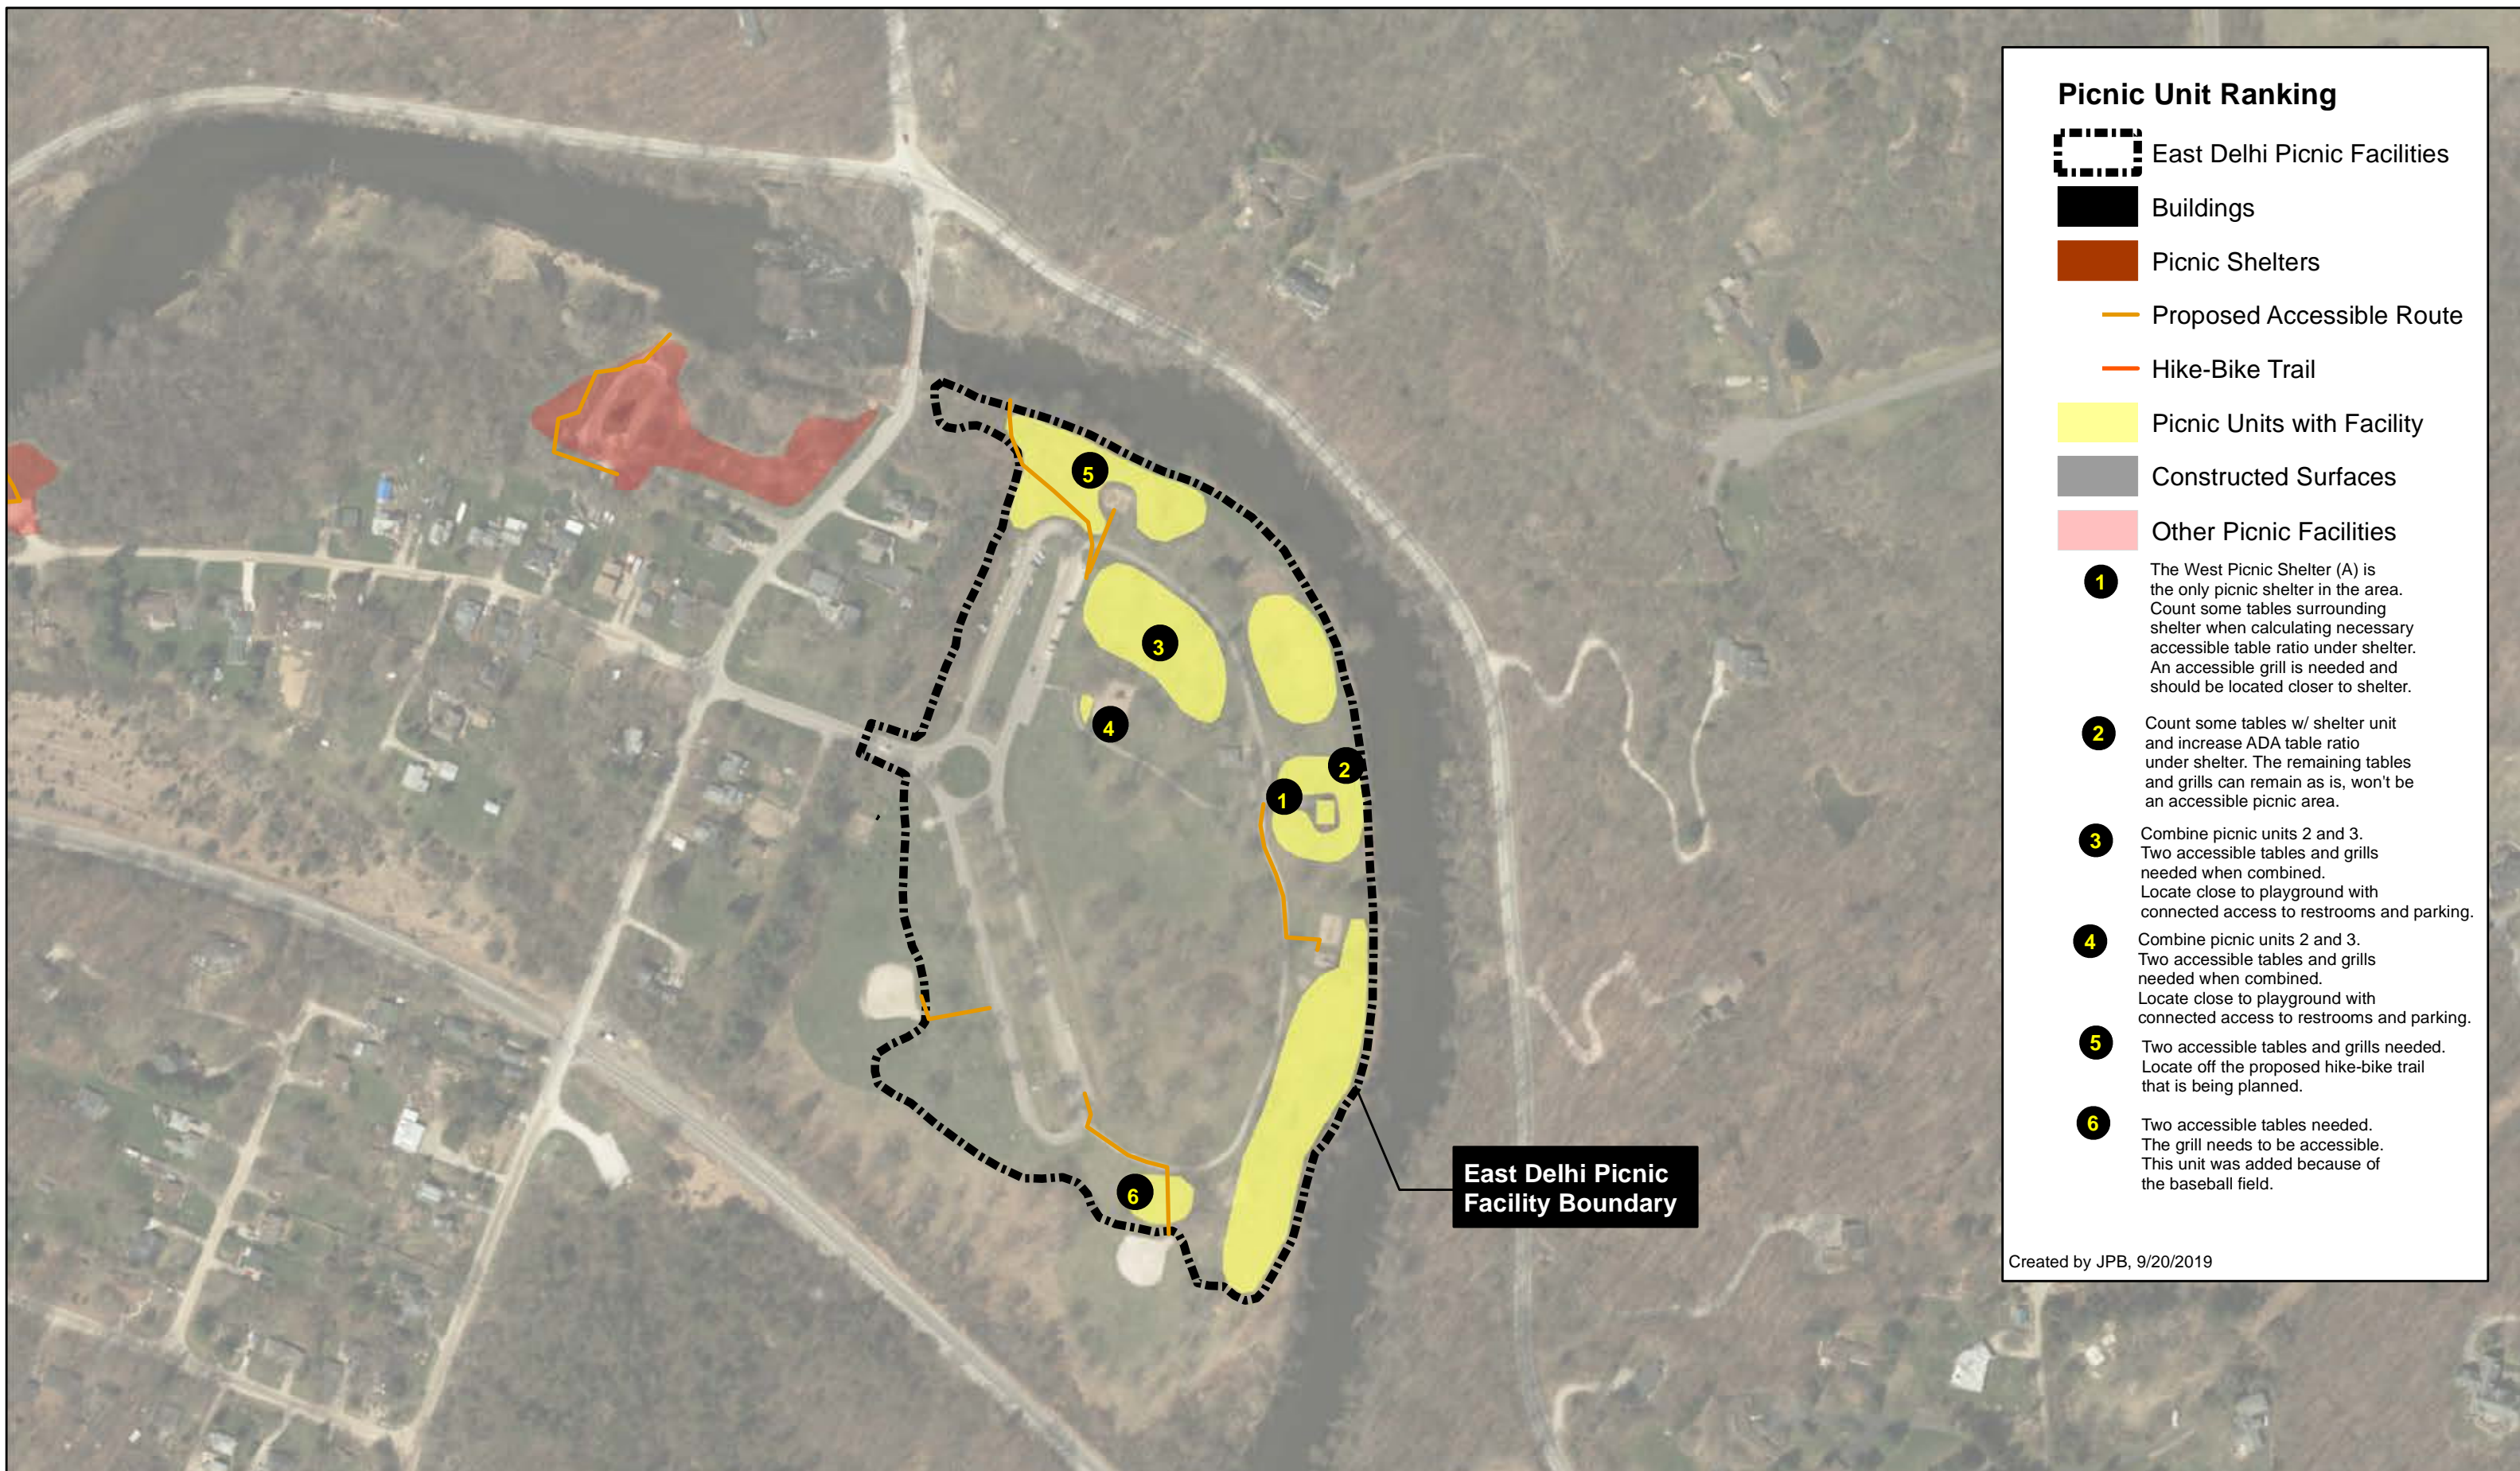
-   East Delhi Picnic Facilities
-   Buildings
-

- 1** The West Picnic Shelter (A) is the only picnic shelter in the area. Count some tables surrounding shelter when calculating necessary accessible table ratio under shelter. An accessible grill is needed and should be located closer to shelter.

- 2** Count some tables w/ shelter unit and increase ADA table ratio under shelter. The remaining tables and grills can remain as is, won't be an accessible picnic area.

- 3** Combine picnic units 2 and 3. Two accessible tables and grills needed when combined. Locate close to playground with connected access to restrooms and parking.

- 4** Combine picnic units 2 and 3. Two accessible tables and grills needed when combined. Locate close to playground with connected access to restrooms and parking.

- 5** Two accessible tables and grills needed. Locate off the proposed hike-bike trail that is being planned.
- 6** Two accessible tables needed. The grill needs to be accessible. This unit was added because of the baseball field.

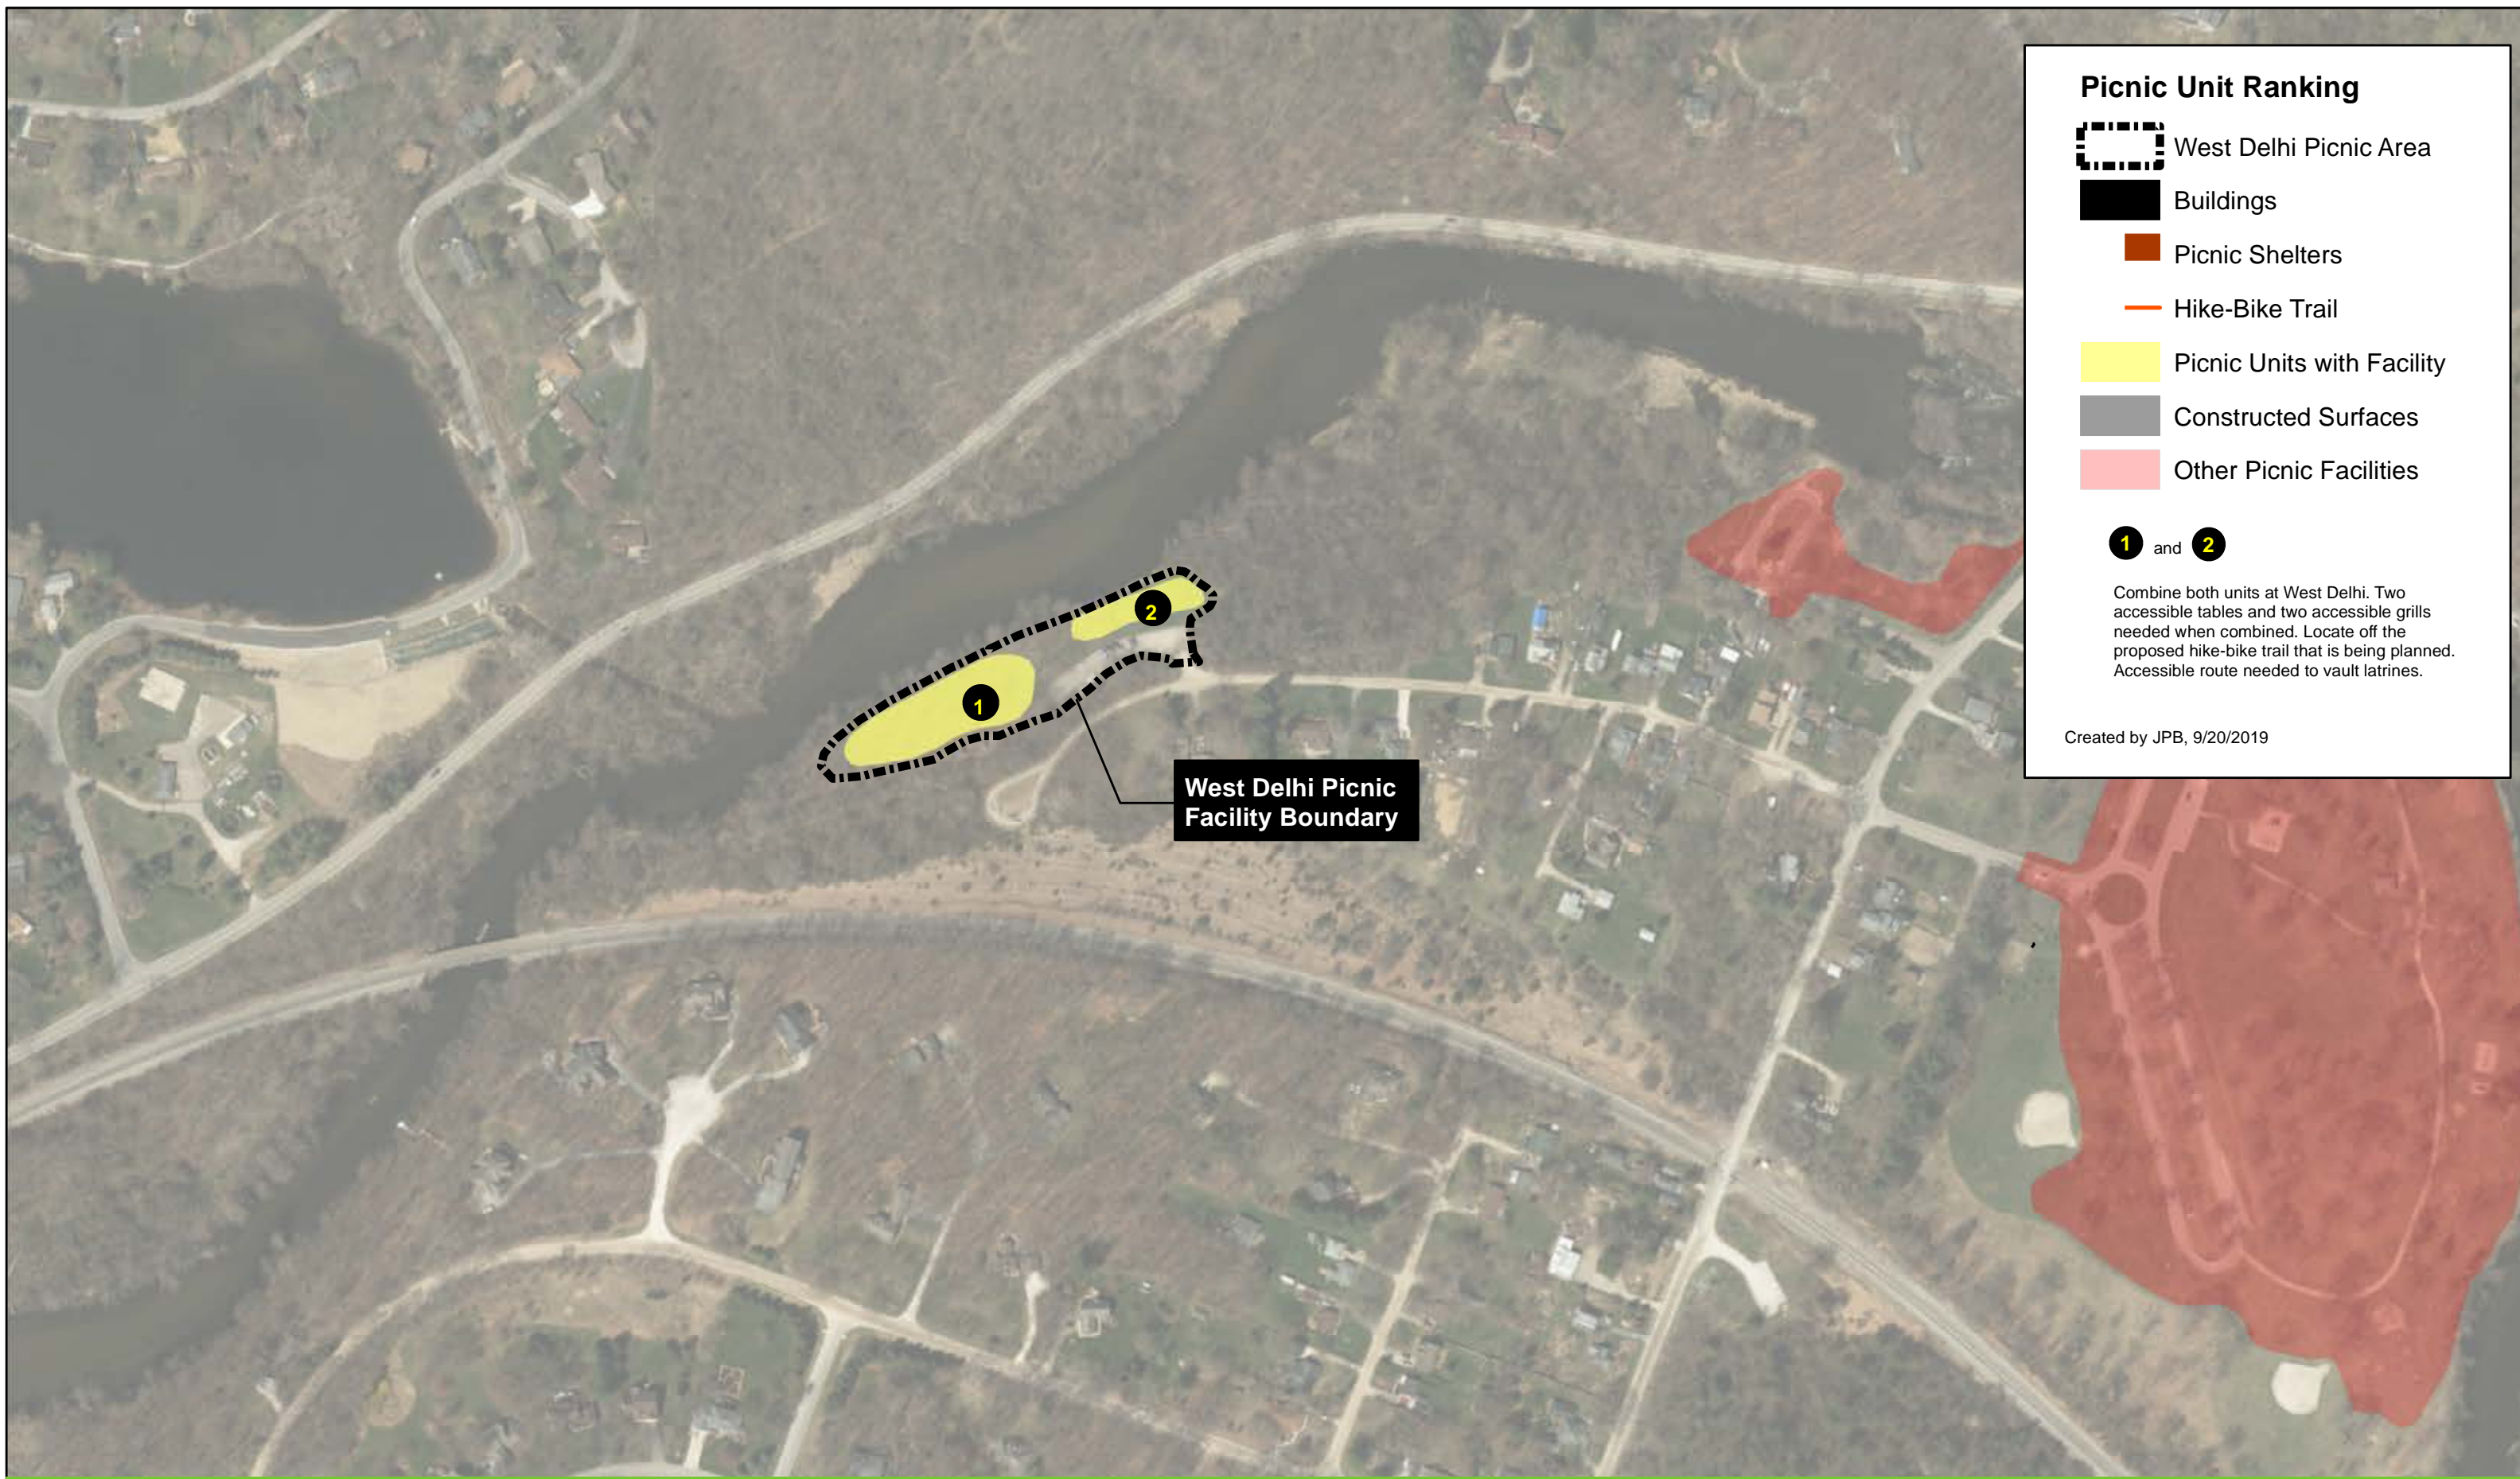
West Delhi Picnic Facility Boundary

Combine both units at West Delhi. Two accessible tables and two accessible grills needed when combined. Locate off the proposed hike-bike trail that is being planned. Accessible route needed to vault latrines.

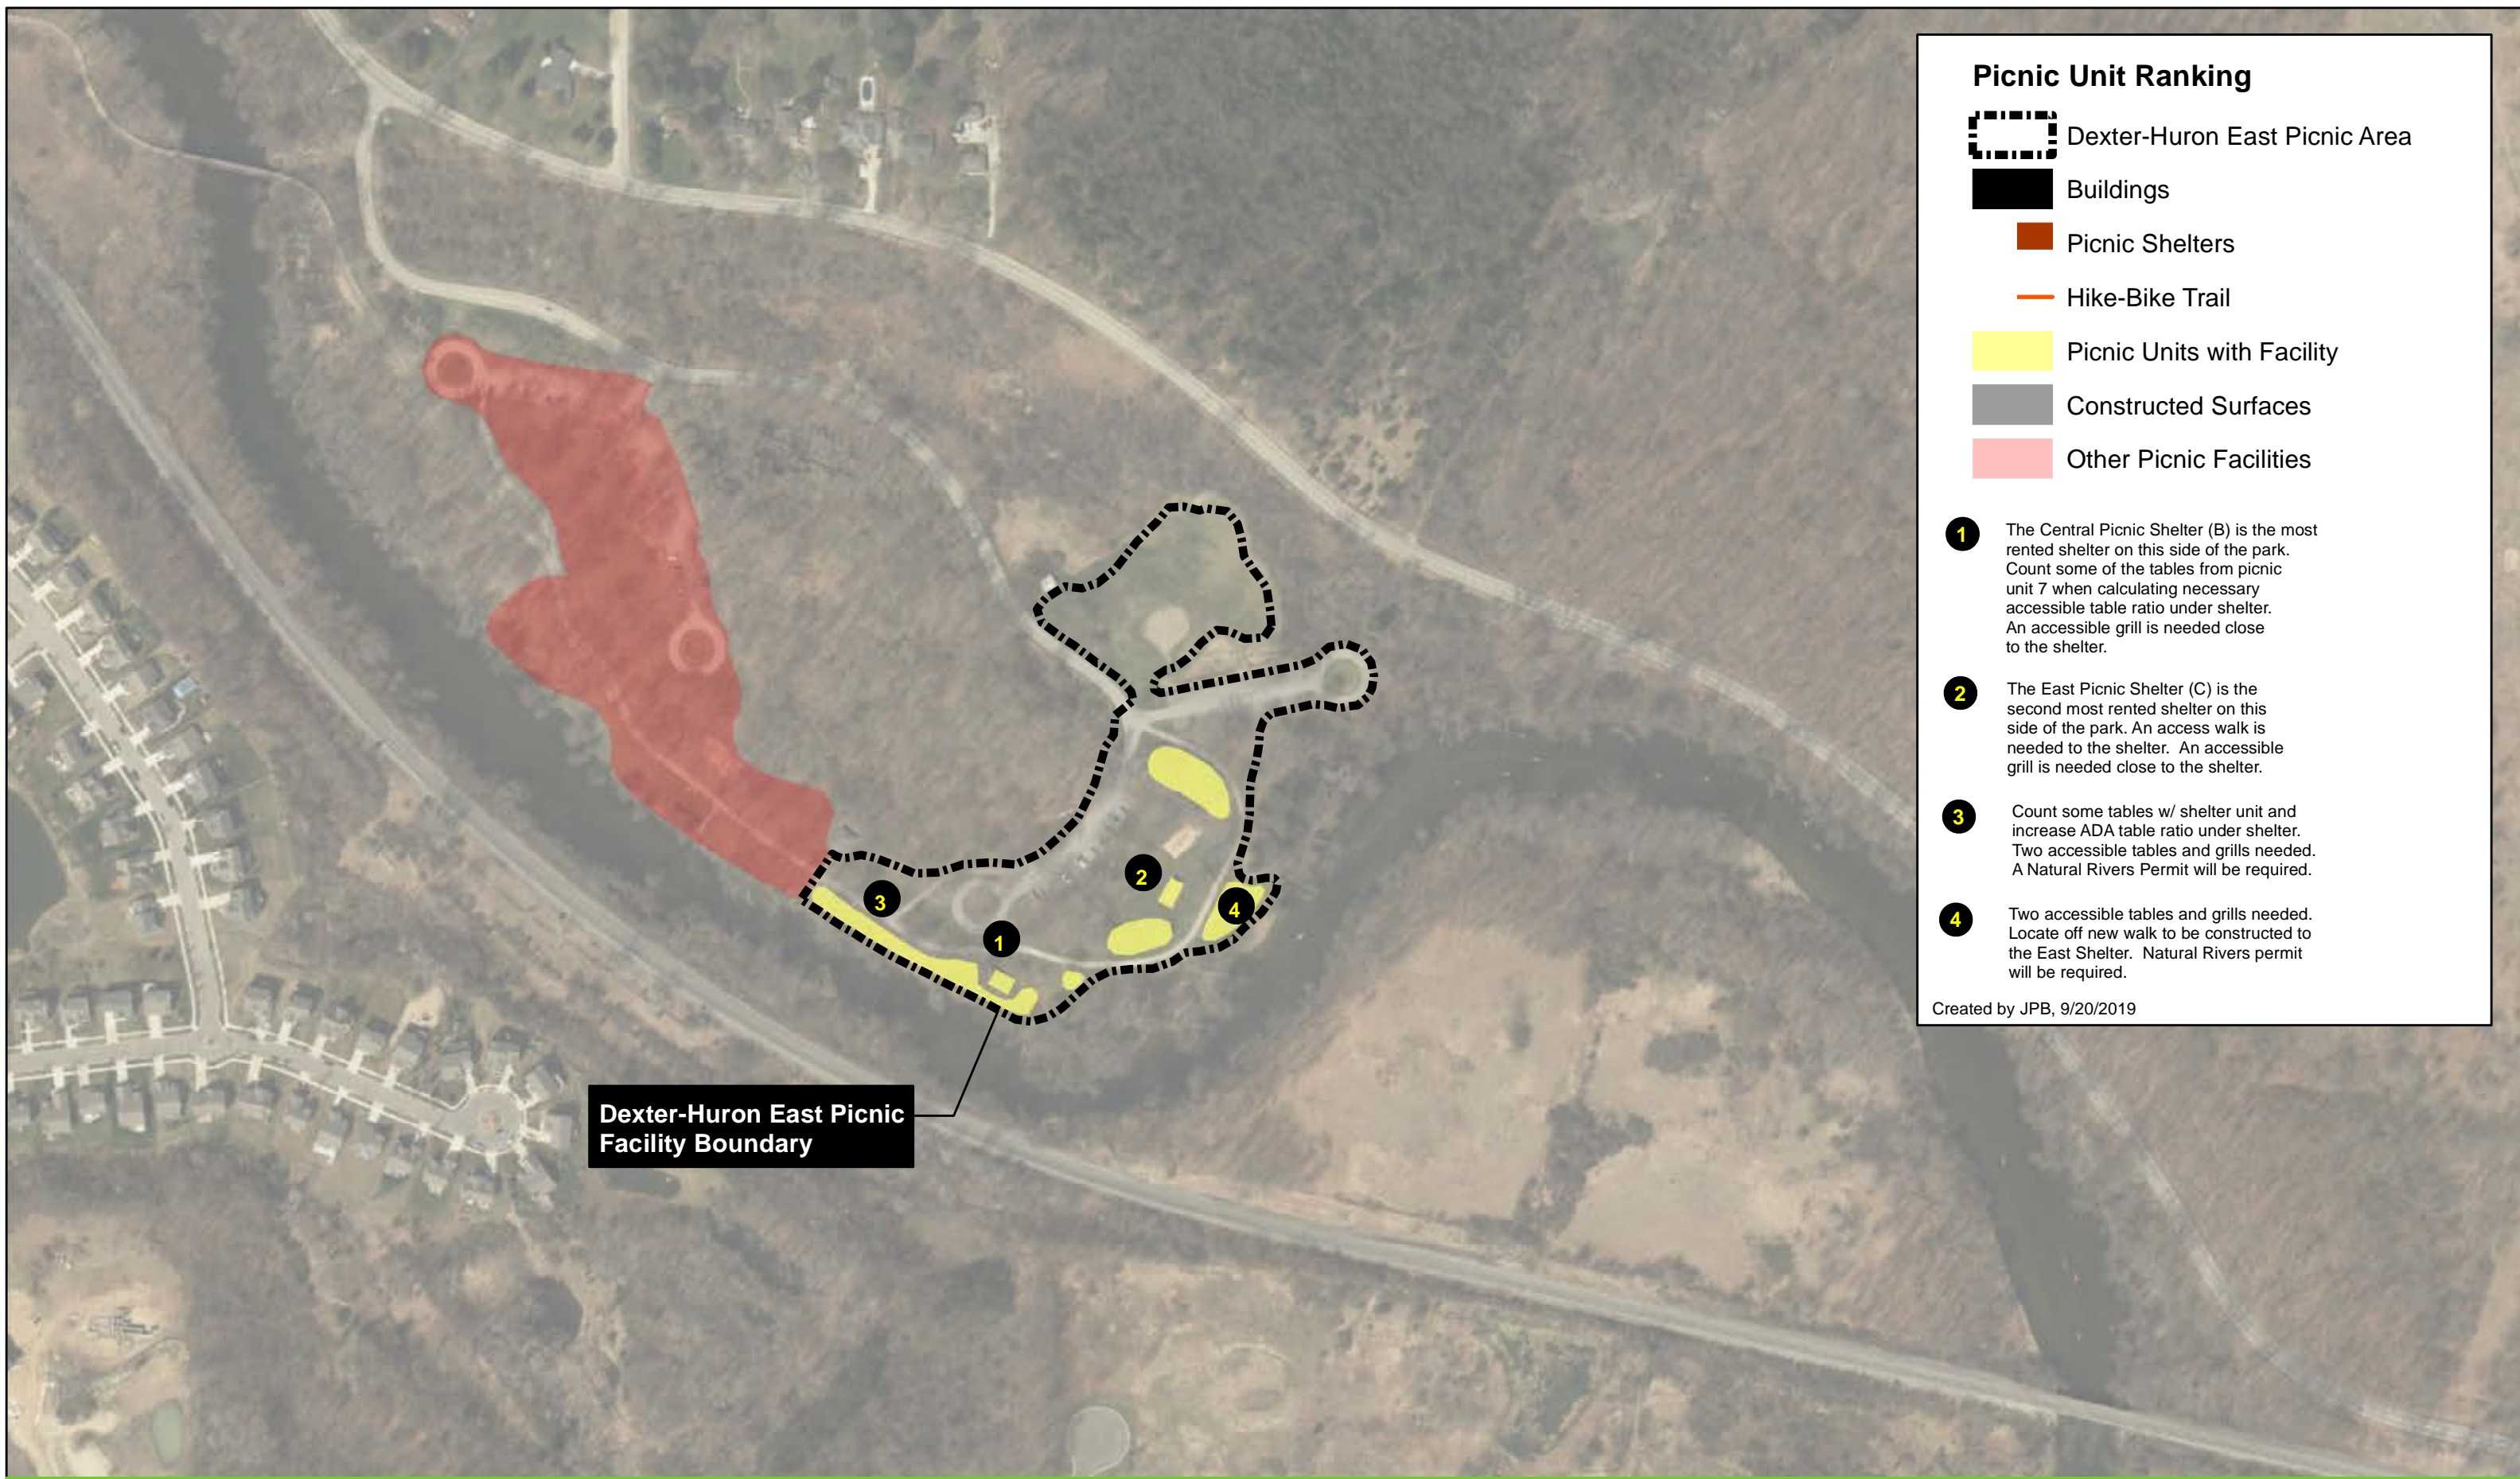
Dexter-Huron East Picnic Facility Boundary

- 1** The Central Picnic Shelter (B) is the most rented shelter on this side of the park. Count some of the tables from picnic unit 7 when calculating necessary accessible table ratio under shelter. An accessible grill is needed close to the shelter.
- 2** The East Picnic Shelter (C) is the second most rented shelter on this side of the park. An access walk is needed to the shelter. An accessible grill is needed close to the shelter.
- 3** Count some tables w/ shelter unit and increase ADA table ratio under shelter. Two accessible tables and grills needed. A Natural Rivers Permit will be required.
- 4** Two accessible tables and grills needed. Locate off new walk to be constructed to the East Shelter. Natural Rivers permit will be required.

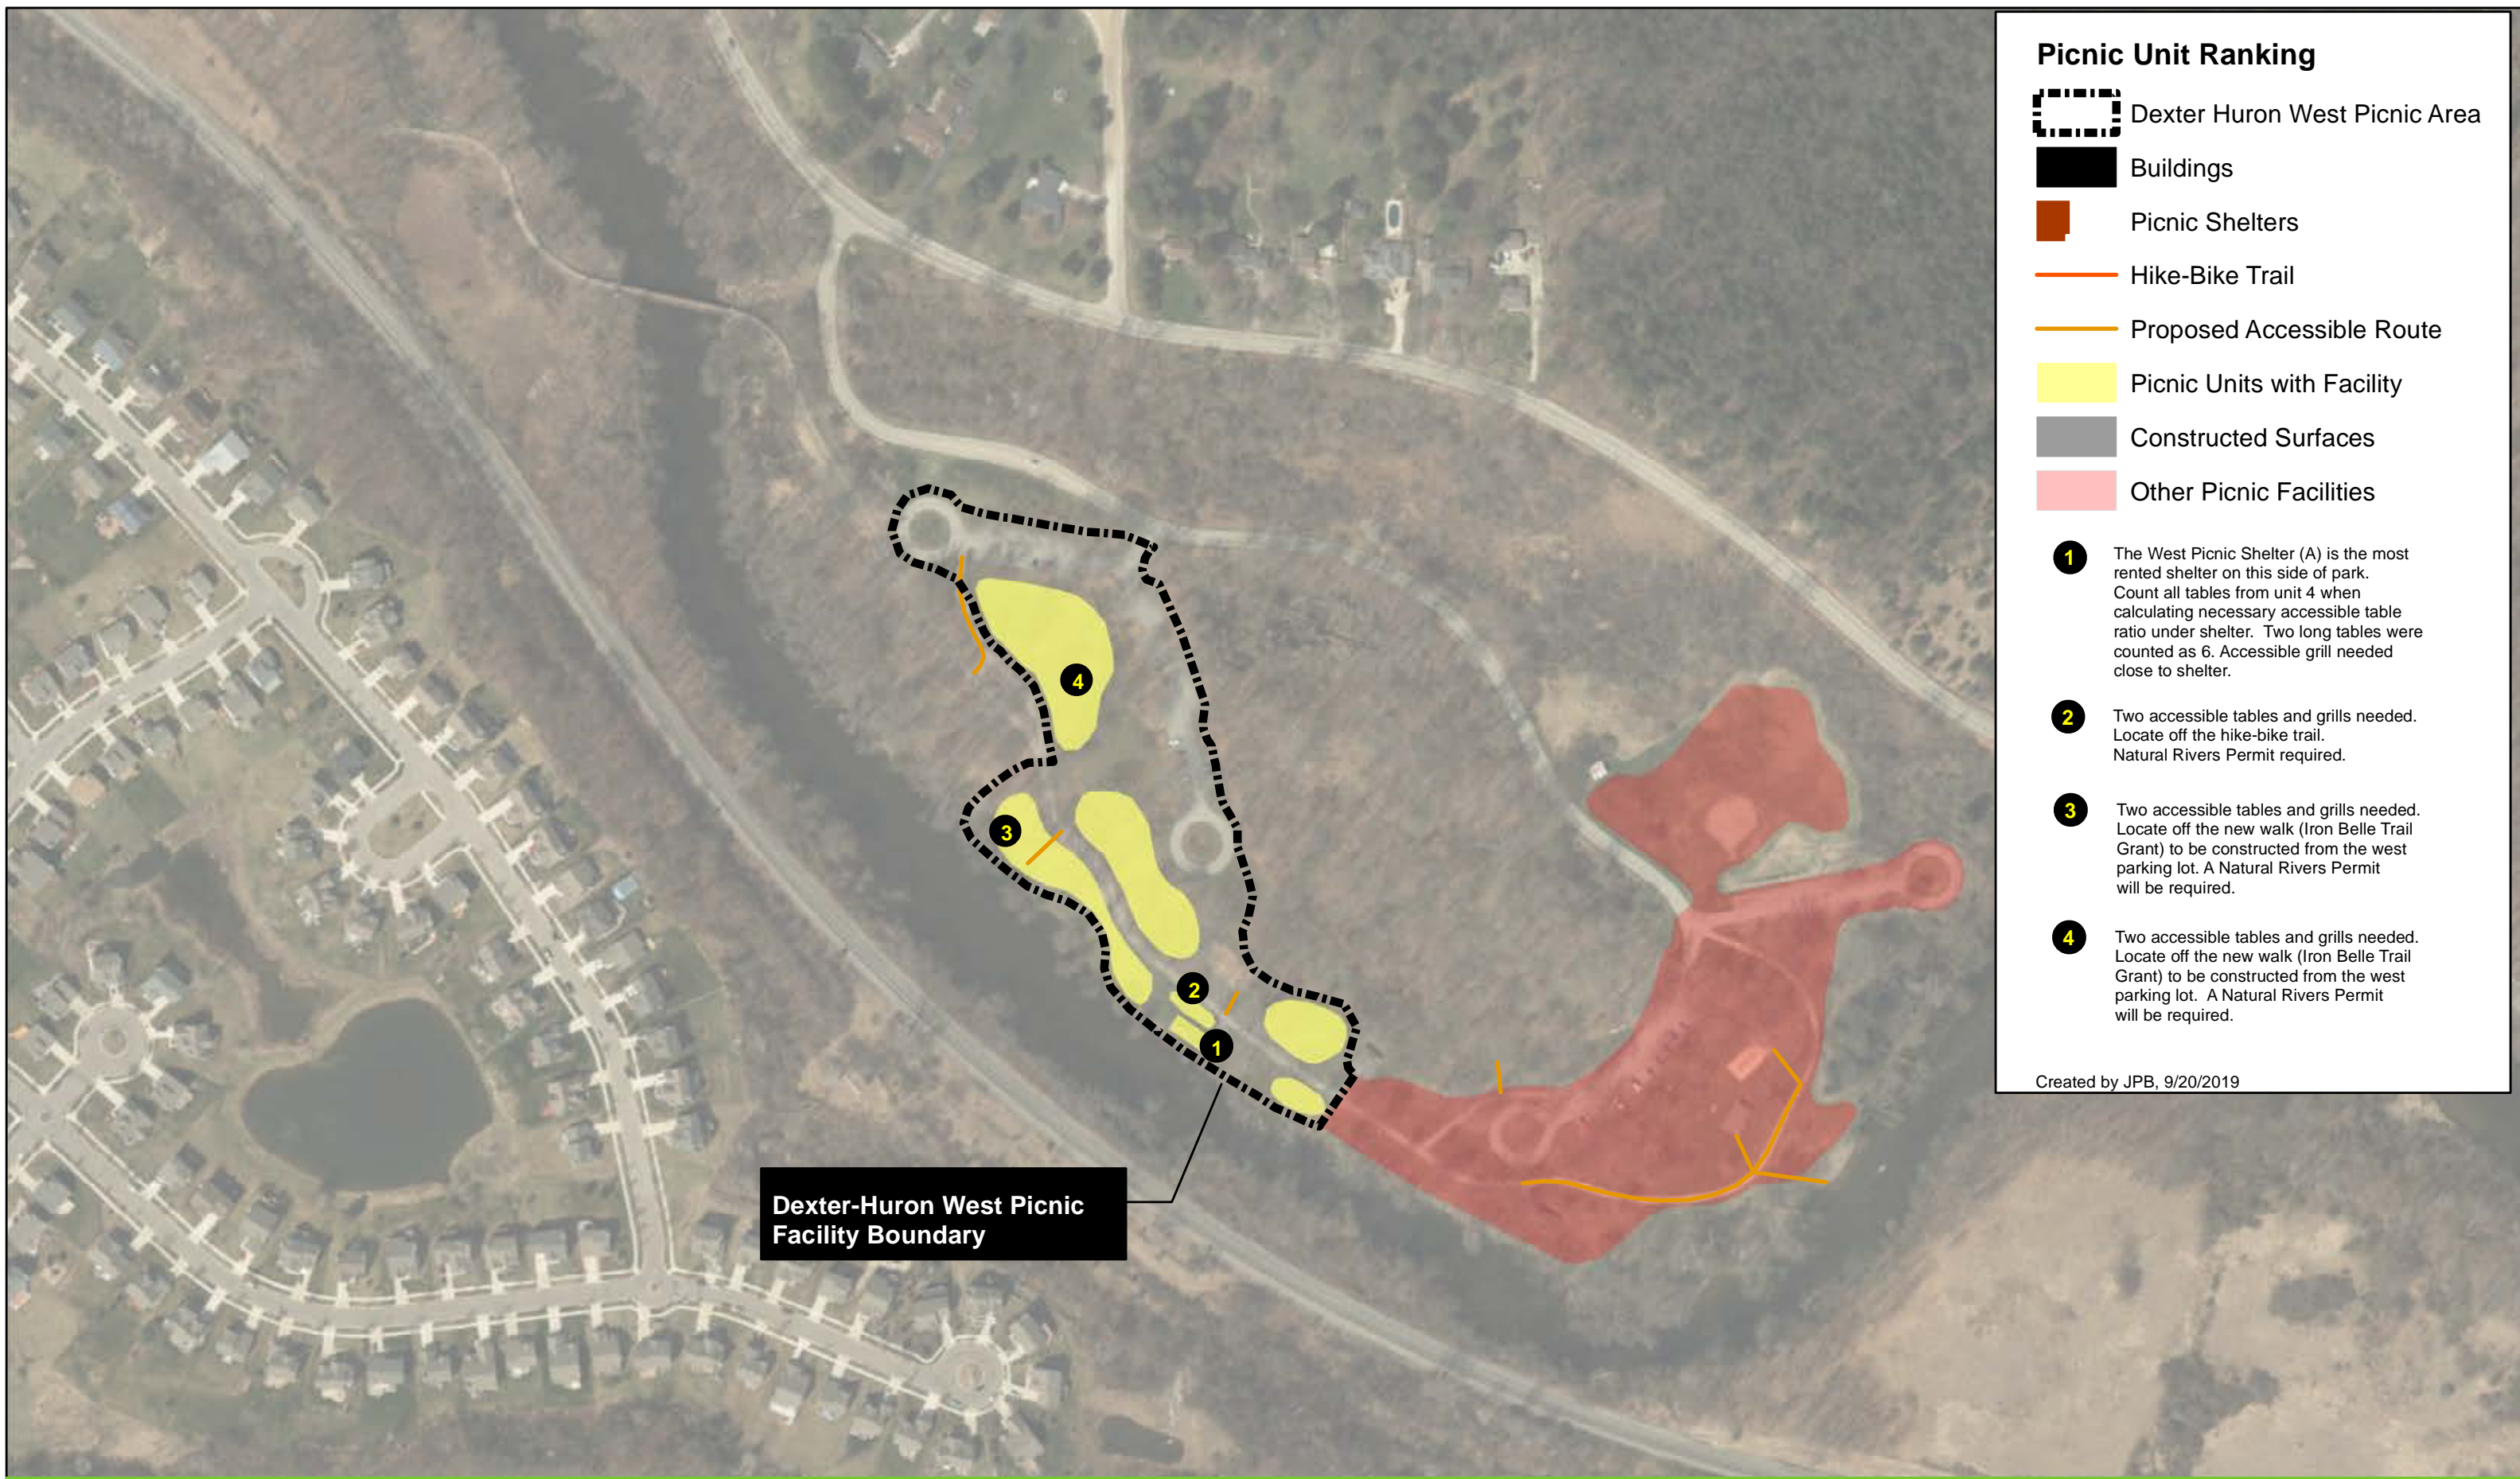
Dexter-Huron West Picnic Facility Boundary

- 1** The West Picnic Shelter (A) is the most rented shelter on this side of park. Count all tables from unit 4 when calculating necessary accessible table ratio under shelter. Two long tables were counted as 6. Accessible grill needed close to shelter.
- 2** Two accessible tables and grills needed. Locate off the hike-bike trail. Natural Rivers Permit required.
- 3** Two accessible tables and grills needed. Locate off the new walk (Iron Belle Trail Grant) to be constructed from the west parking lot. A Natural Rivers Permit will be required.
- 4** Two accessible tables and grills needed. Locate off the new walk (Iron Belle Trail Grant) to be constructed from the west parking lot. A Natural Rivers Permit will be required.

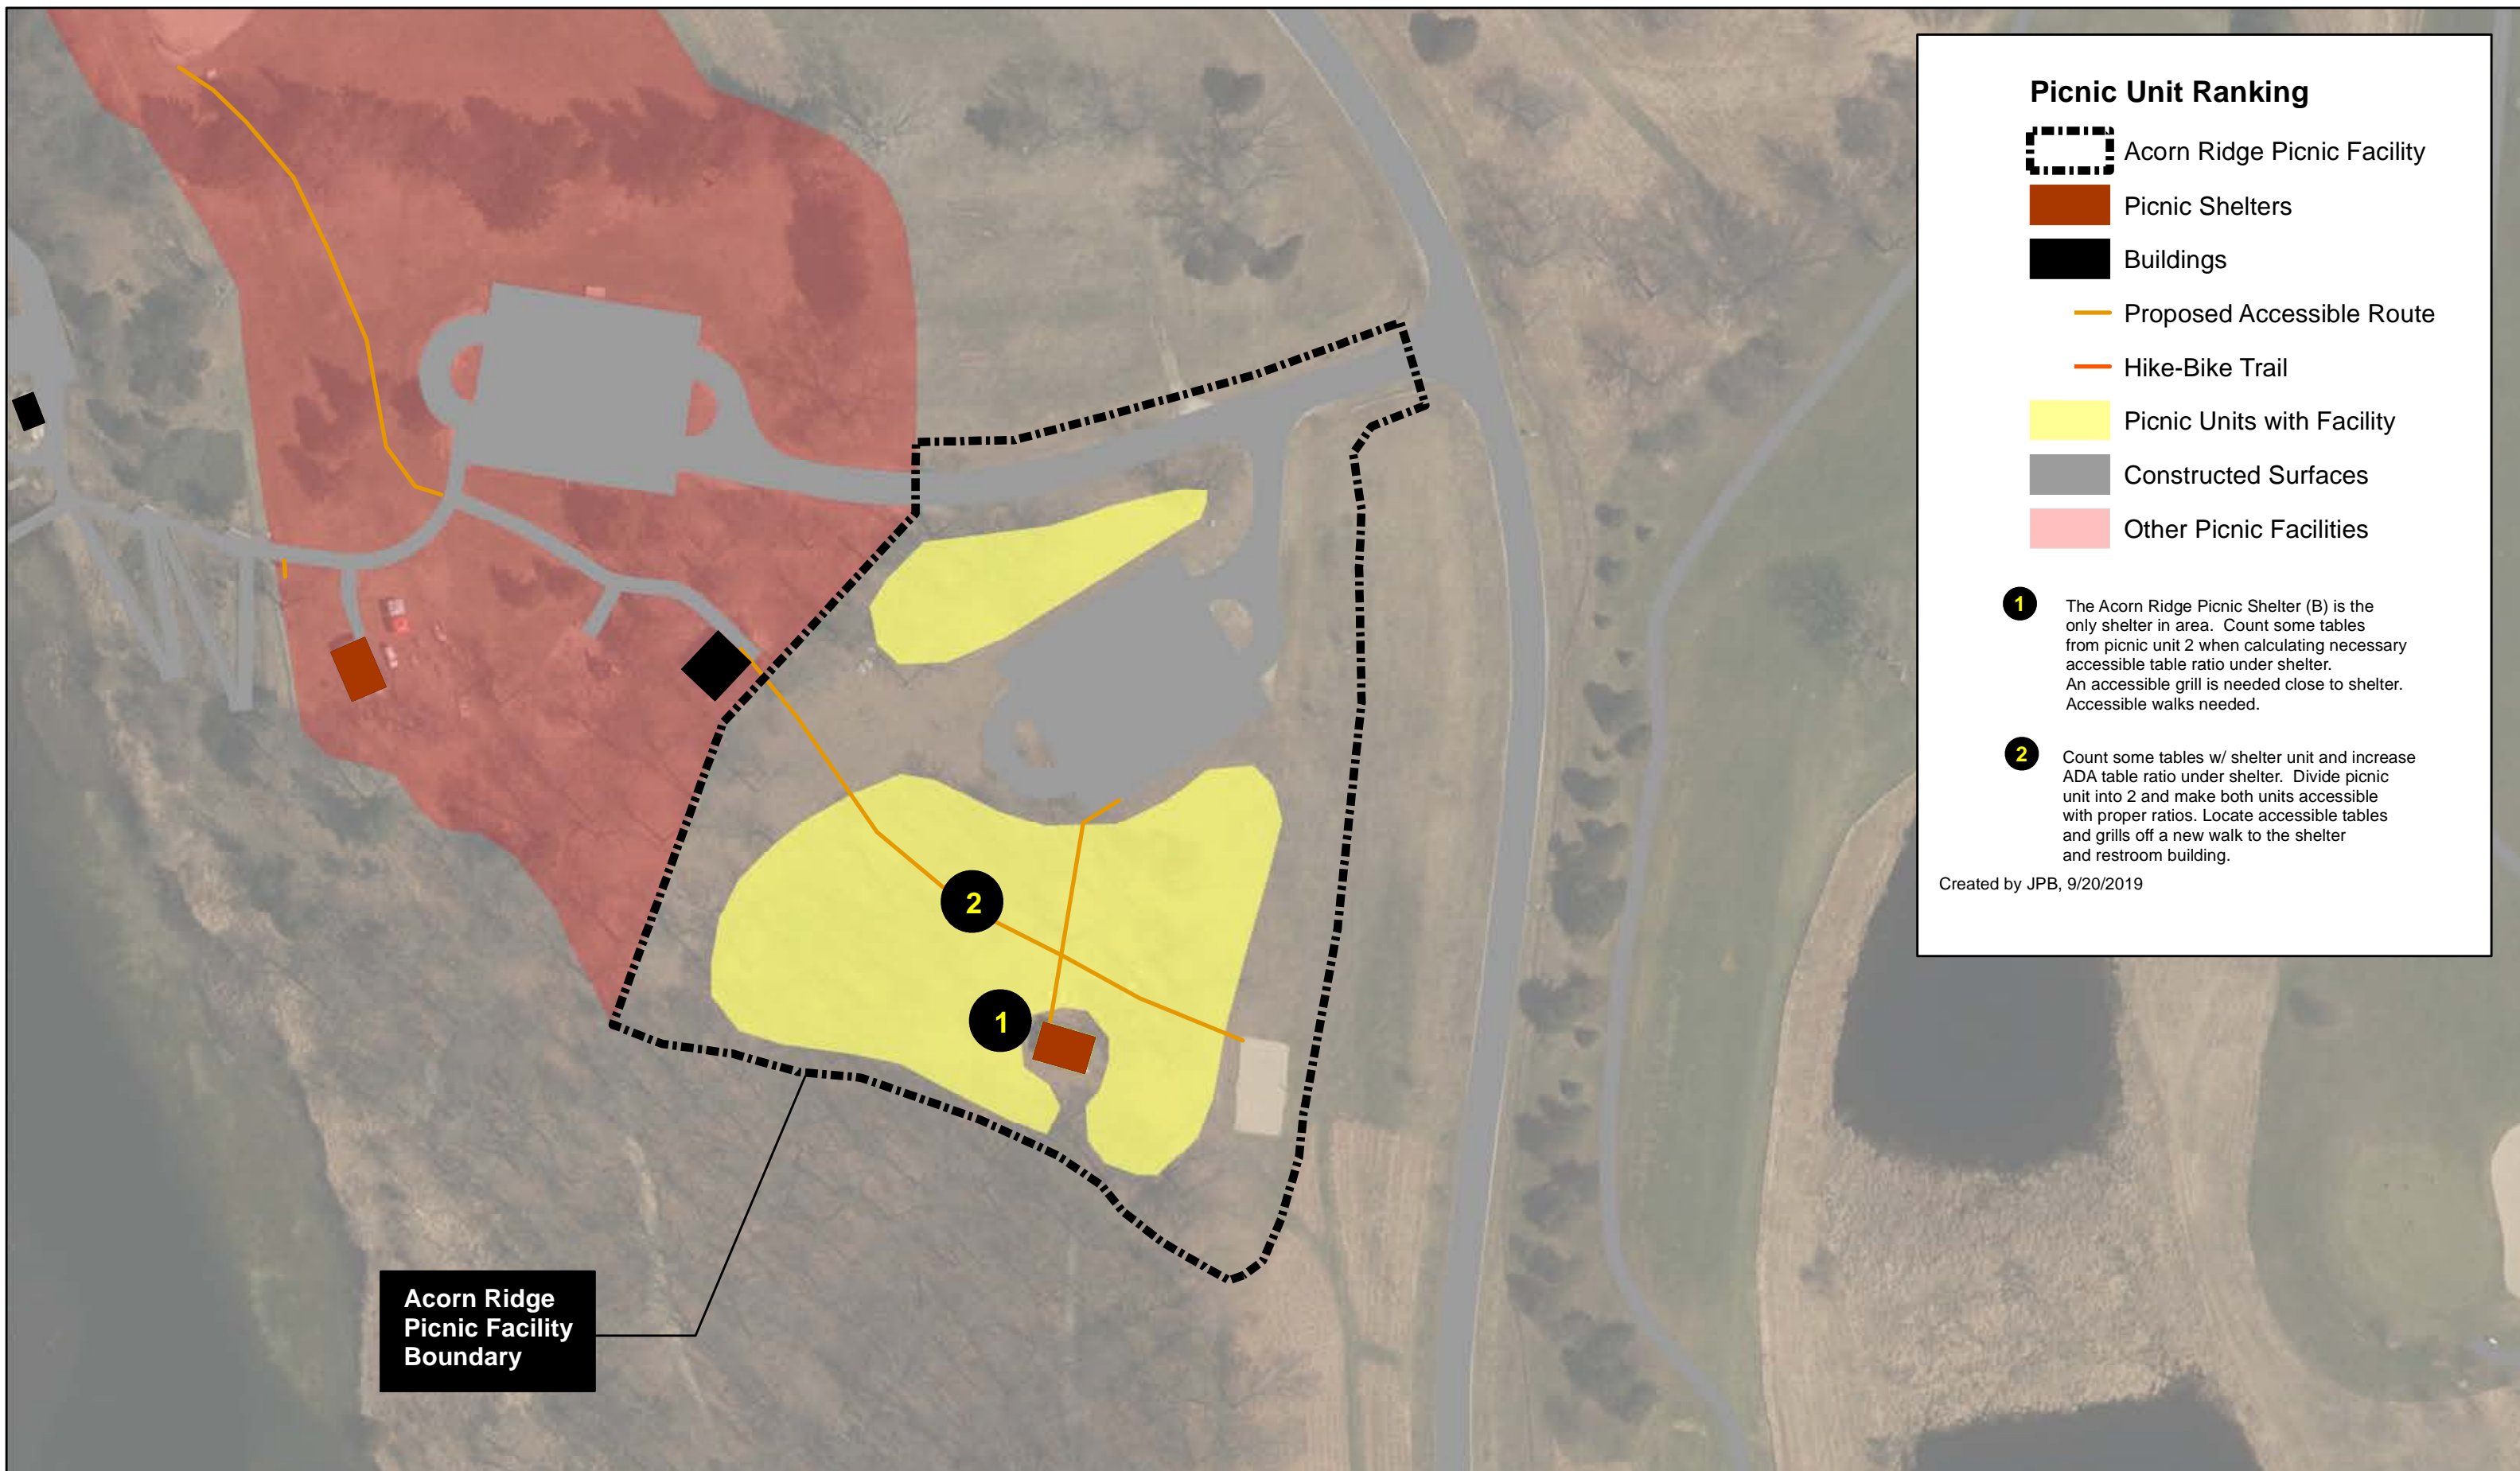
Acorn Ridge
Picnic Facility
Boundary

- 1** The Acorn Ridge Picnic Shelter (B) is the only shelter in area. Count some tables from picnic unit 2 when calculating necessary accessible table ratio under shelter. An accessible grill is needed close to shelter. Accessible walks needed.
- 2** Count some tables w/ shelter unit and increase ADA table ratio under shelter. Divide picnic unit into 2 and make both units accessible with proper ratios. Locate accessible tables and grills off a new walk to the shelter and restroom building.
