APPENDIX 3: PICNIC FACILITIES MAP

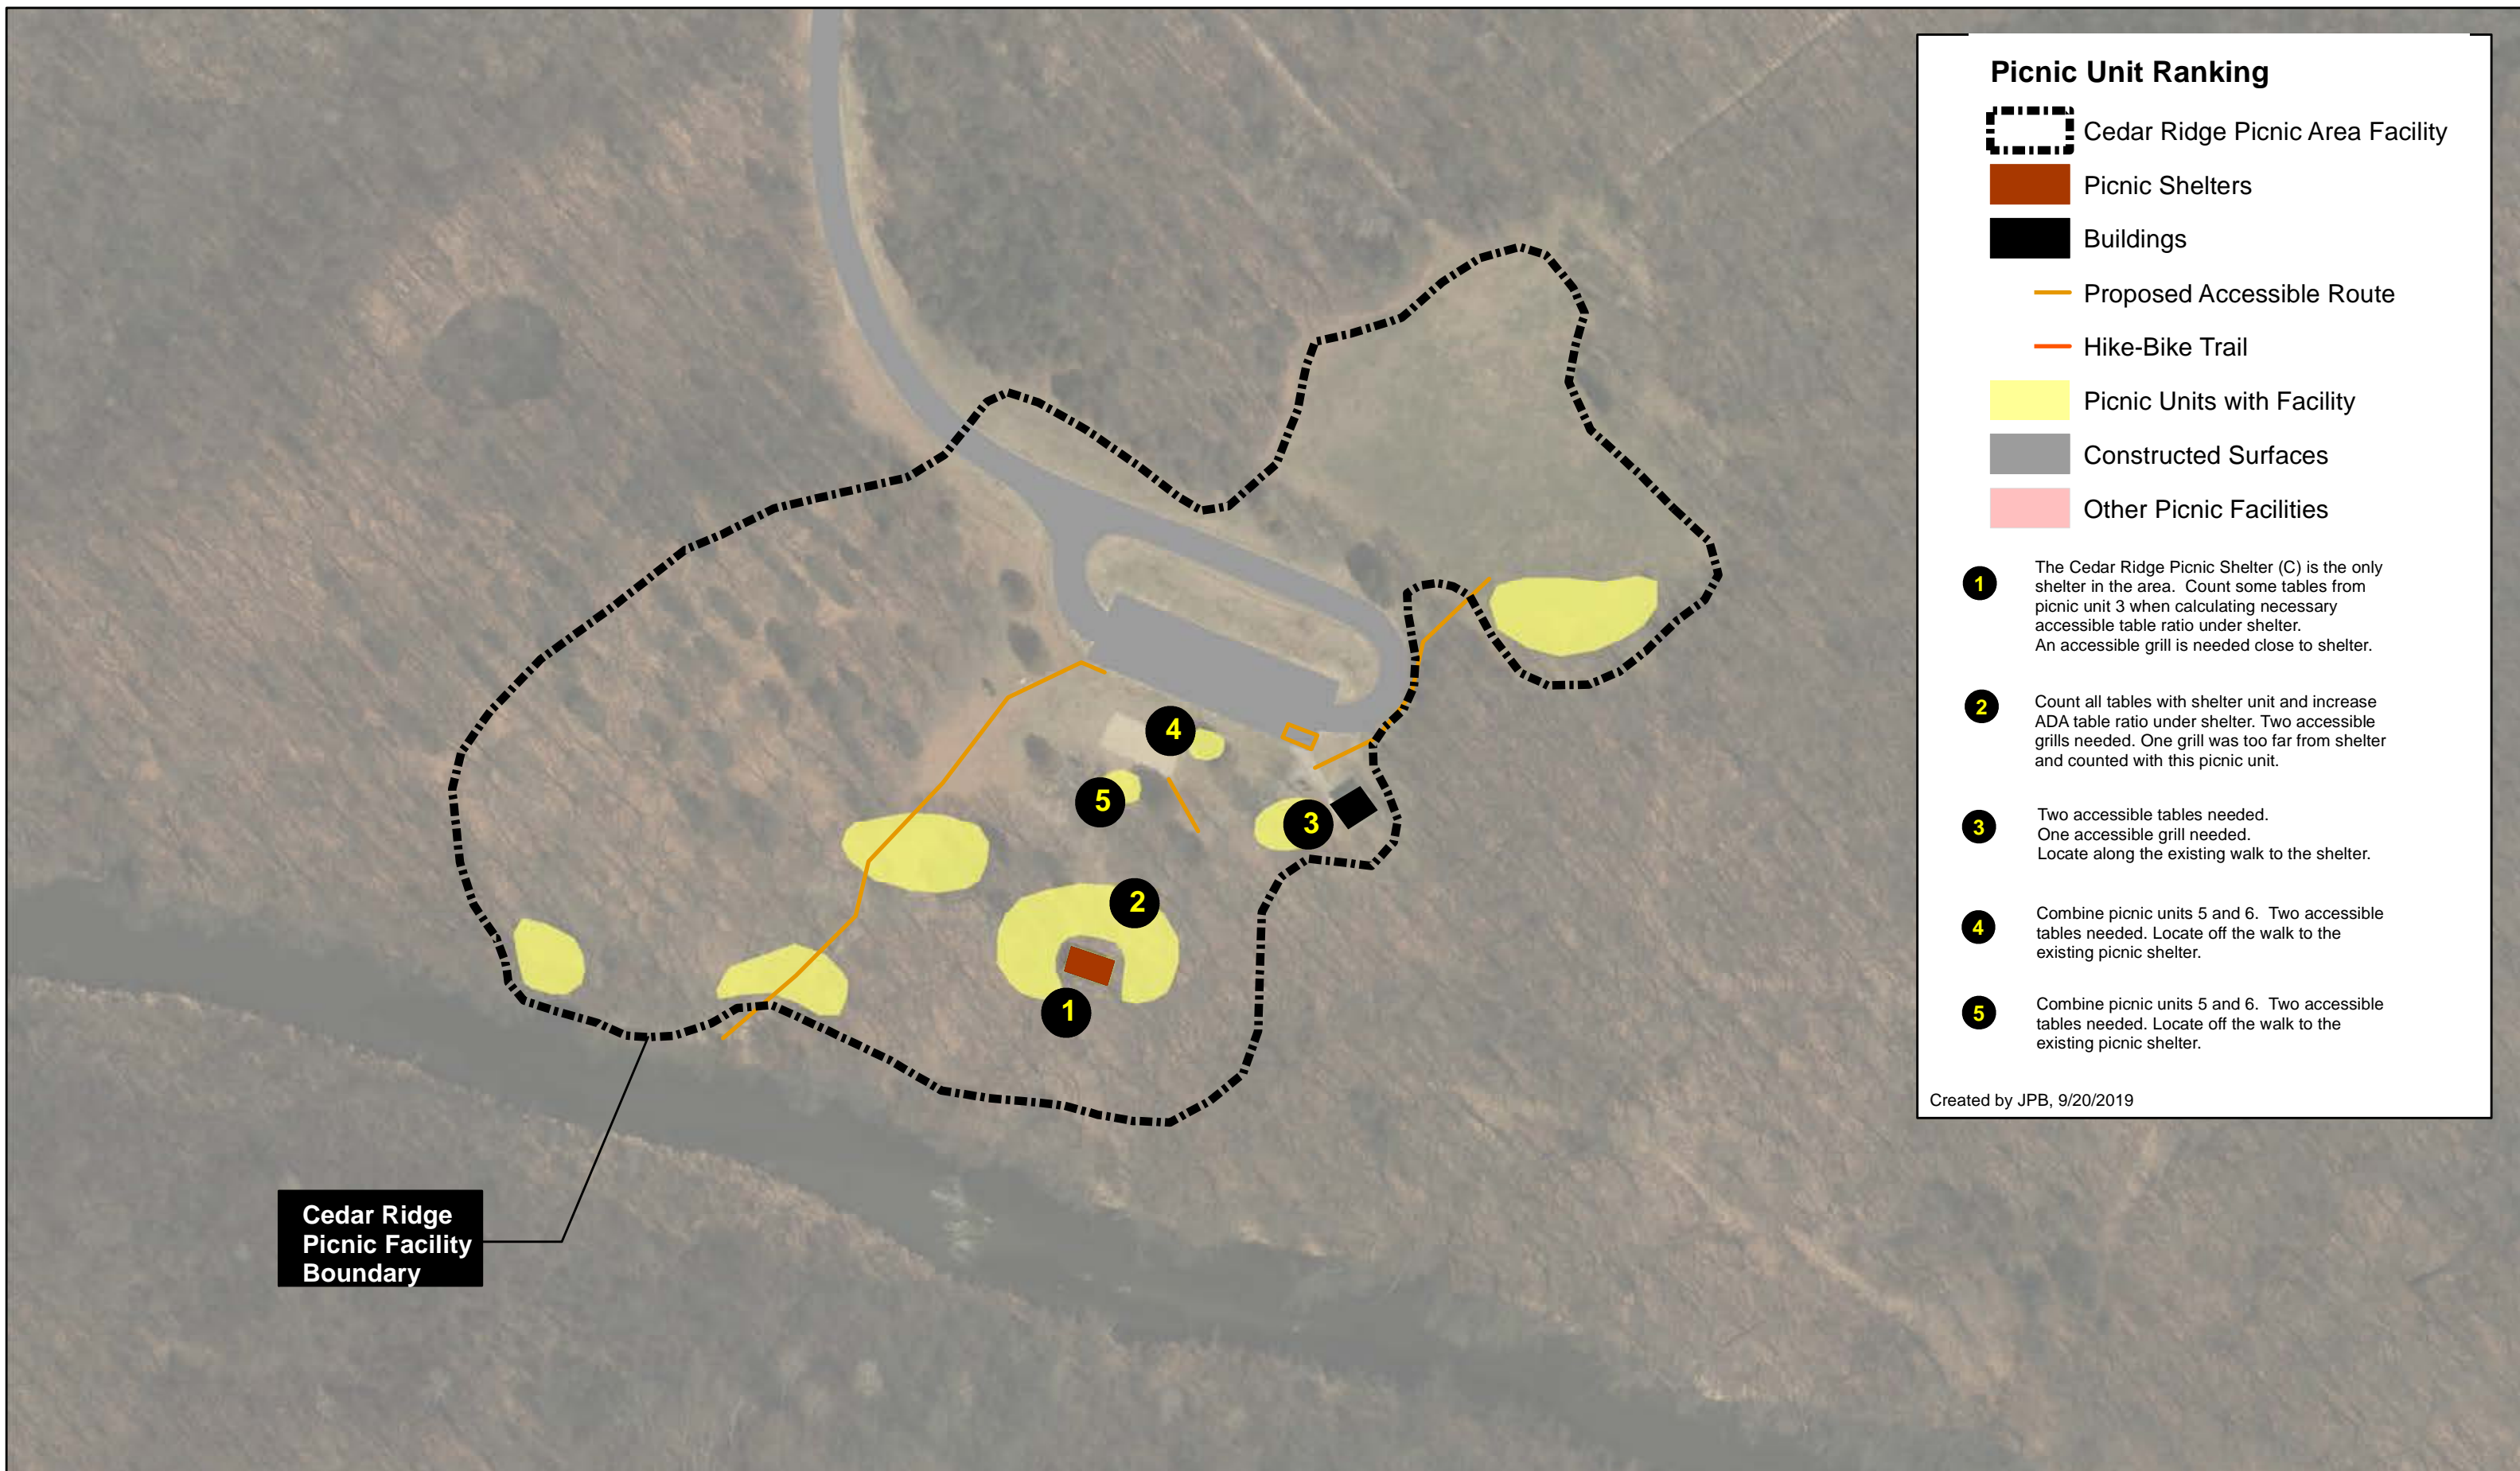
Cedar Ridge Picnic Facility Boundary

- 1** The Cedar Ridge Picnic Shelter (C) is the only shelter in the area. Count some tables from picnic unit 3 when calculating necessary accessible table ratio under shelter. An accessible grill is needed close to shelter.
- 2** Count all tables with shelter unit and increase ADA table ratio under shelter. Two accessible grills needed. One grill was too far from shelter and counted with this picnic unit.
- 3** Two accessible tables needed. One accessible grill needed. Locate along the existing walk to the shelter.
- 4** Combine picnic units 5 and 6. Two accessible tables needed. Locate off the walk to the existing picnic shelter.
- 5** Combine picnic units 5 and 6. Two accessible tables needed. Locate off the walk to the existing picnic shelter.

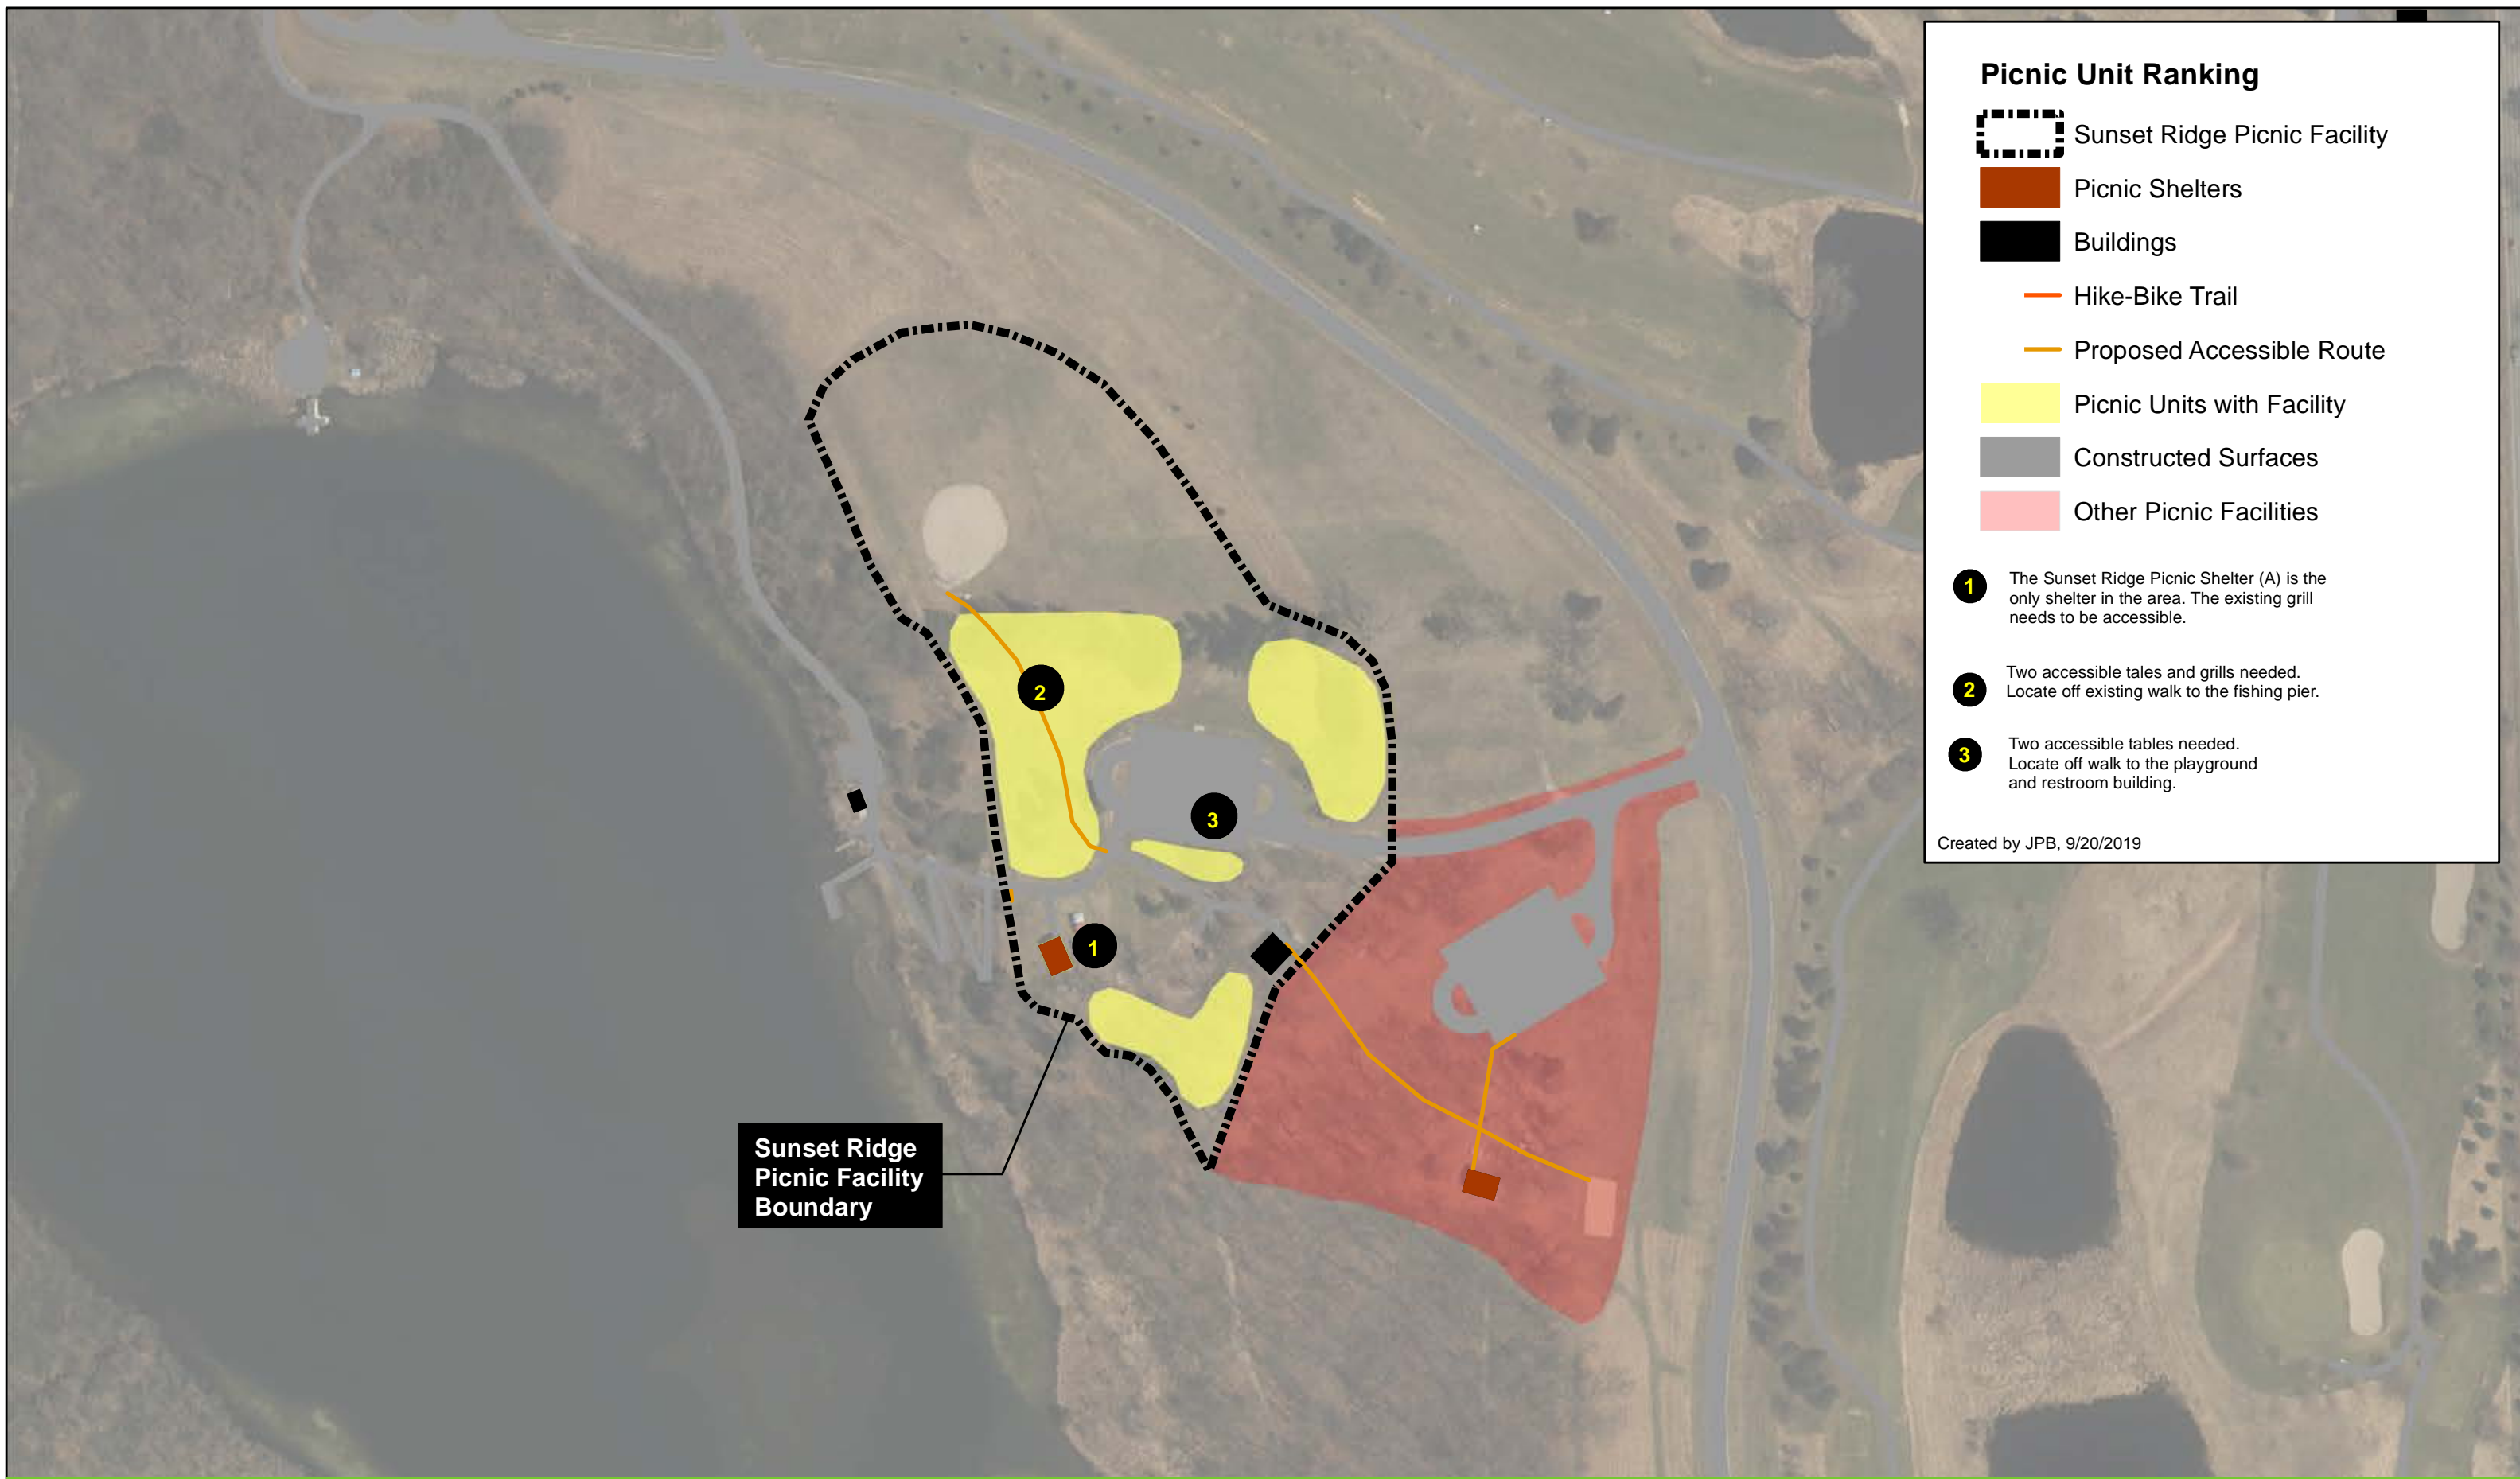
Sunset Ridge Picnic Facility Boundary

- 1** The Sunset Ridge Picnic Shelter (A) is the only shelter in the area. The existing grill needs to be accessible.
- 2** Two accessible tables and grills needed. Locate off existing walk to the fishing pier.
- 3** Two accessible tables needed. Locate off walk to the playground and restroom building.

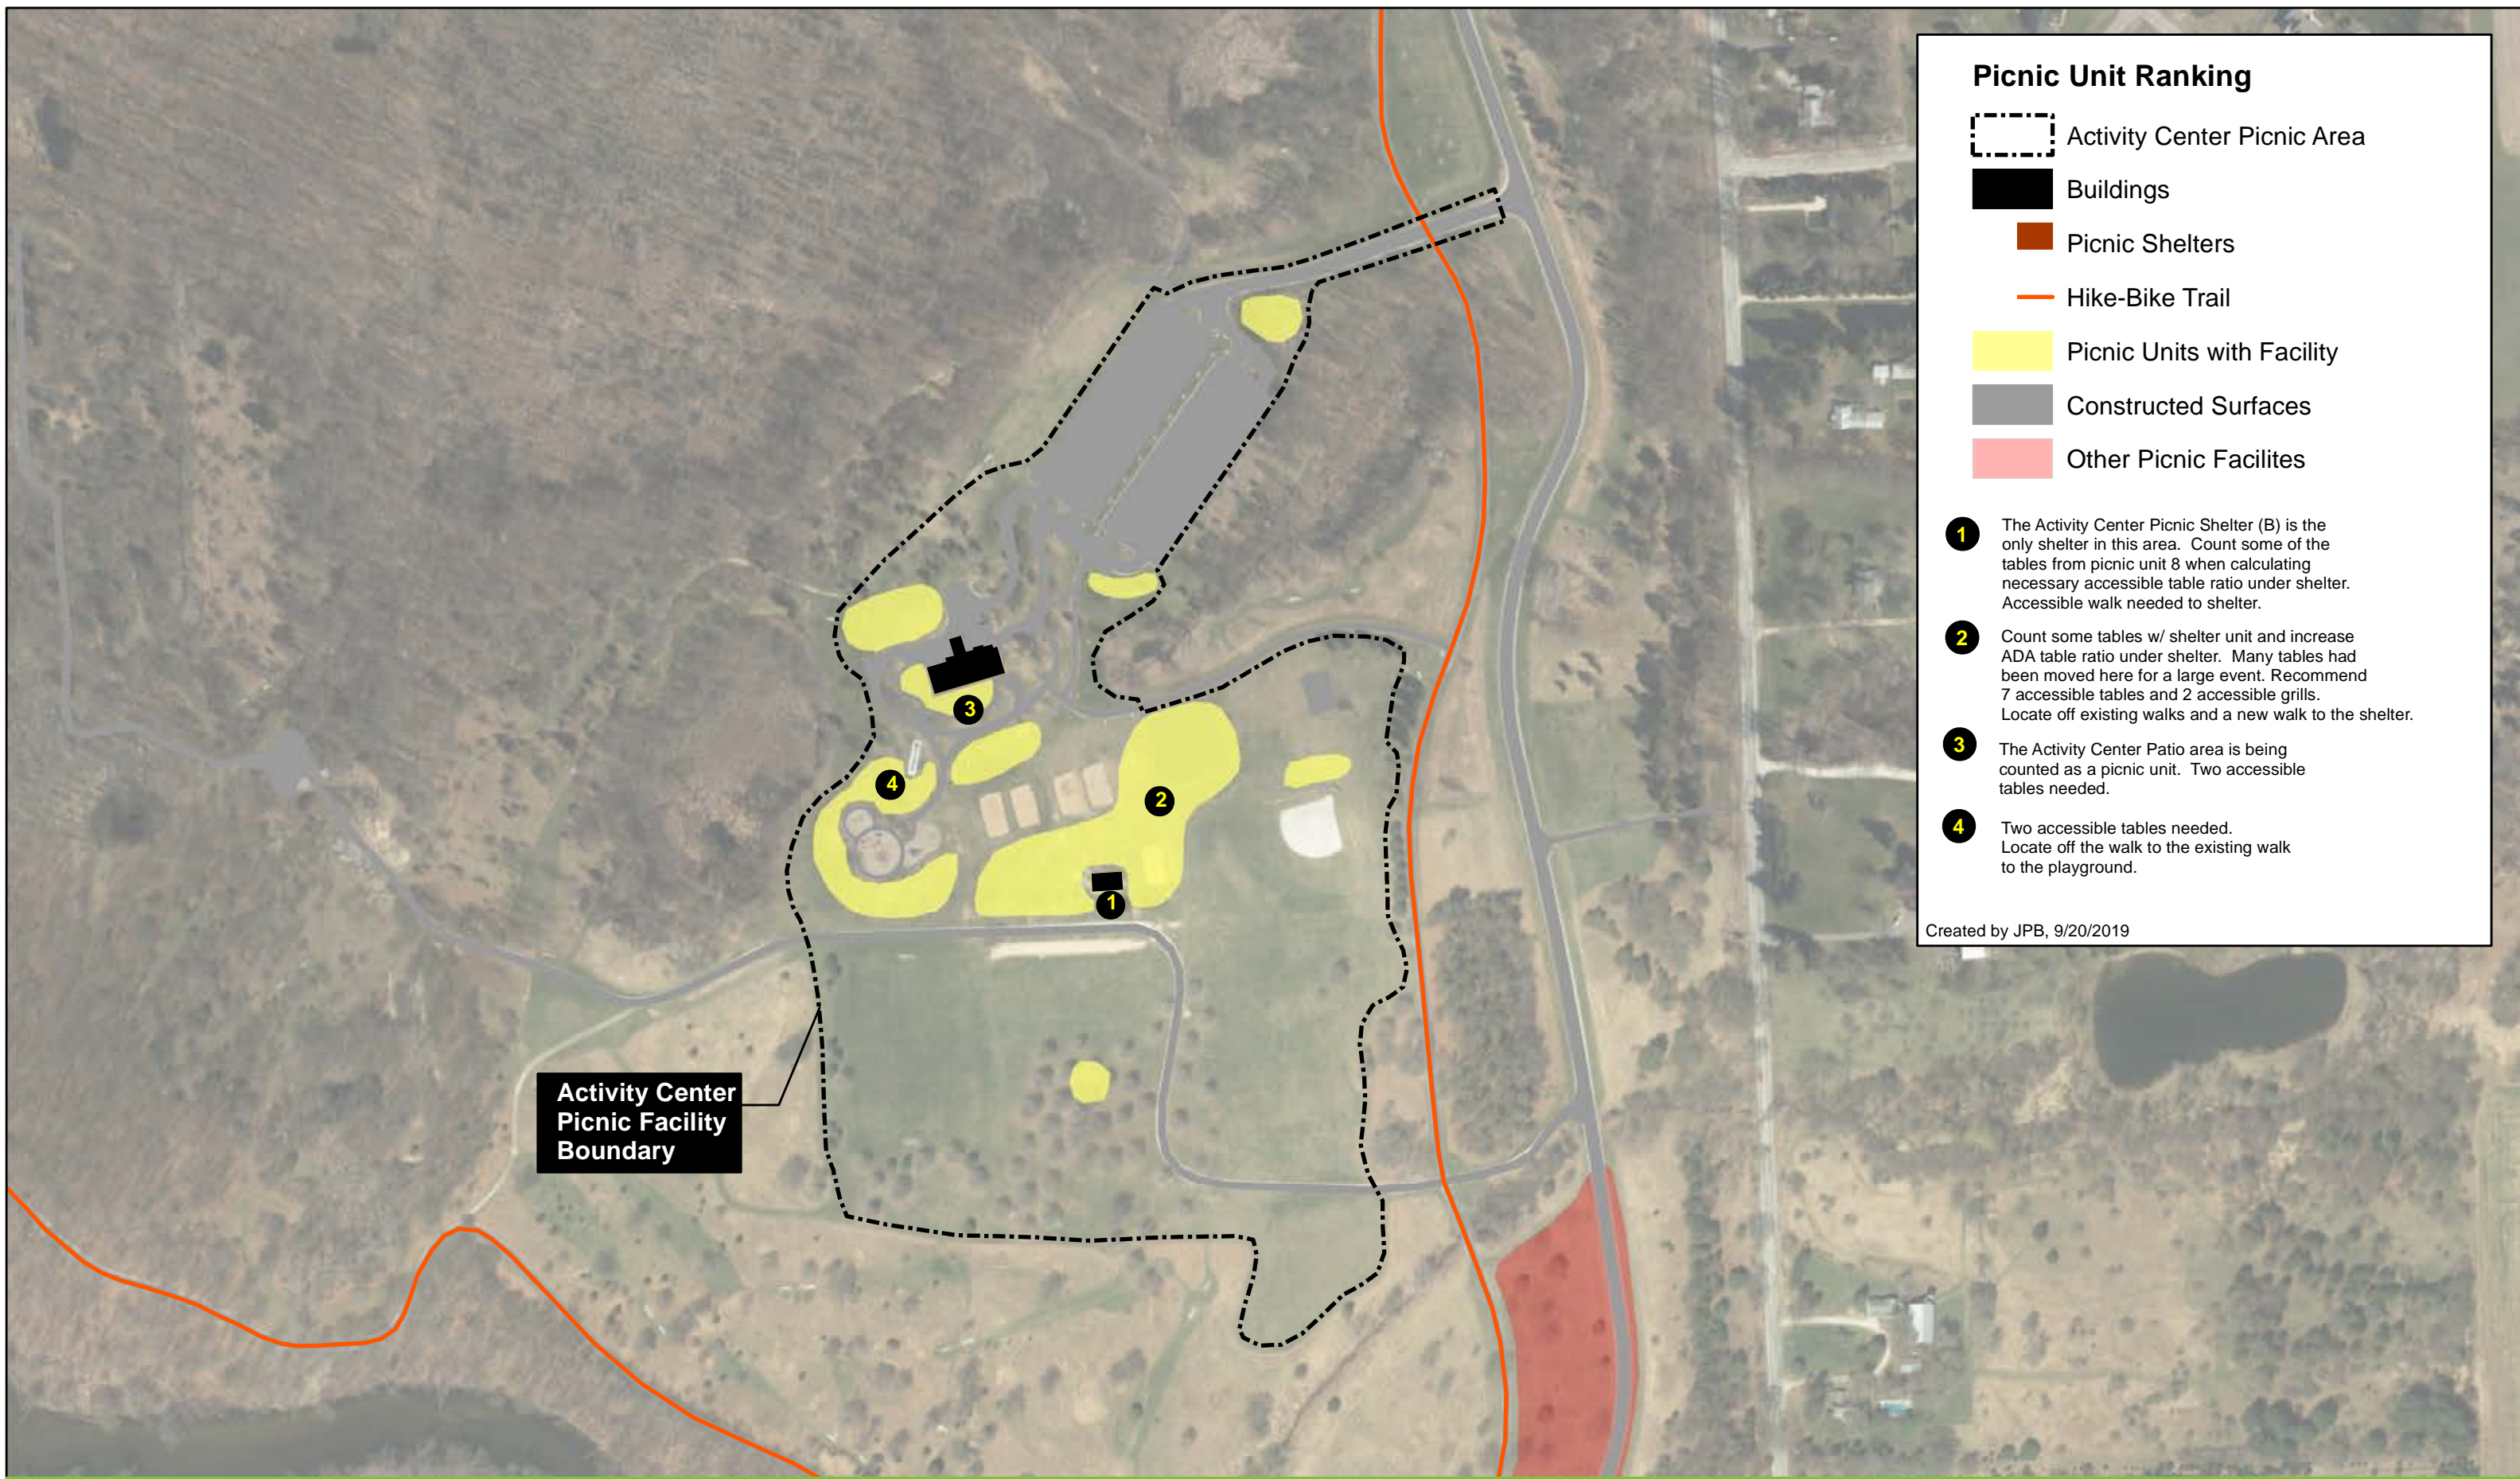
Activity Center
Picnic Facility
Boundary

- 1** The Activity Center Picnic Shelter (B) is the only shelter in this area. Count some of the tables from picnic unit 8 when calculating necessary accessible table ratio under shelter. Accessible walk needed to shelter.
- 2** Count some tables w/ shelter unit and increase ADA table ratio under shelter. Many tables had been moved here for a large event. Recommend 7 accessible tables and 2 accessible grills. Locate off existing walks and a new walk to the shelter.
- 3** The Activity Center Patio area is being counted as a picnic unit. Two accessible tables needed.
- 4** Two accessible tables needed. Locate off the walk to the existing walk to the playground.

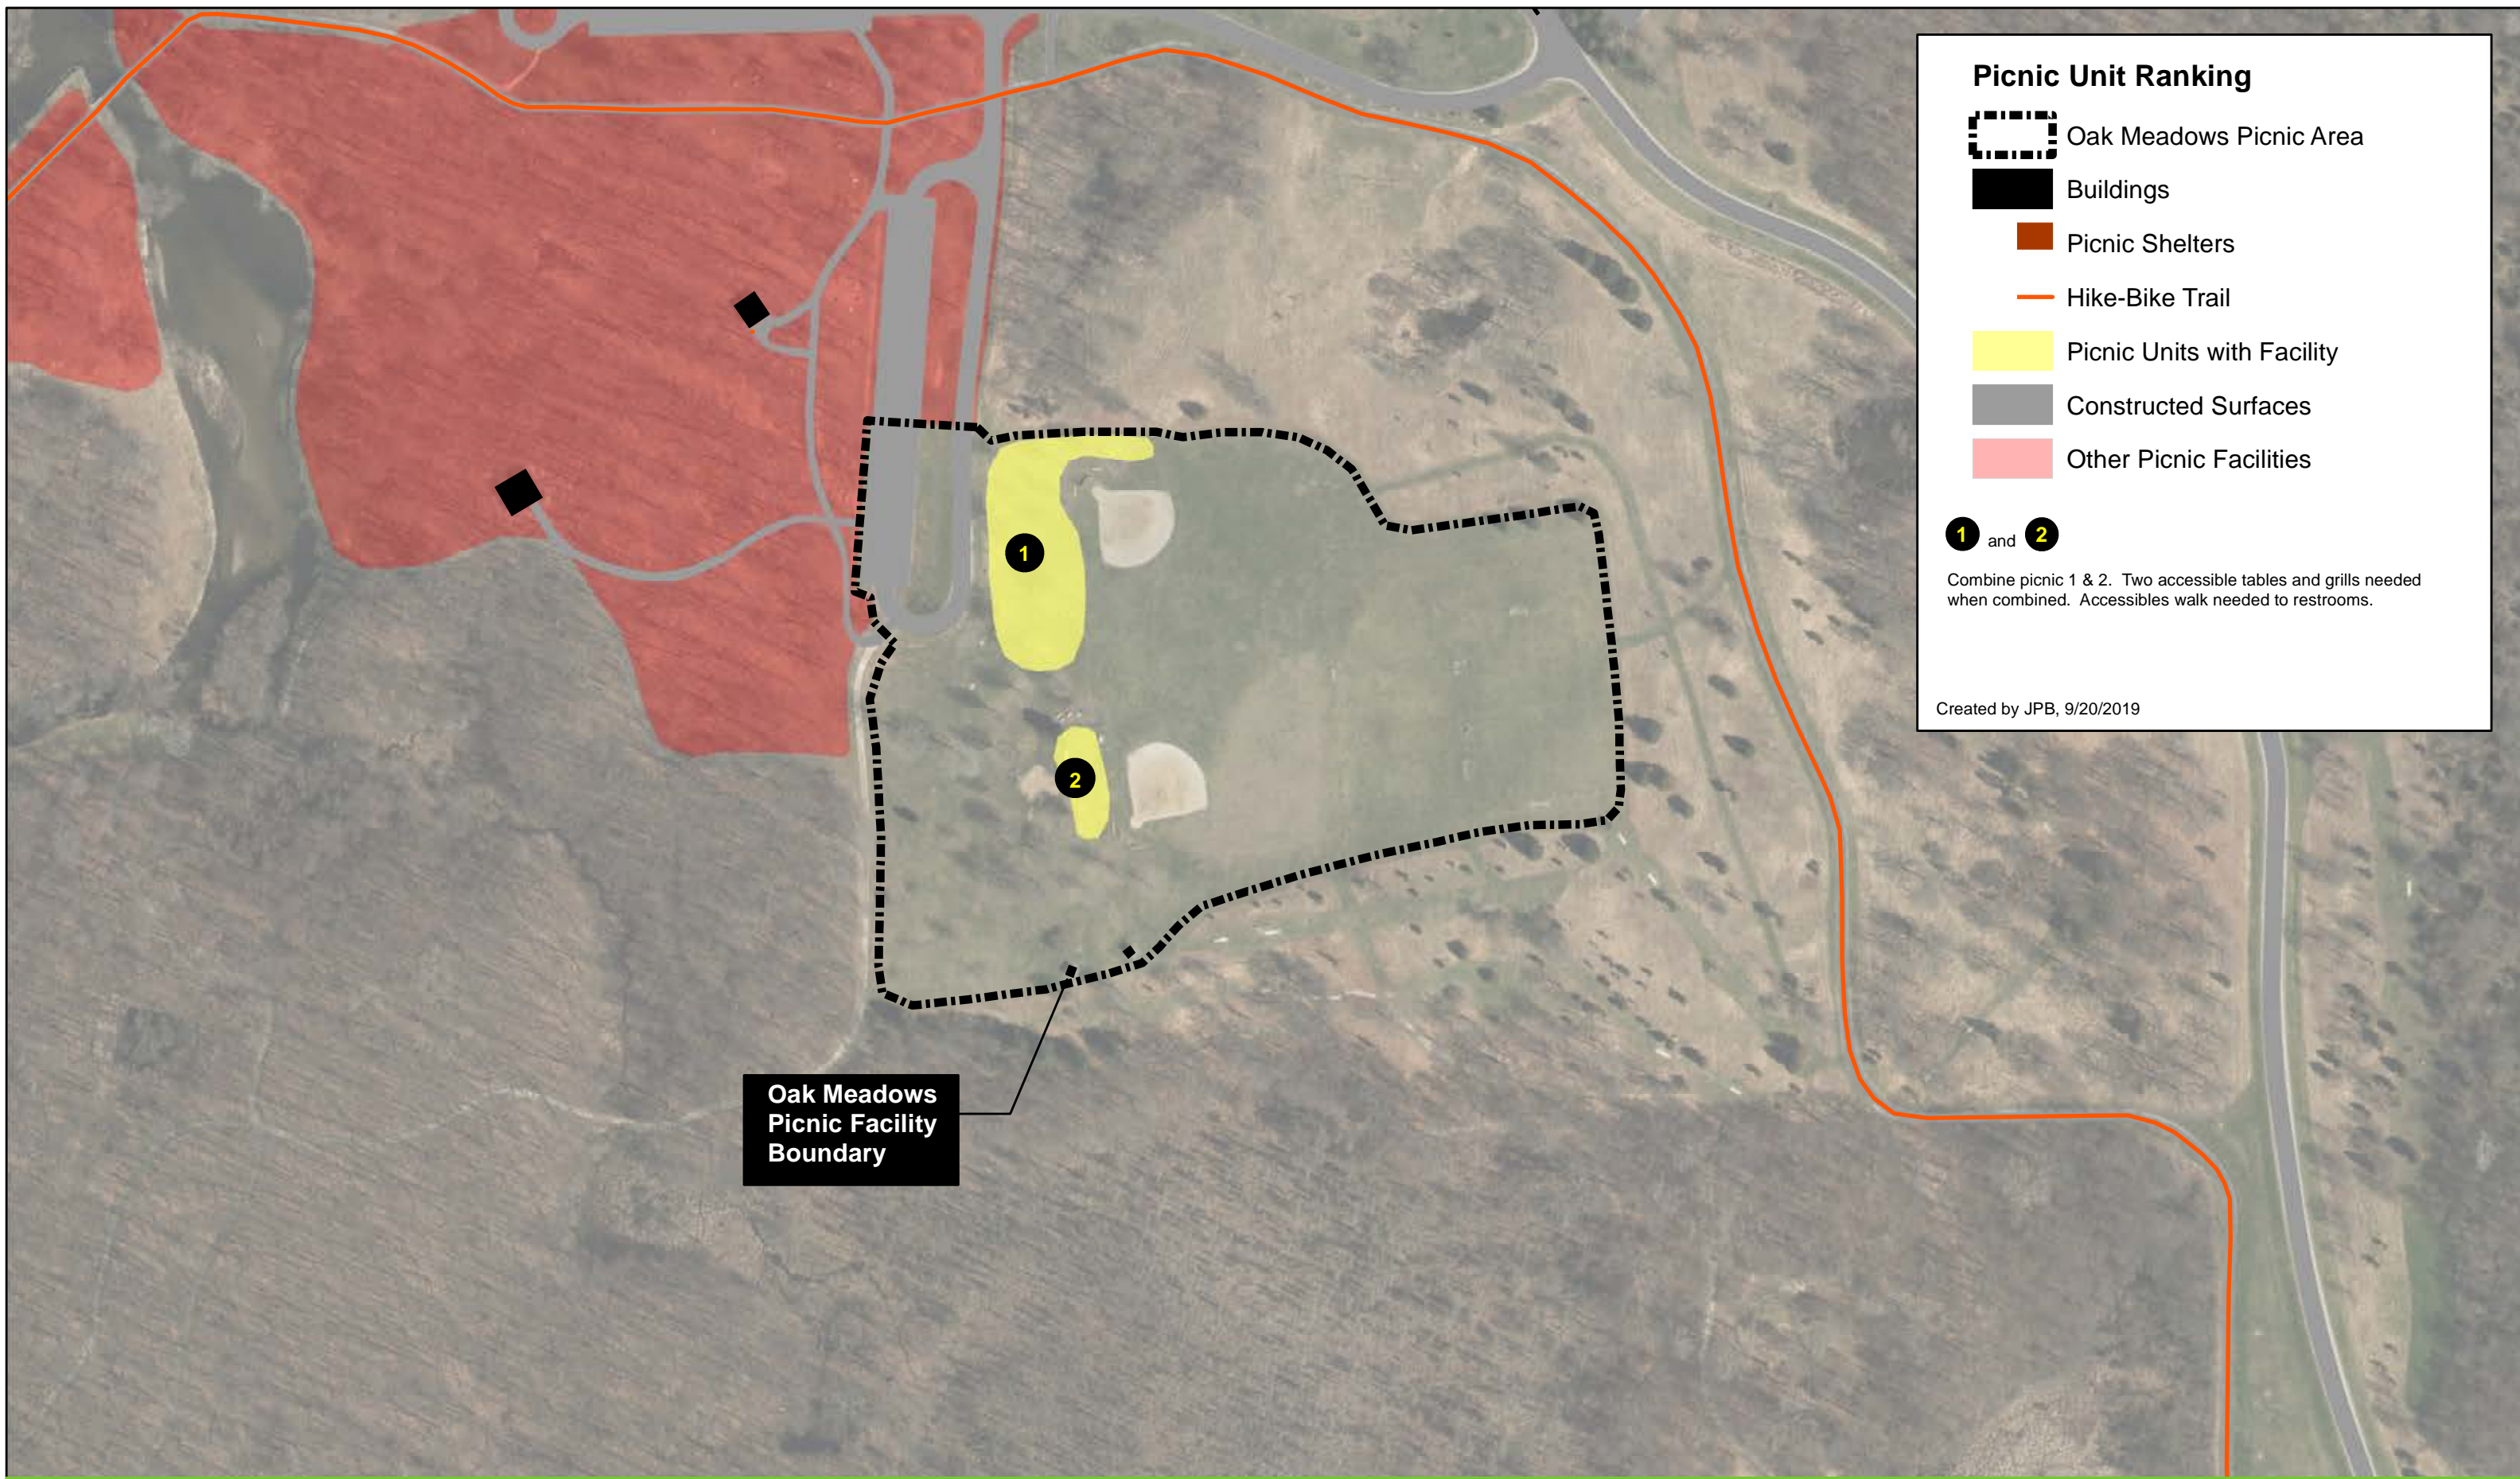
Oak Meadows
Picnic Facility
Boundary

Combine picnic 1 & 2. Two accessible tables and grills needed when combined. Accessible walk needed to restrooms.

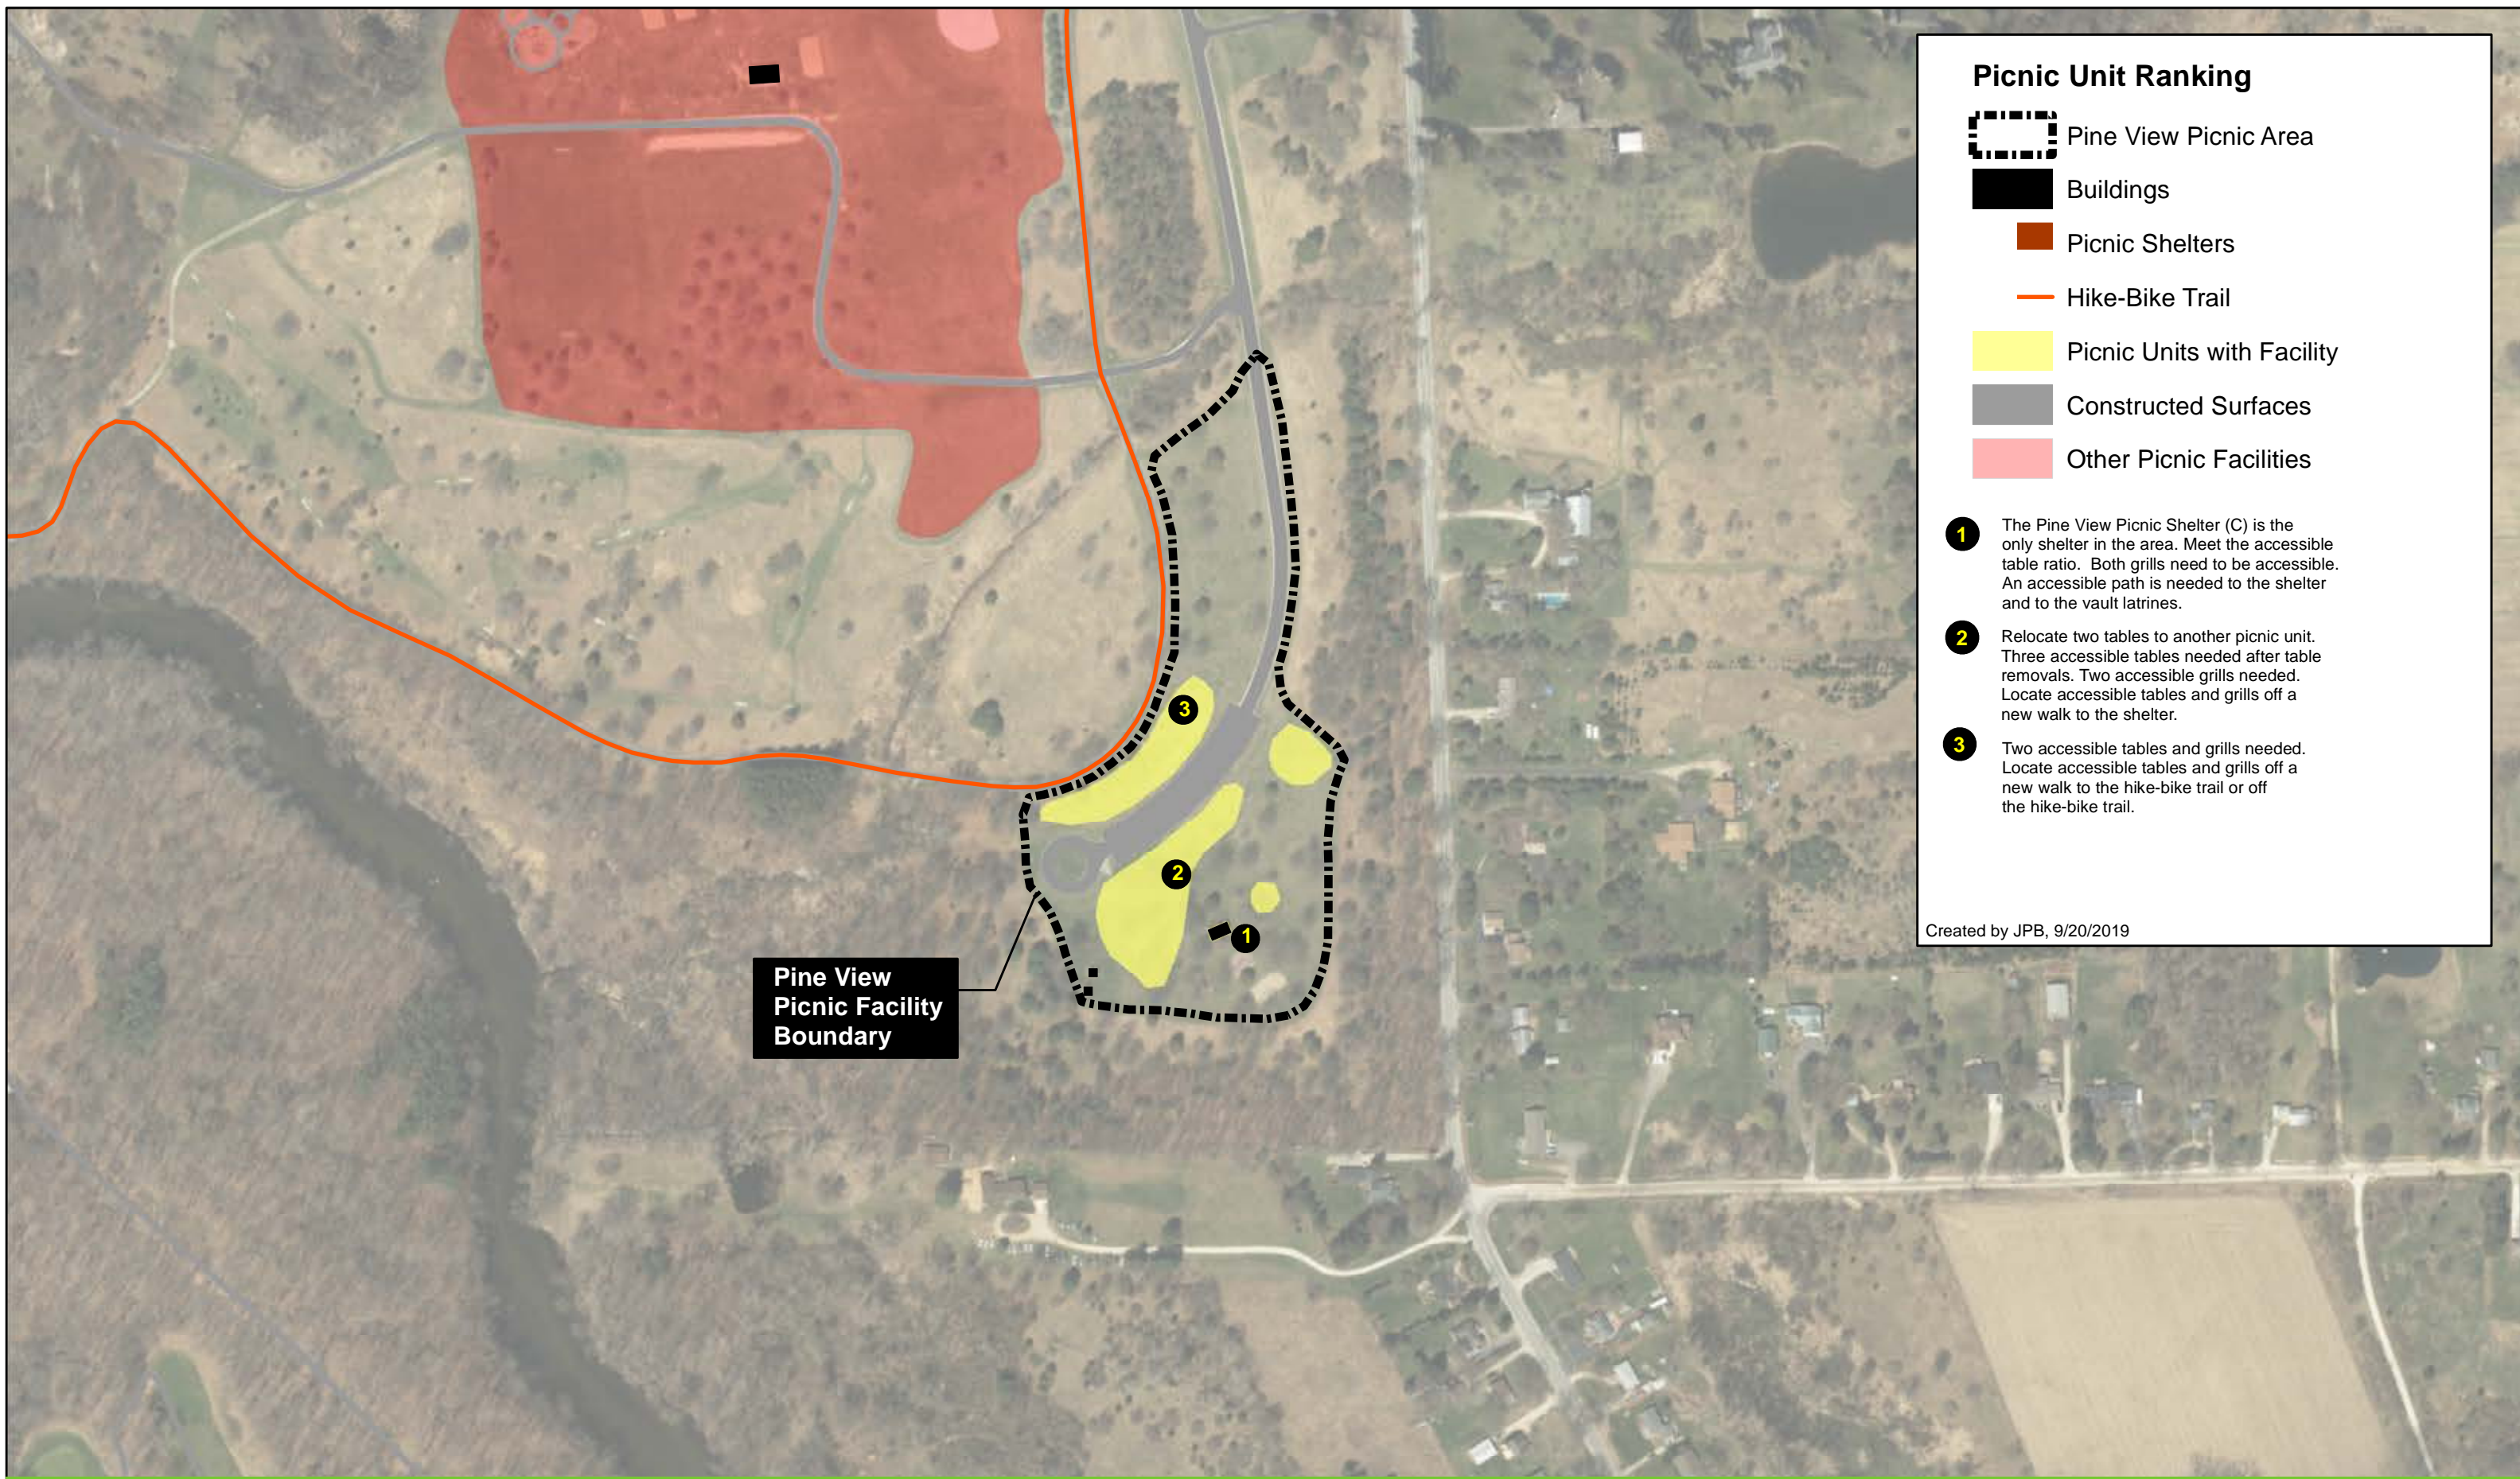
Pine View Picnic Facility Boundary

- 1** The Pine View Picnic Shelter (C) is the only shelter in the area. Meet the accessible table ratio. Both grills need to be accessible. An accessible path is needed to the shelter and to the vault latrines.
- 2** Relocate two tables to another picnic unit. Three accessible tables needed after table removals. Two accessible grills needed. Locate accessible tables and grills off a new walk to the shelter.
- 3** Two accessible tables and grills needed. Locate accessible tables and grills off a new walk to the hike-bike trail or off the hike-bike trail.

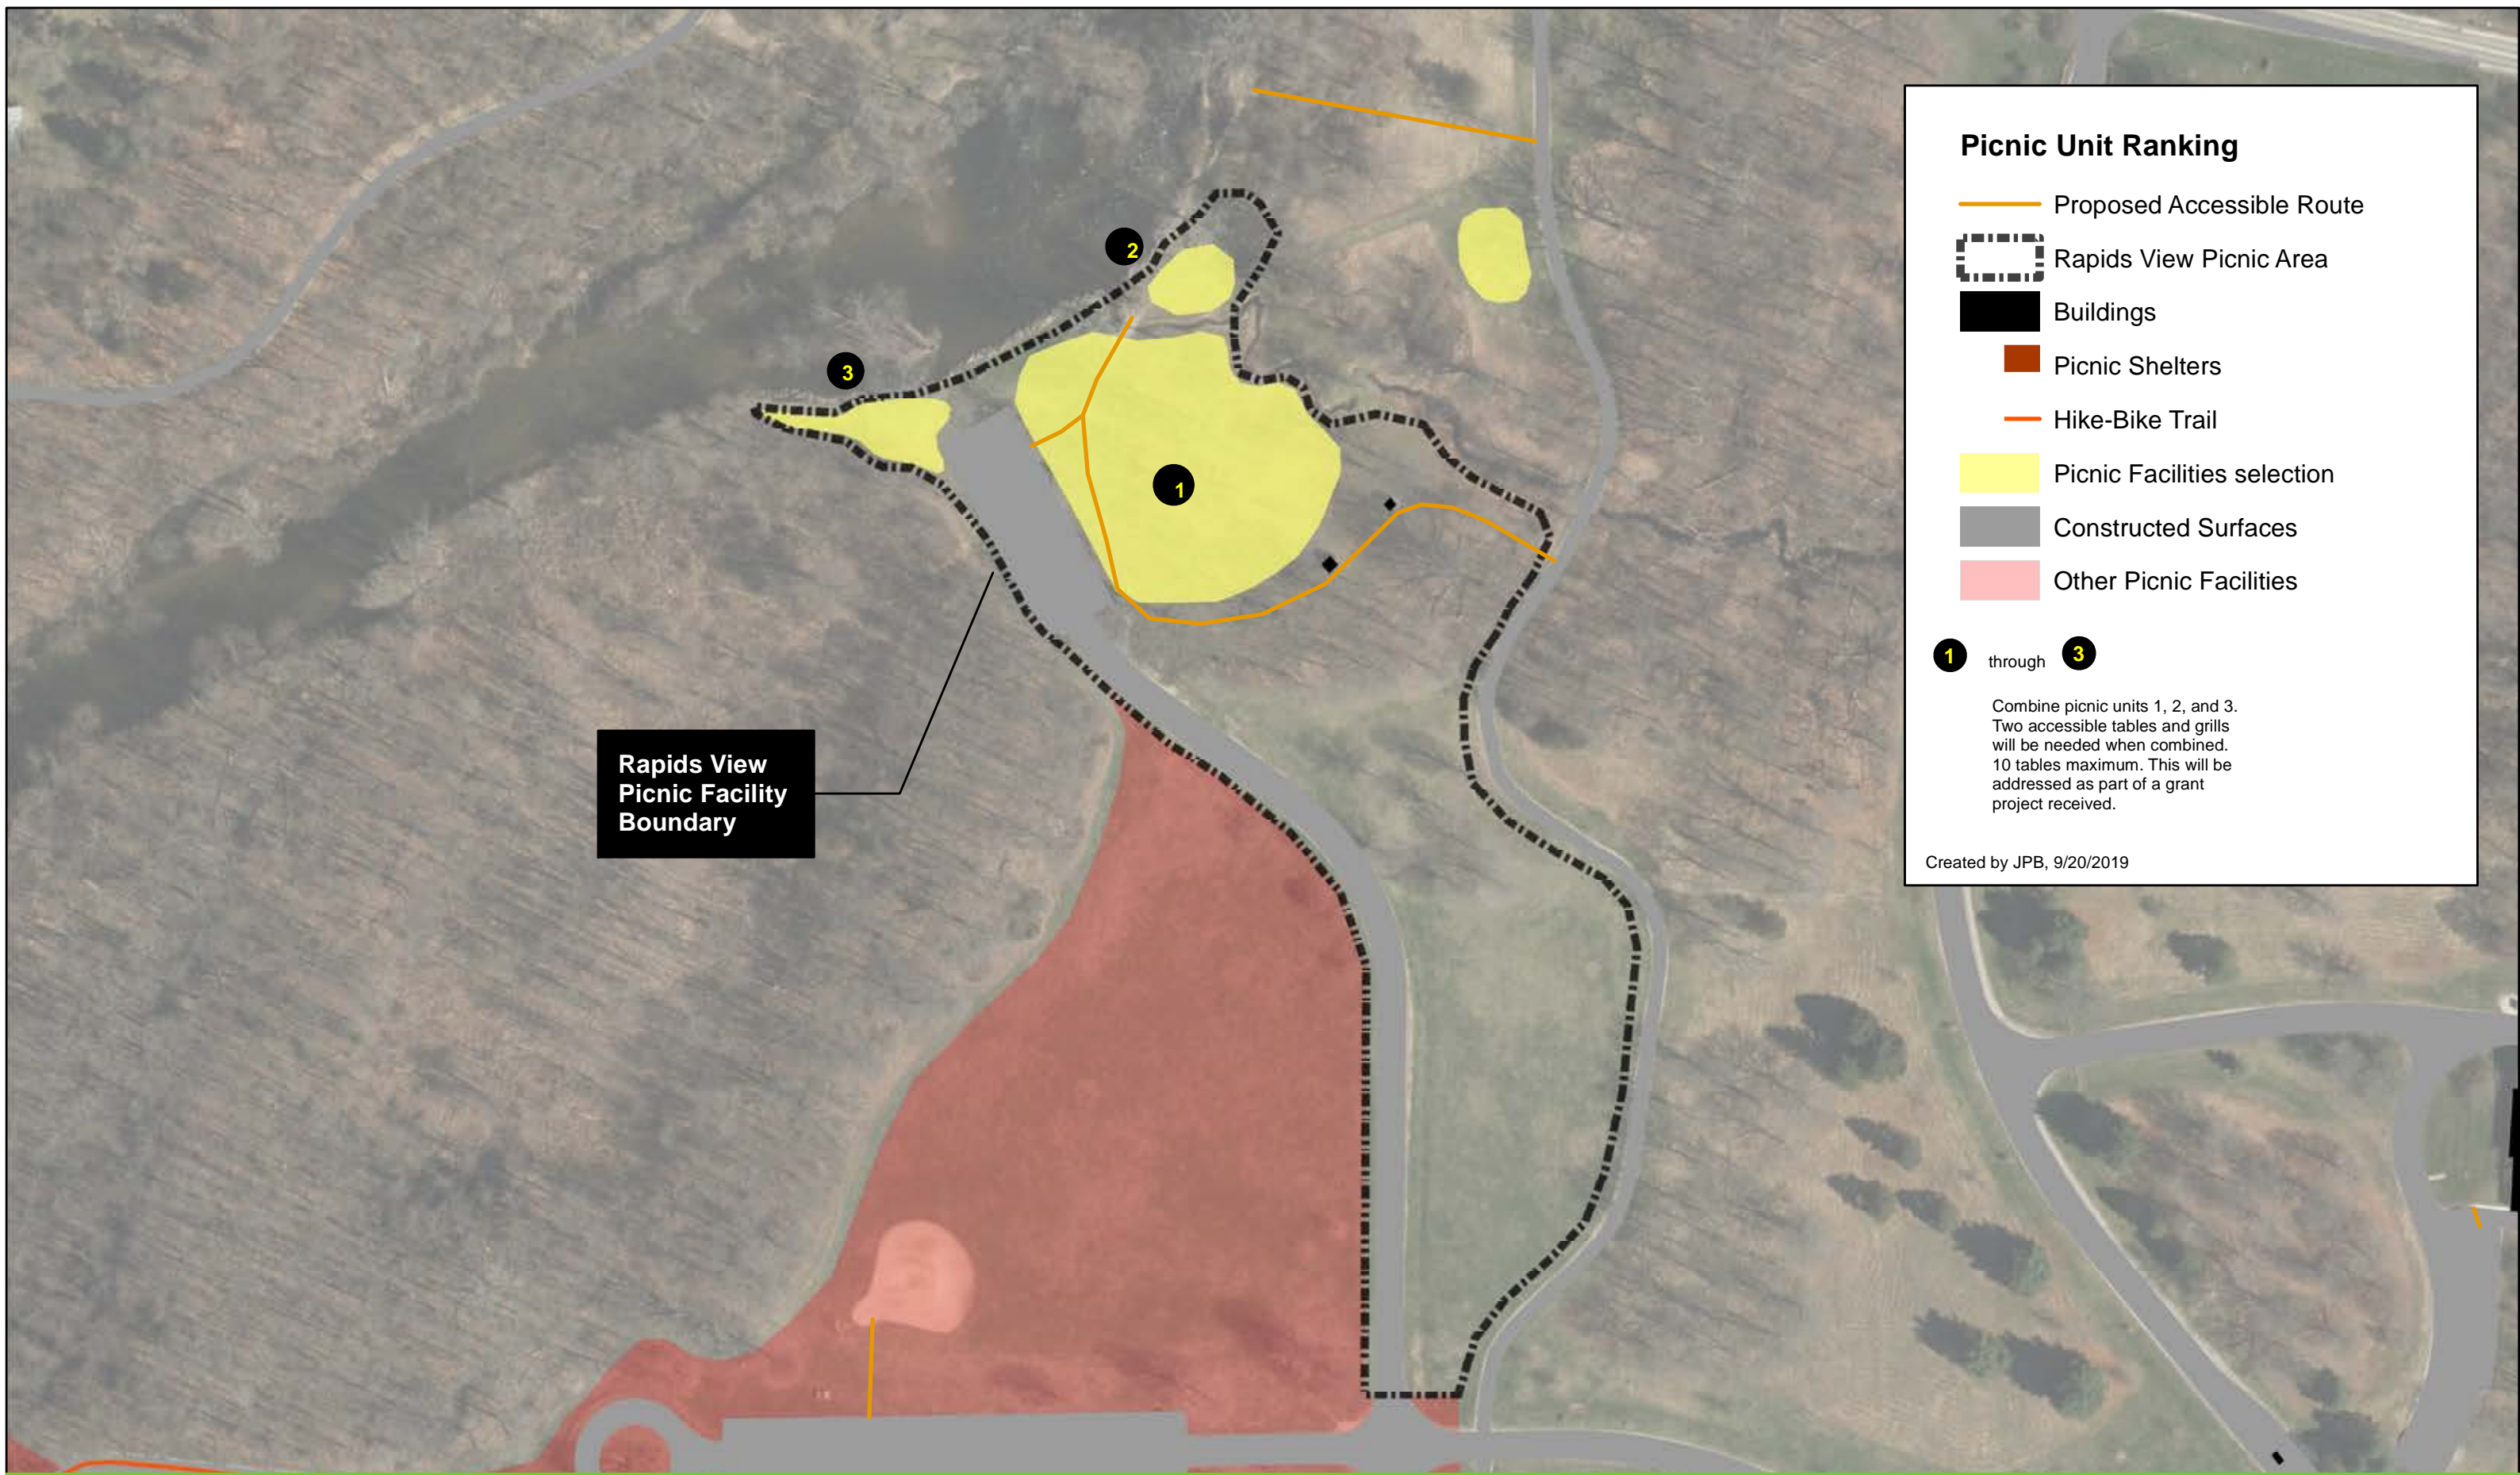
Rapids View Picnic Facility Boundary

1 through **3**
 Combine picnic units 1, 2, and 3. Two accessible tables and grills will be needed when combined. 10 tables maximum. This will be addressed as part of a grant project received.
