APPENDIX 3: PICNIC FACILITIES MAP

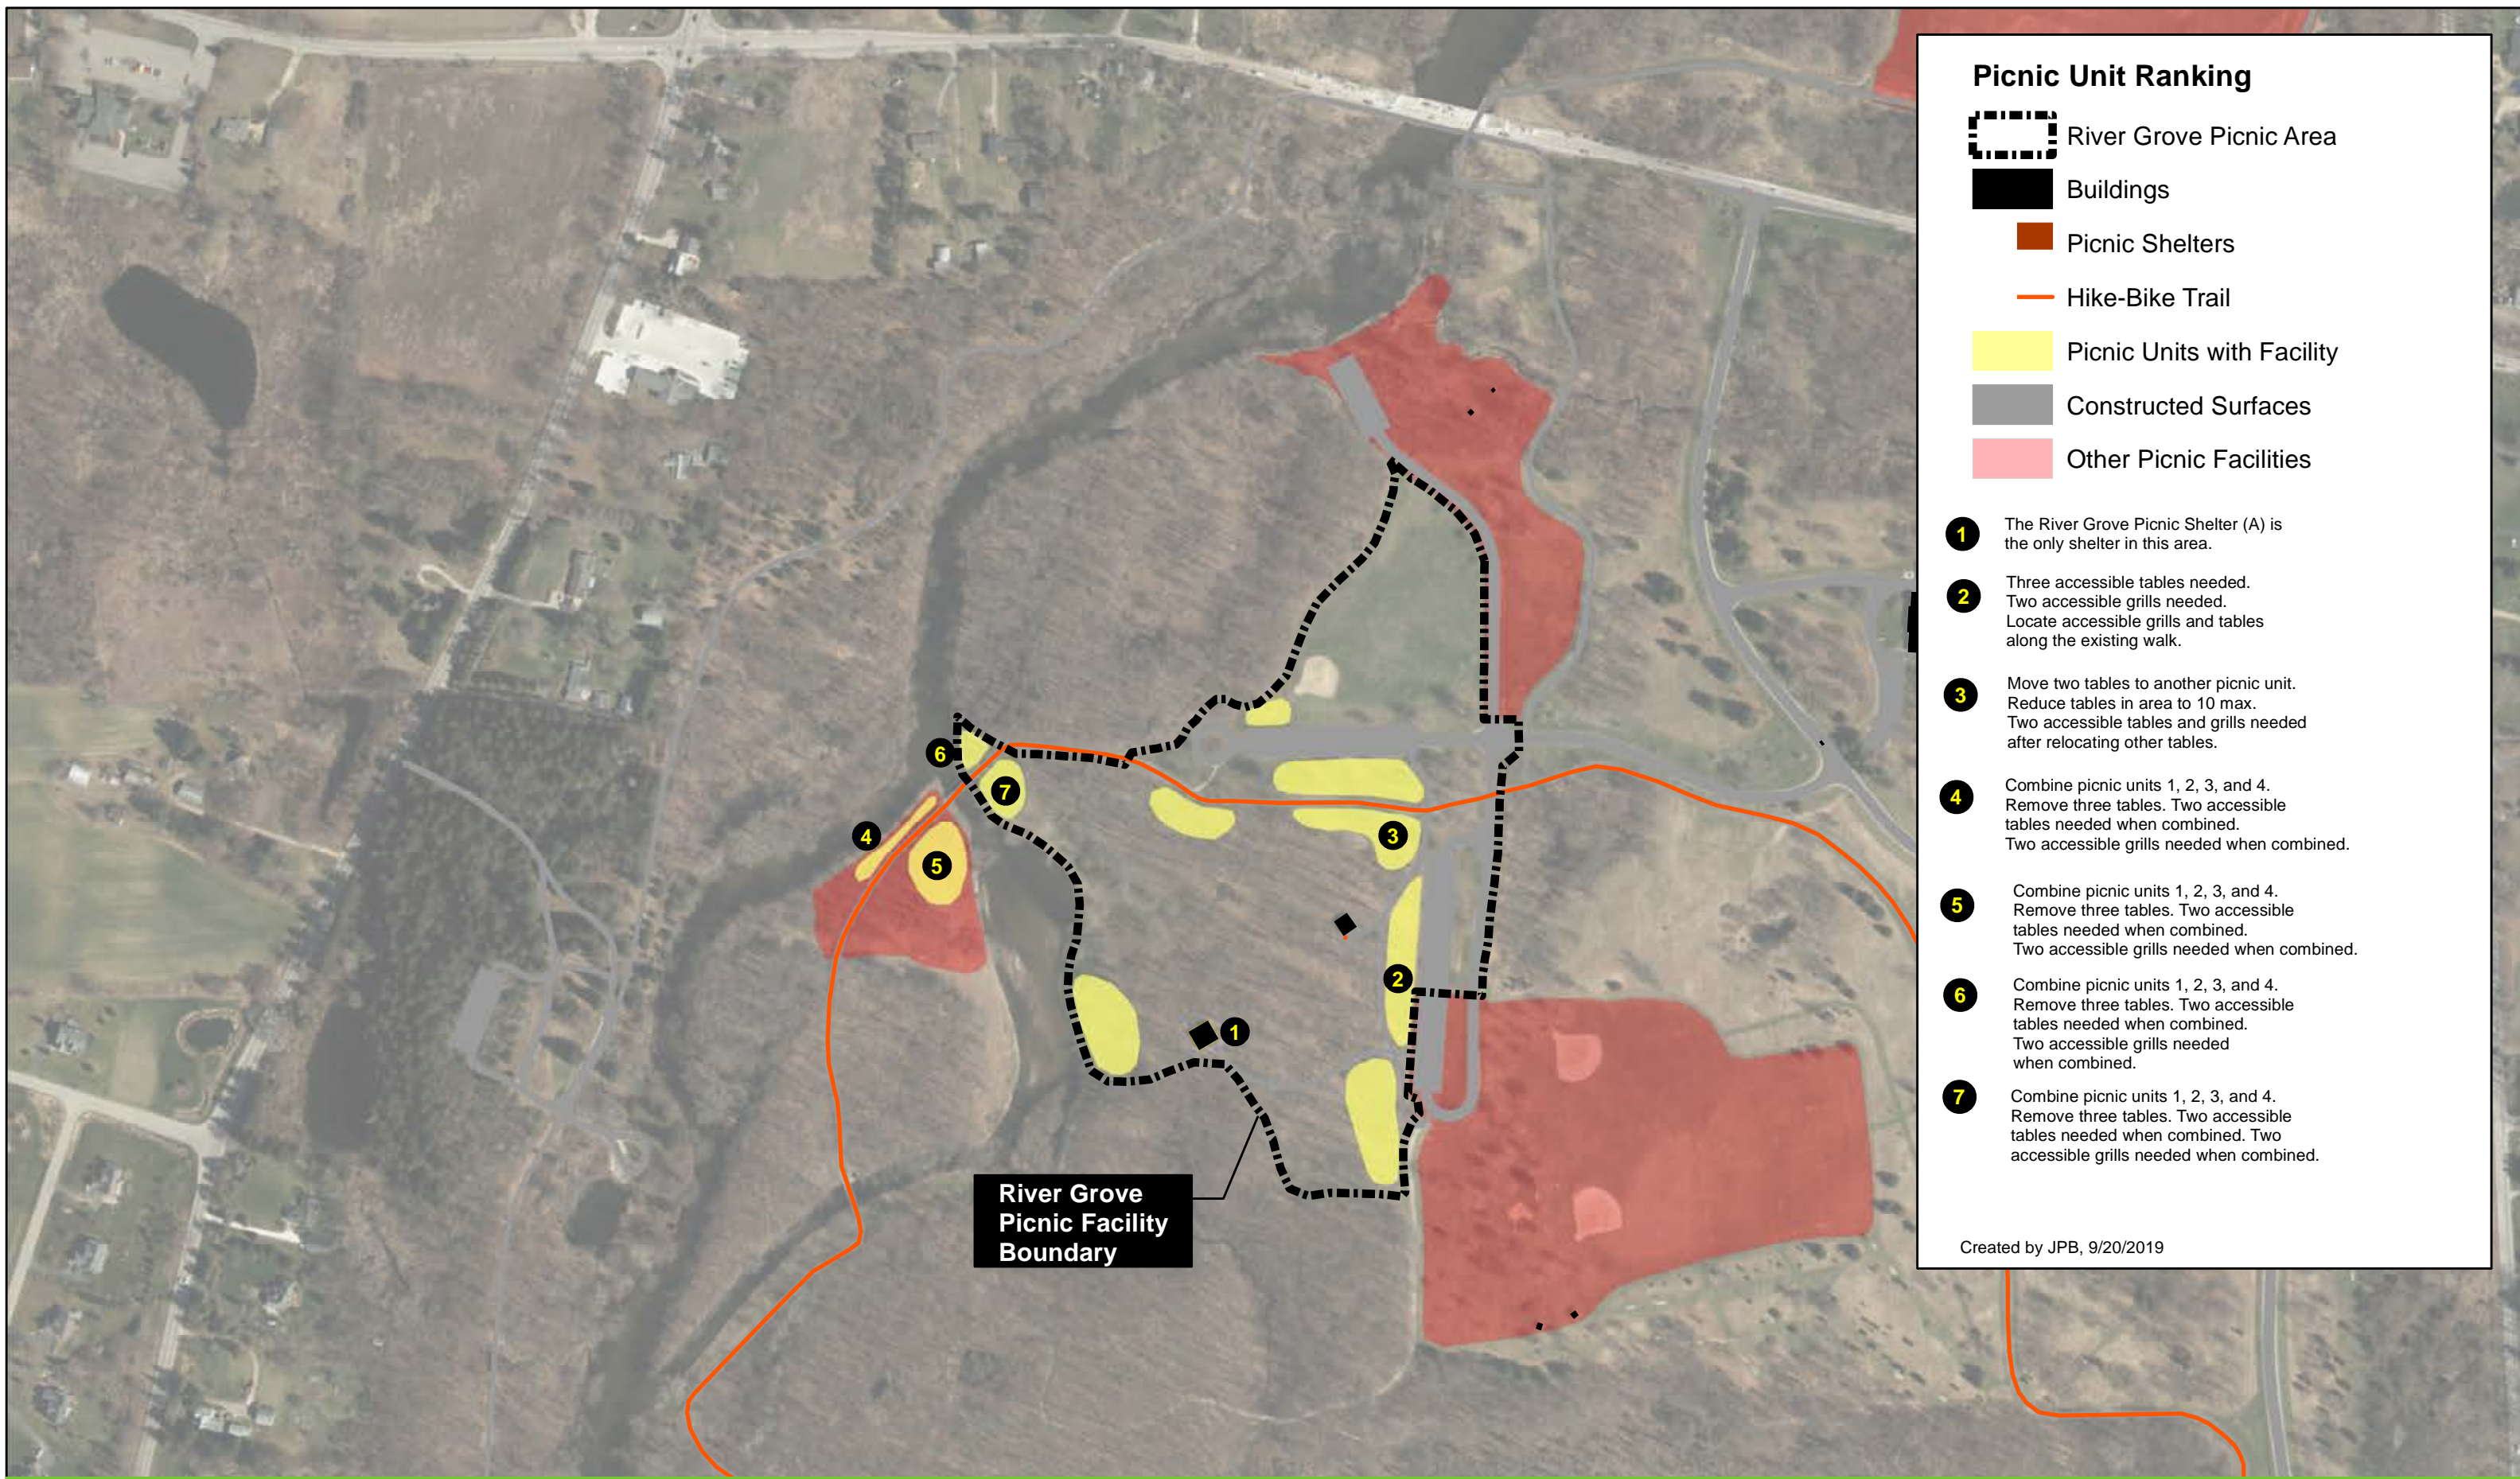
**River Grove
Picnic Facility
Boundary**

- 1** The River Grove Picnic Shelter (A) is the only shelter in this area.
- 2** Three accessible tables needed. Two accessible grills needed. Locate accessible grills and tables along the existing walk.

- 3** Move two tables to another picnic unit. Reduce tables in area to 10 max. Two accessible tables and grills needed after relocating other tables.
- 4** Combine picnic units 1, 2, 3, and 4. Remove three tables. Two accessible tables needed when combined. Two accessible grills needed when combined.

- 5** Combine picnic units 1, 2, 3, and 4. Remove three tables. Two accessible tables needed when combined. Two accessible grills needed when combined.

- 6** Combine picnic units 1, 2, 3, and 4. Remove three tables. Two accessible tables needed when combined. Two accessible grills needed when combined.

- 7** Combine picnic units 1, 2, 3, and 4. Remove three tables. Two accessible tables needed when combined. Two accessible grills needed when combined.

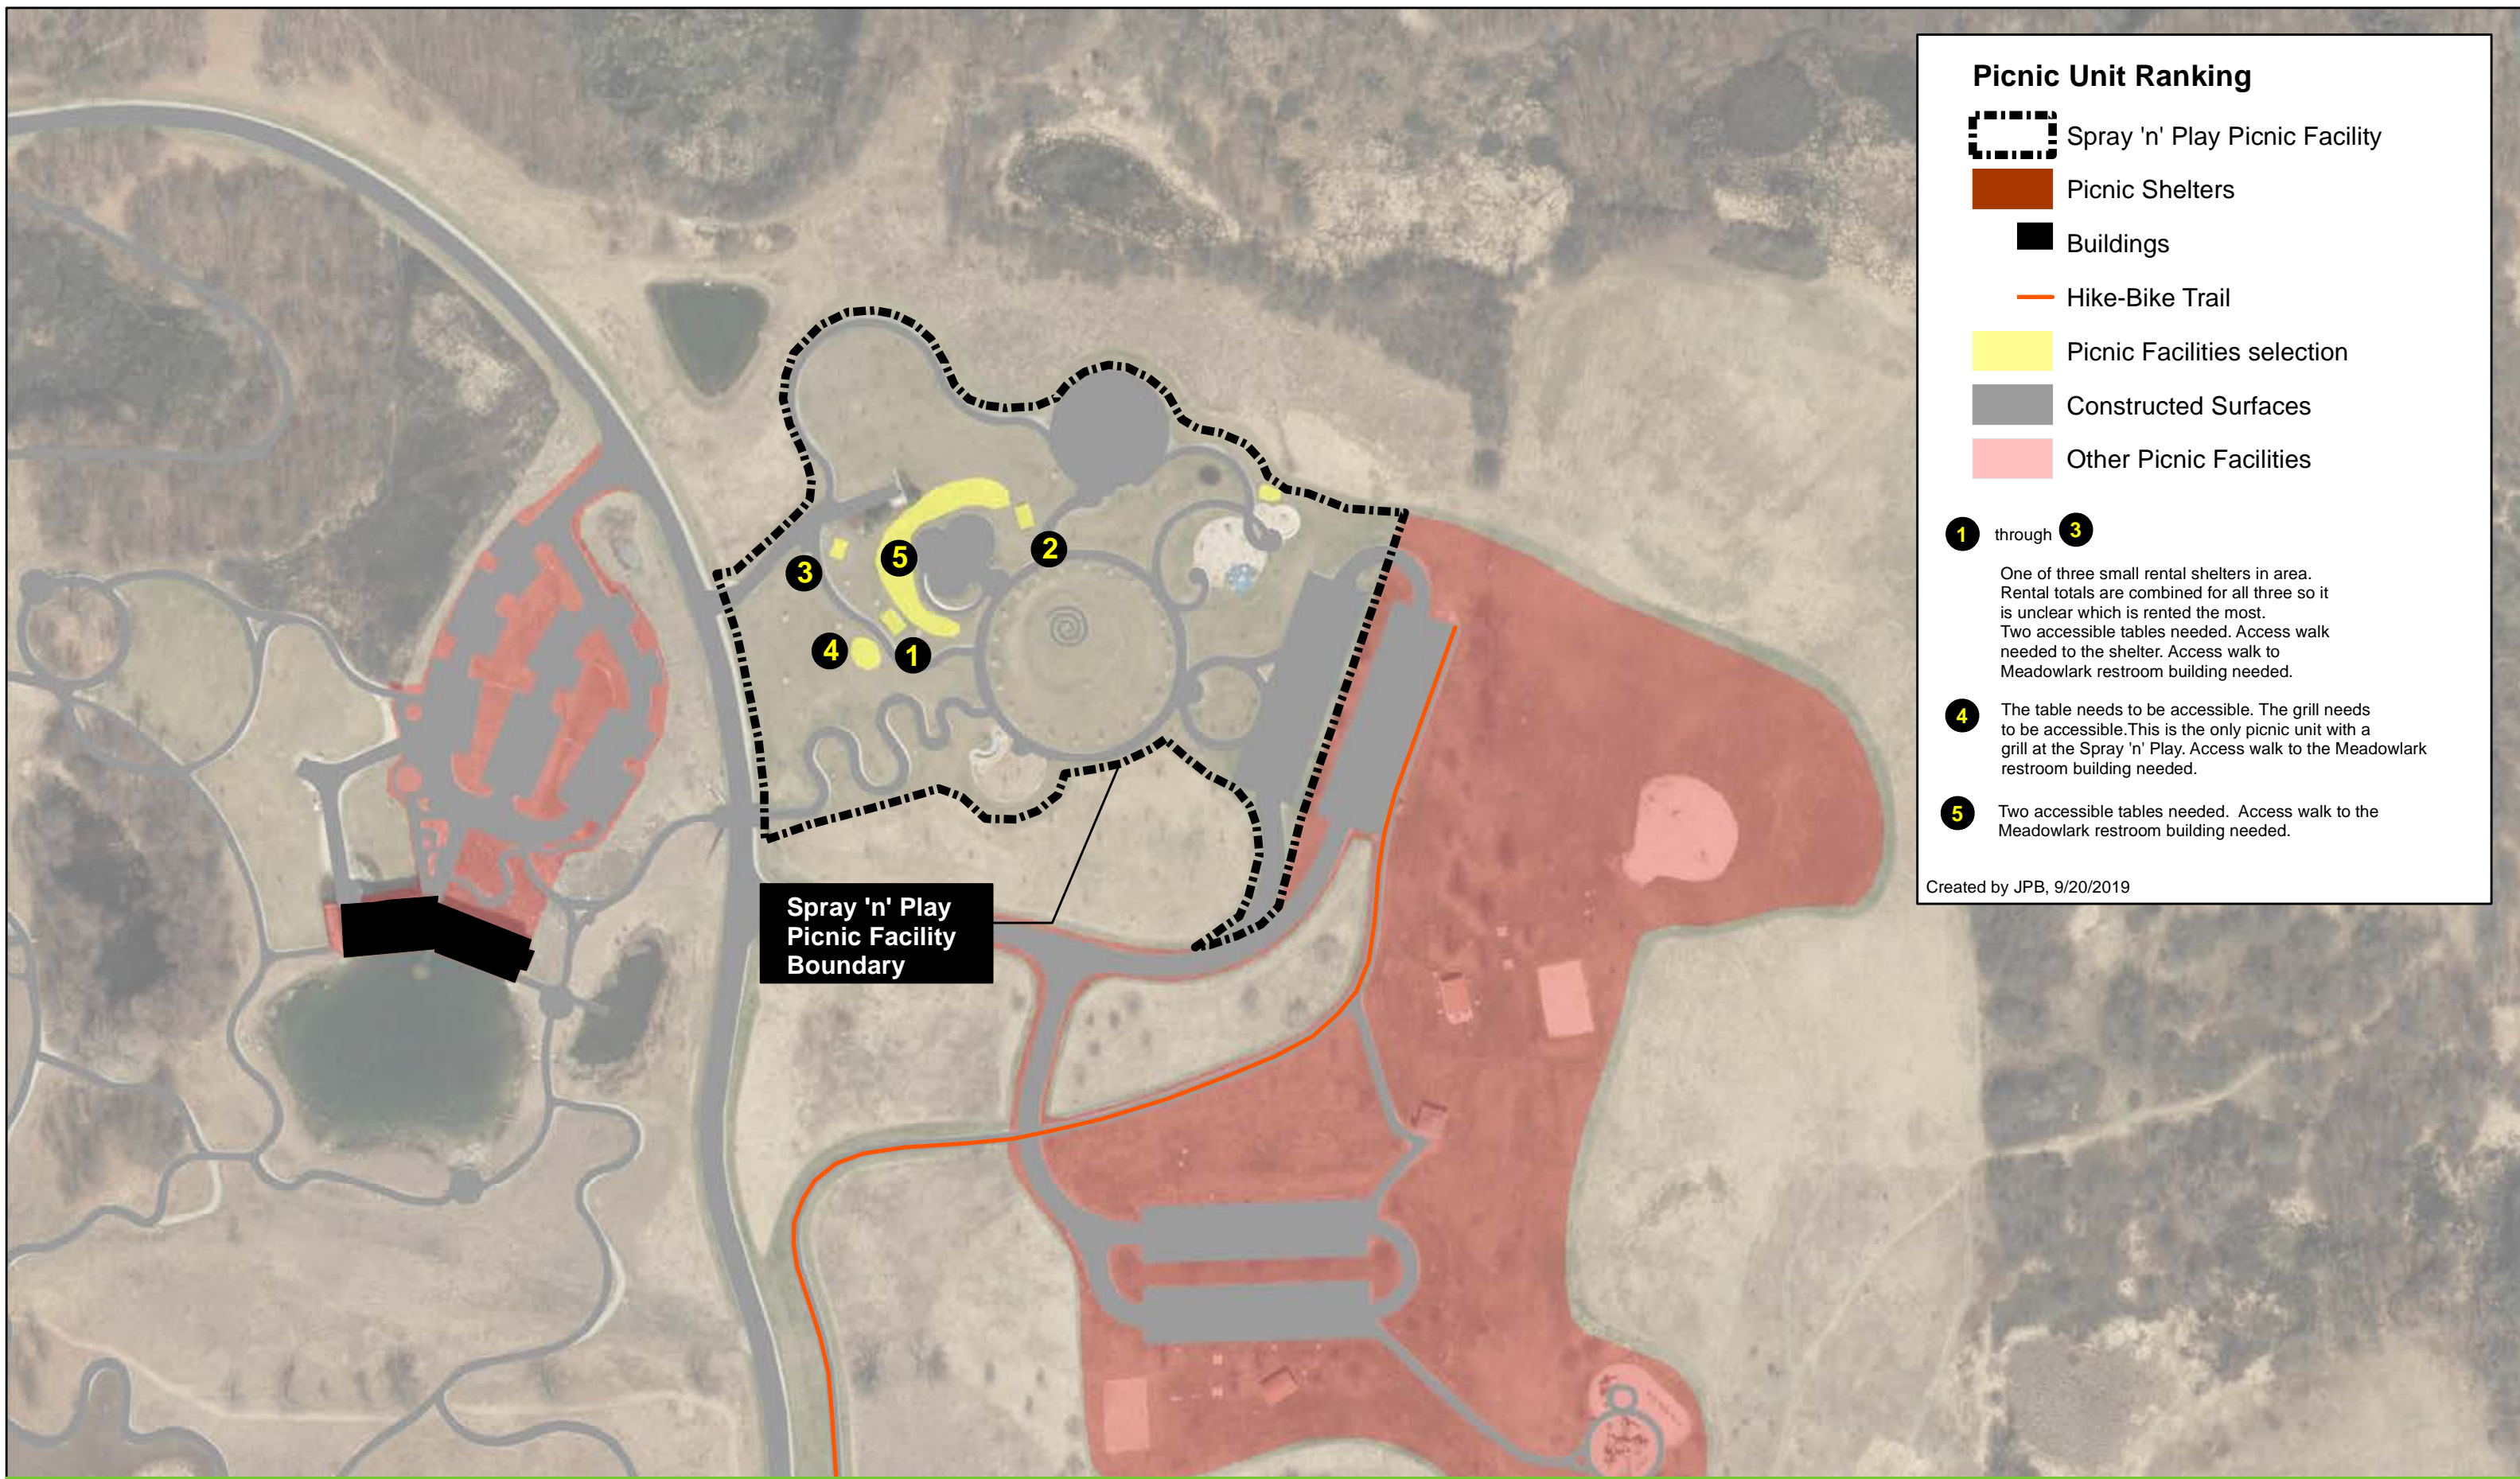
- 1** through **3**
 One of three small rental shelters in area. Rental totals are combined for all three so it is unclear which is rented the most. Two accessible tables needed. Access walk needed to the shelter. Access walk to Meadowlark restroom building needed.
- 4**
 The table needs to be accessible. The grill needs to be accessible. This is the only picnic unit with a grill at the Spray 'n' Play. Access walk to the Meadowlark restroom building needed.
- 5**
 Two accessible tables needed. Access walk to the Meadowlark restroom building needed.

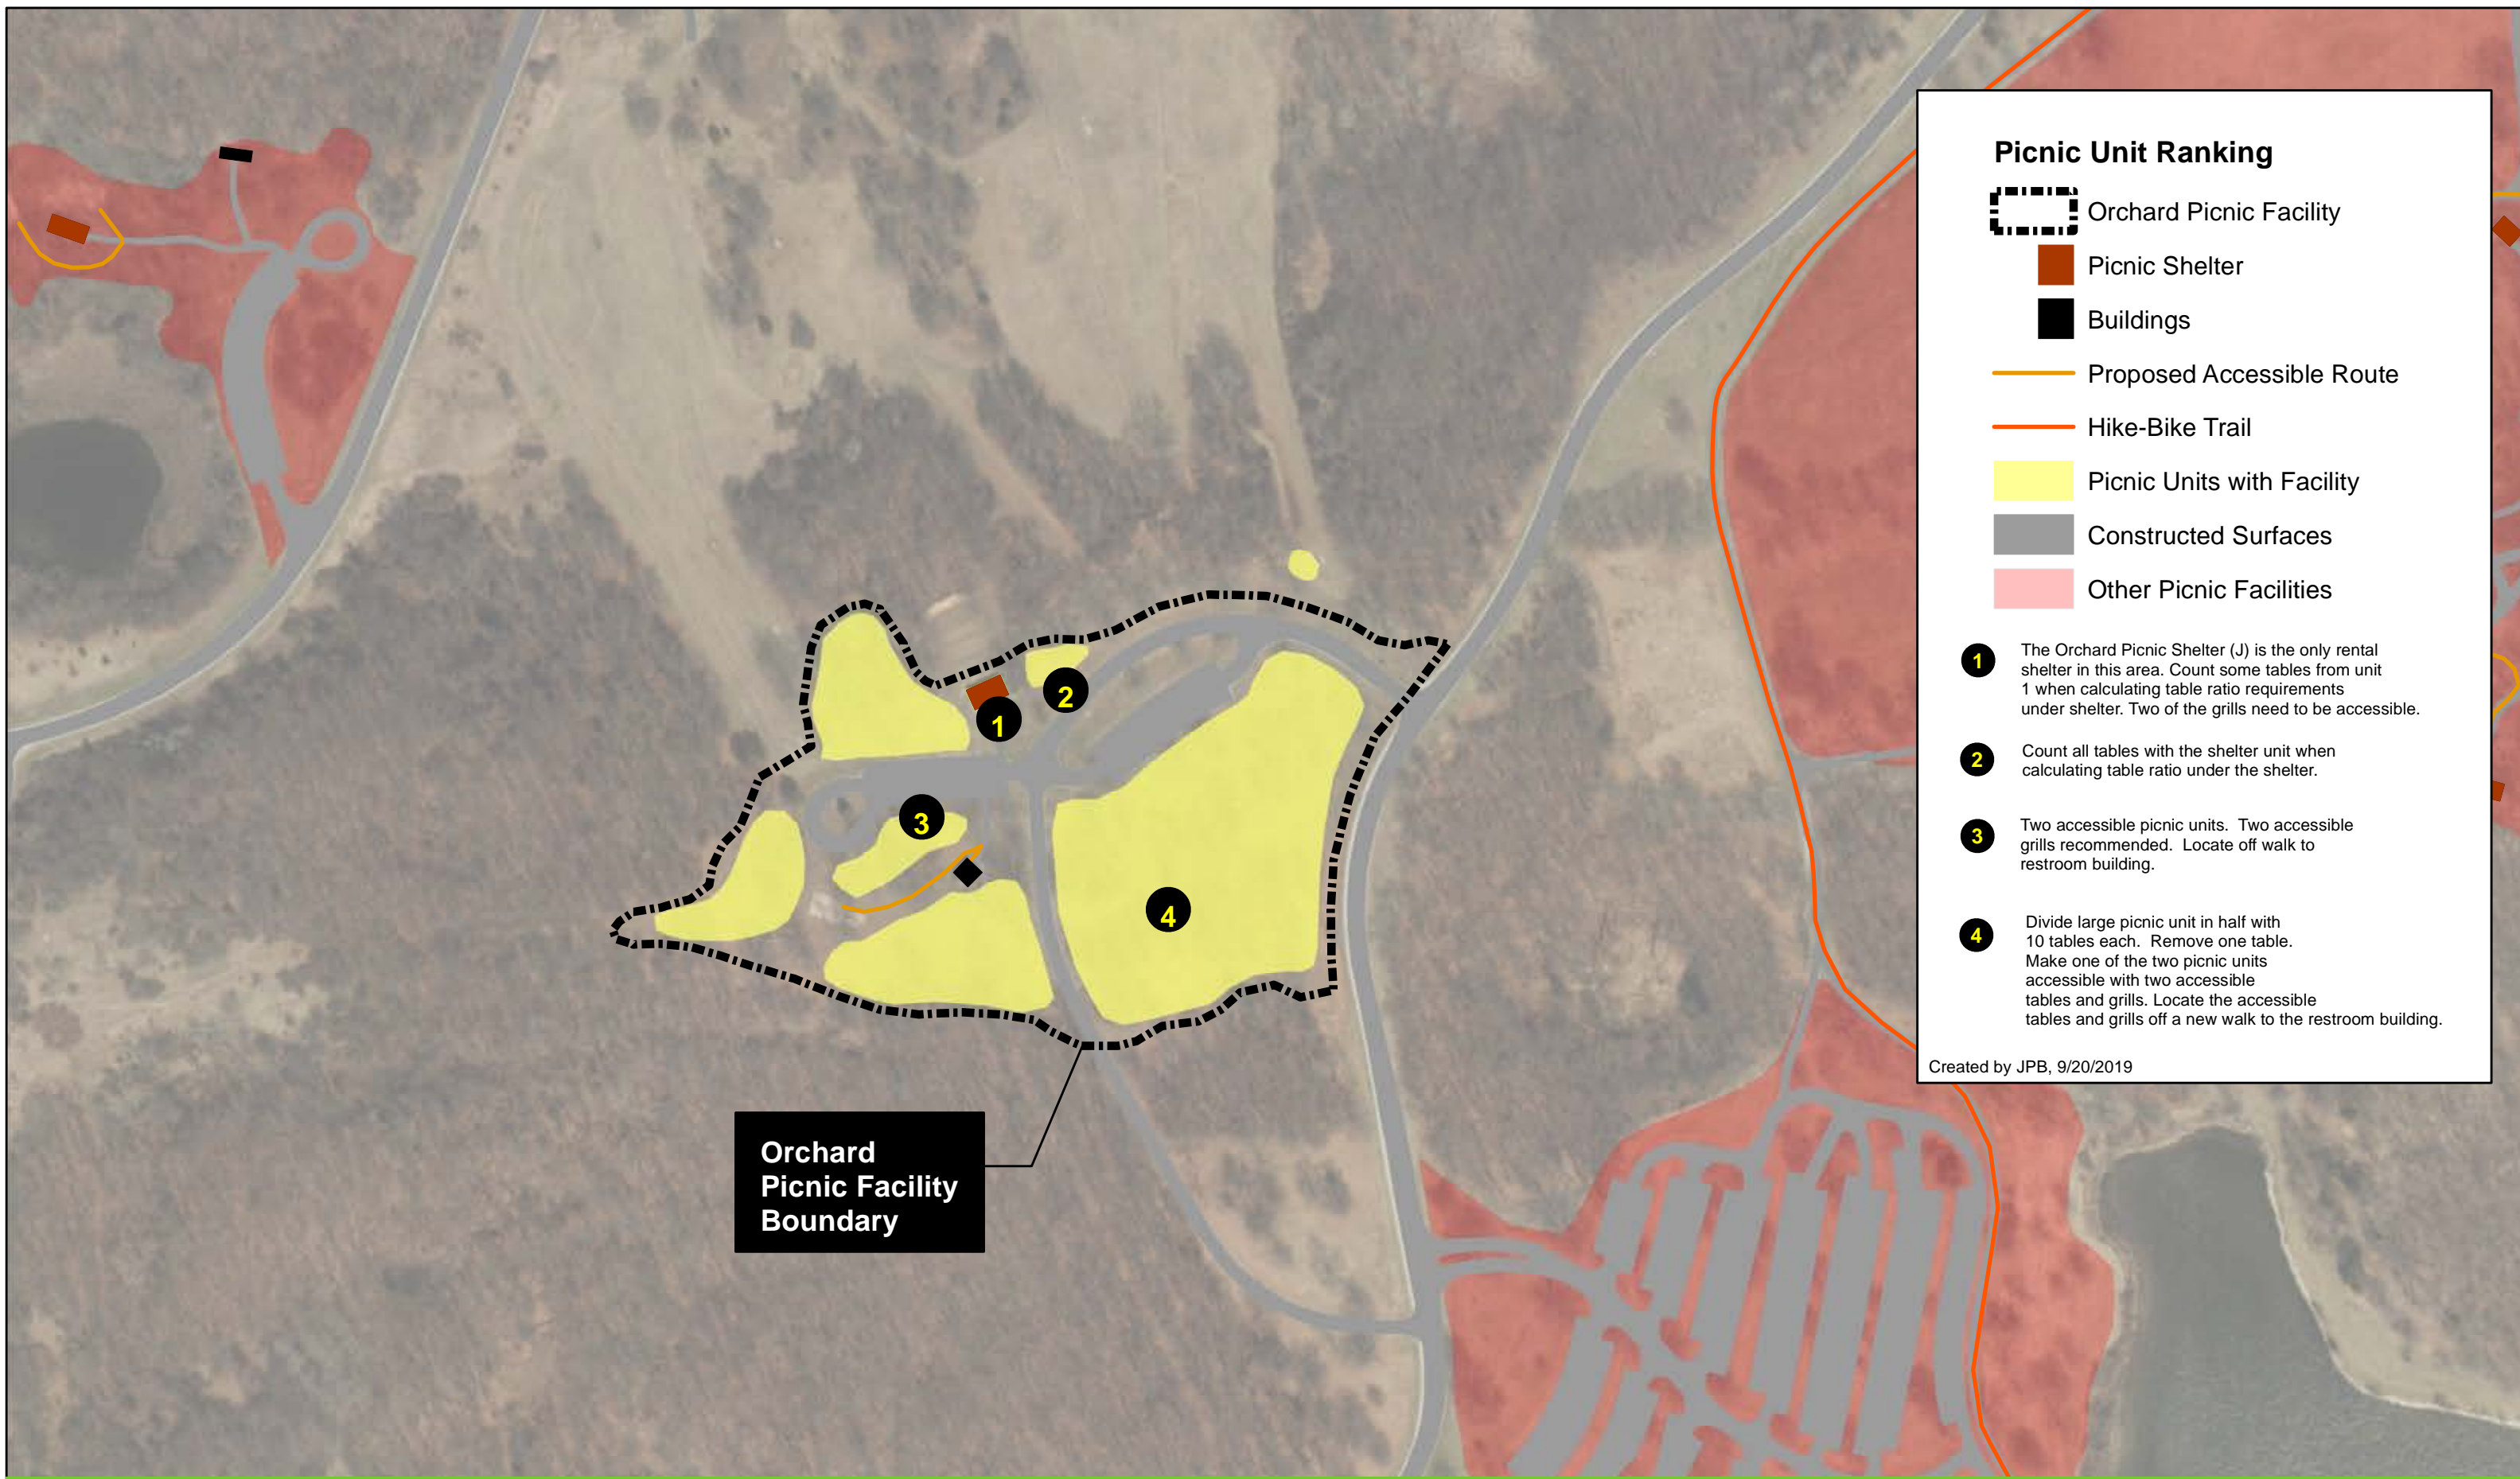
- 1** The Orchard Picnic Shelter (J) is the only rental shelter in this area. Count some tables from unit 1 when calculating table ratio requirements under shelter. Two of the grills need to be accessible.
- 2** Count all tables with the shelter unit when calculating table ratio under the shelter.
- 3** Two accessible picnic units. Two accessible grills recommended. Locate off walk to restroom building.
- 4** Divide large picnic unit in half with 10 tables each. Remove one table. Make one of the two picnic units accessible with two accessible tables and grills. Locate the accessible tables and grills off a new walk to the restroom building.

- 5** Count all tables with the shelter unit when calculating table ratio under the shelter.
- 6 - 9** Combine picnic units 24, 25, 26, and 27. Limit to 15 tables max. Three accessible tables needed when combined. Two accessible grills recommended. Locate accessible tables and grills off existing walks.

- 10** Relocate two tables to another picnic unit. Ten tables max. Two accessible tables needed after removal. Two accessible grills recommended. Locate the accessible tables and grills off new walks to other shelters and the restroom building.

- 12** Two accessible tables needed. Two accessible grills recommended.

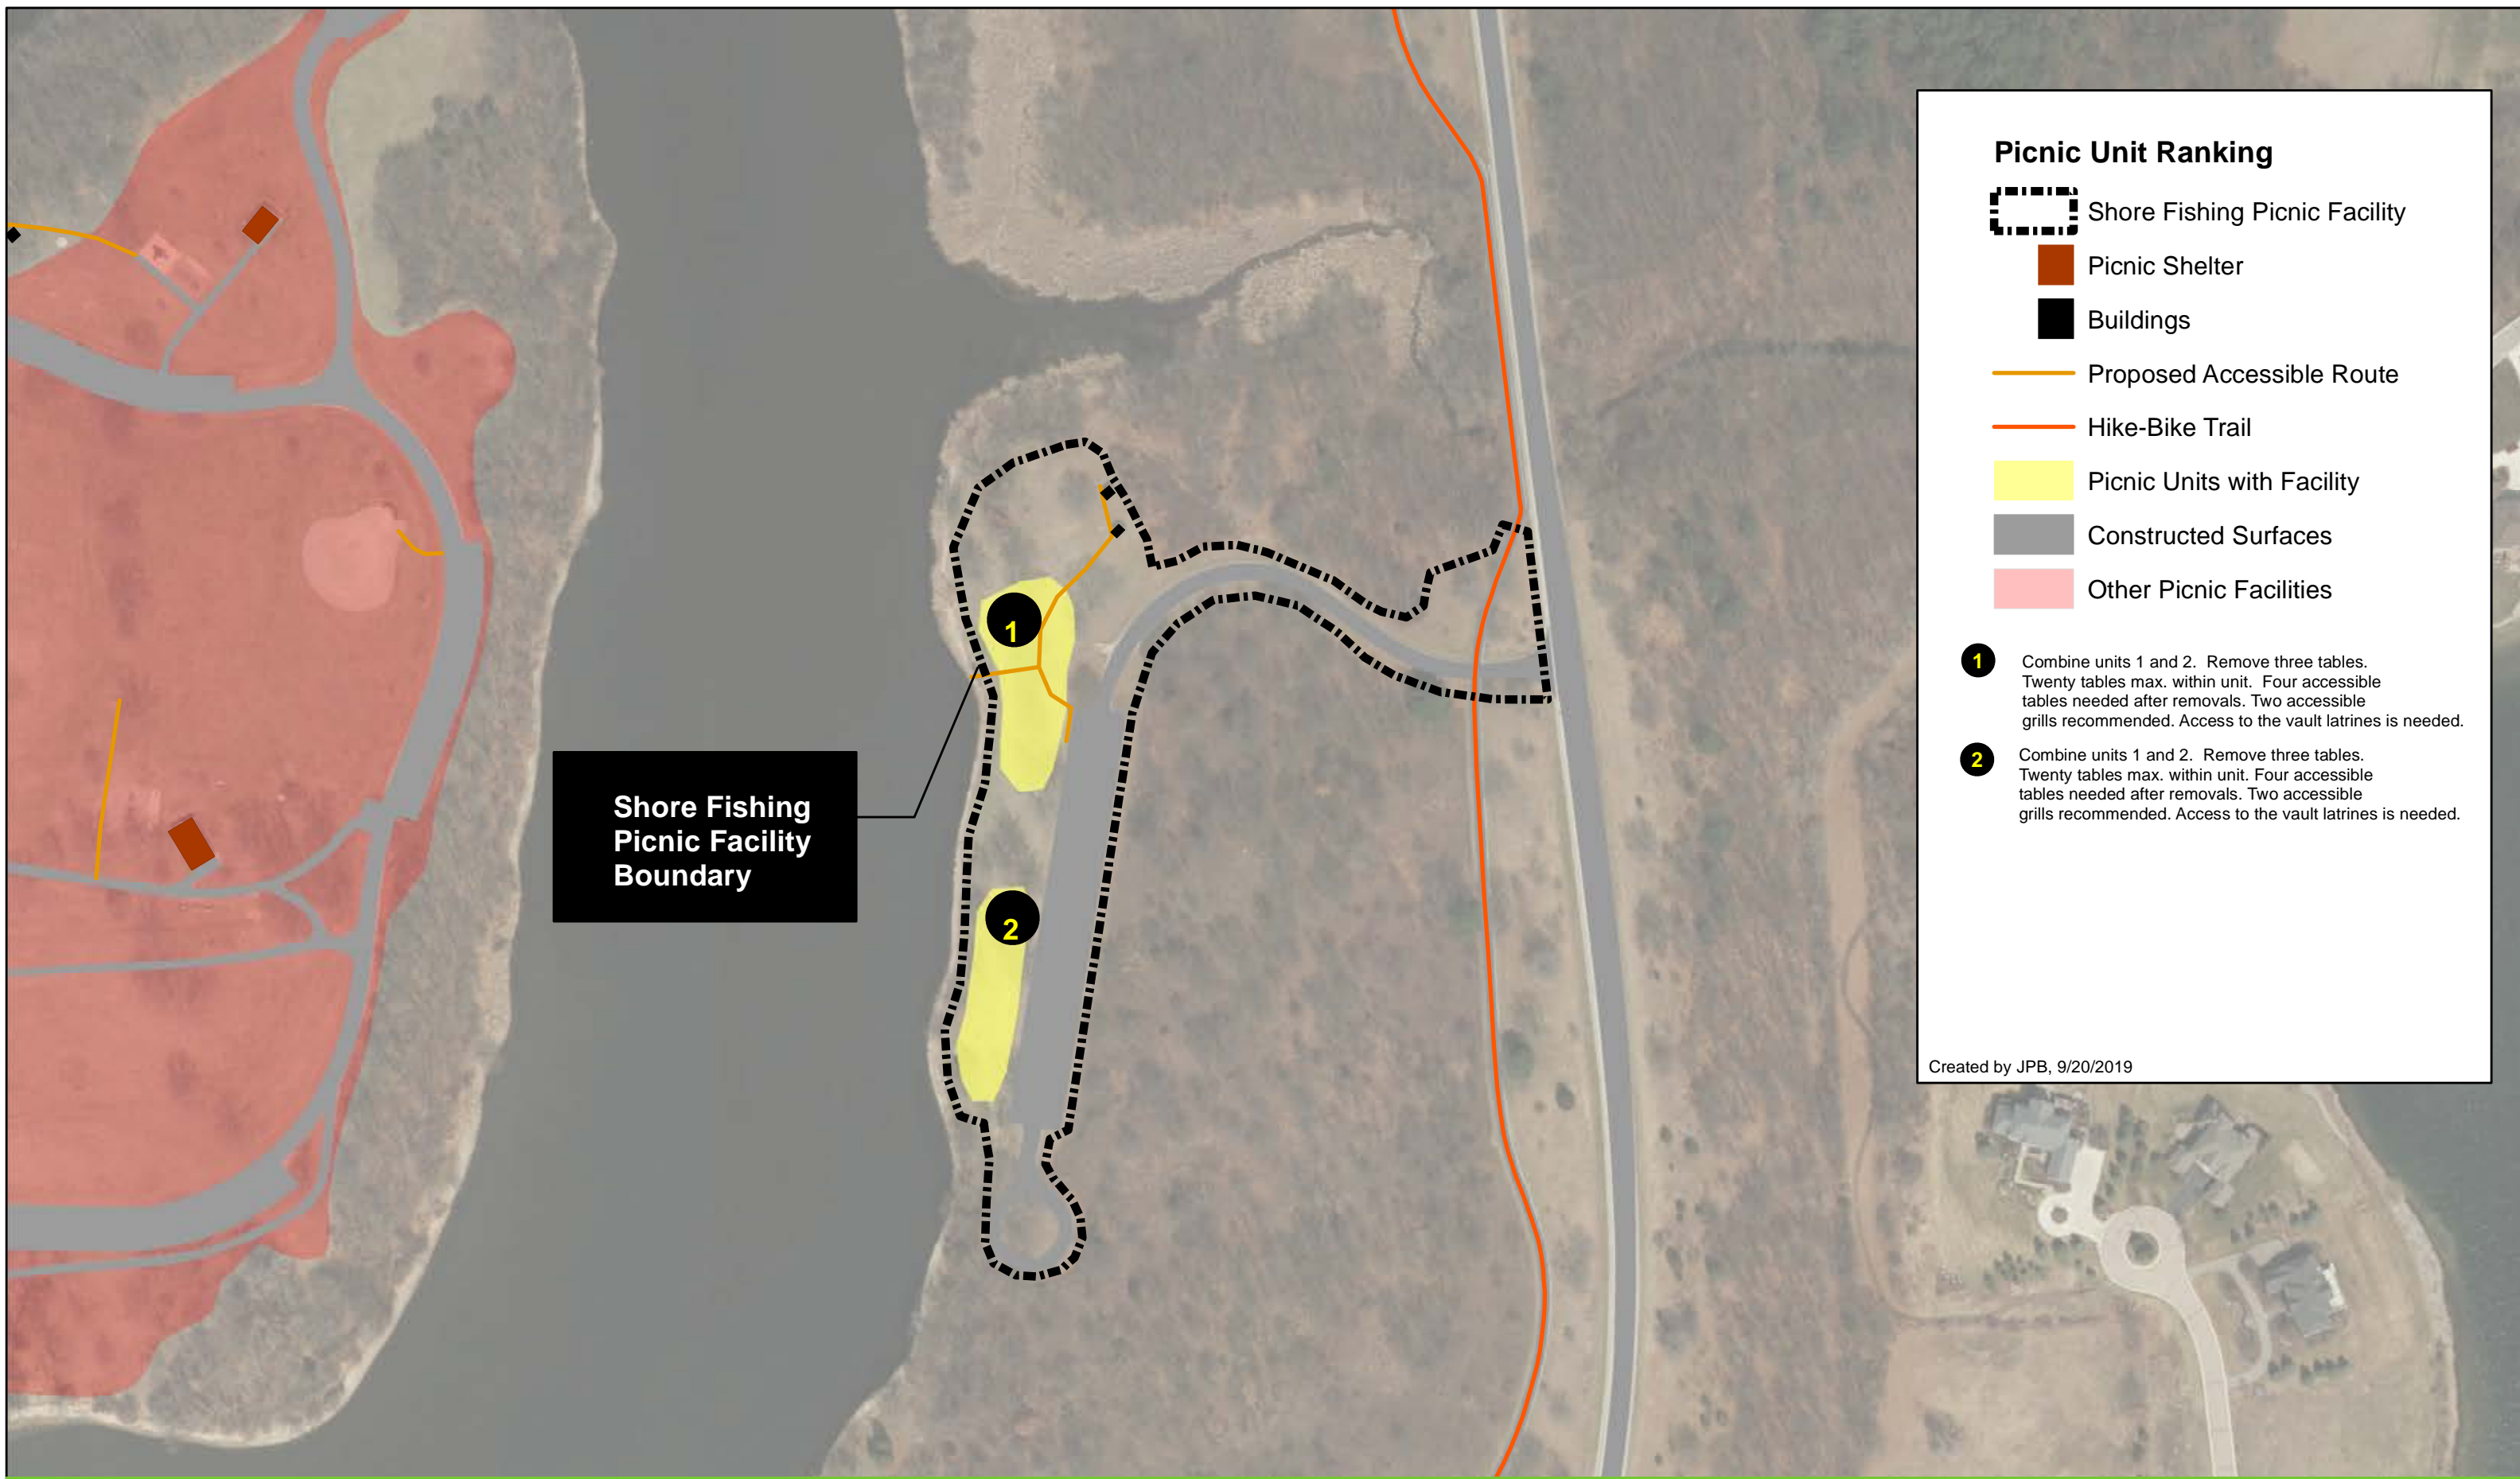
- 1** Combine units 1 and 2. Remove three tables. Twenty tables max. within unit. Four accessible tables needed after removals. Two accessible grills recommended. Access to the vault latrines is needed.
- 2** Combine units 1 and 2. Remove three tables. Twenty tables max. within unit. Four accessible tables needed after removals. Two accessible grills recommended. Access to the vault latrines is needed.

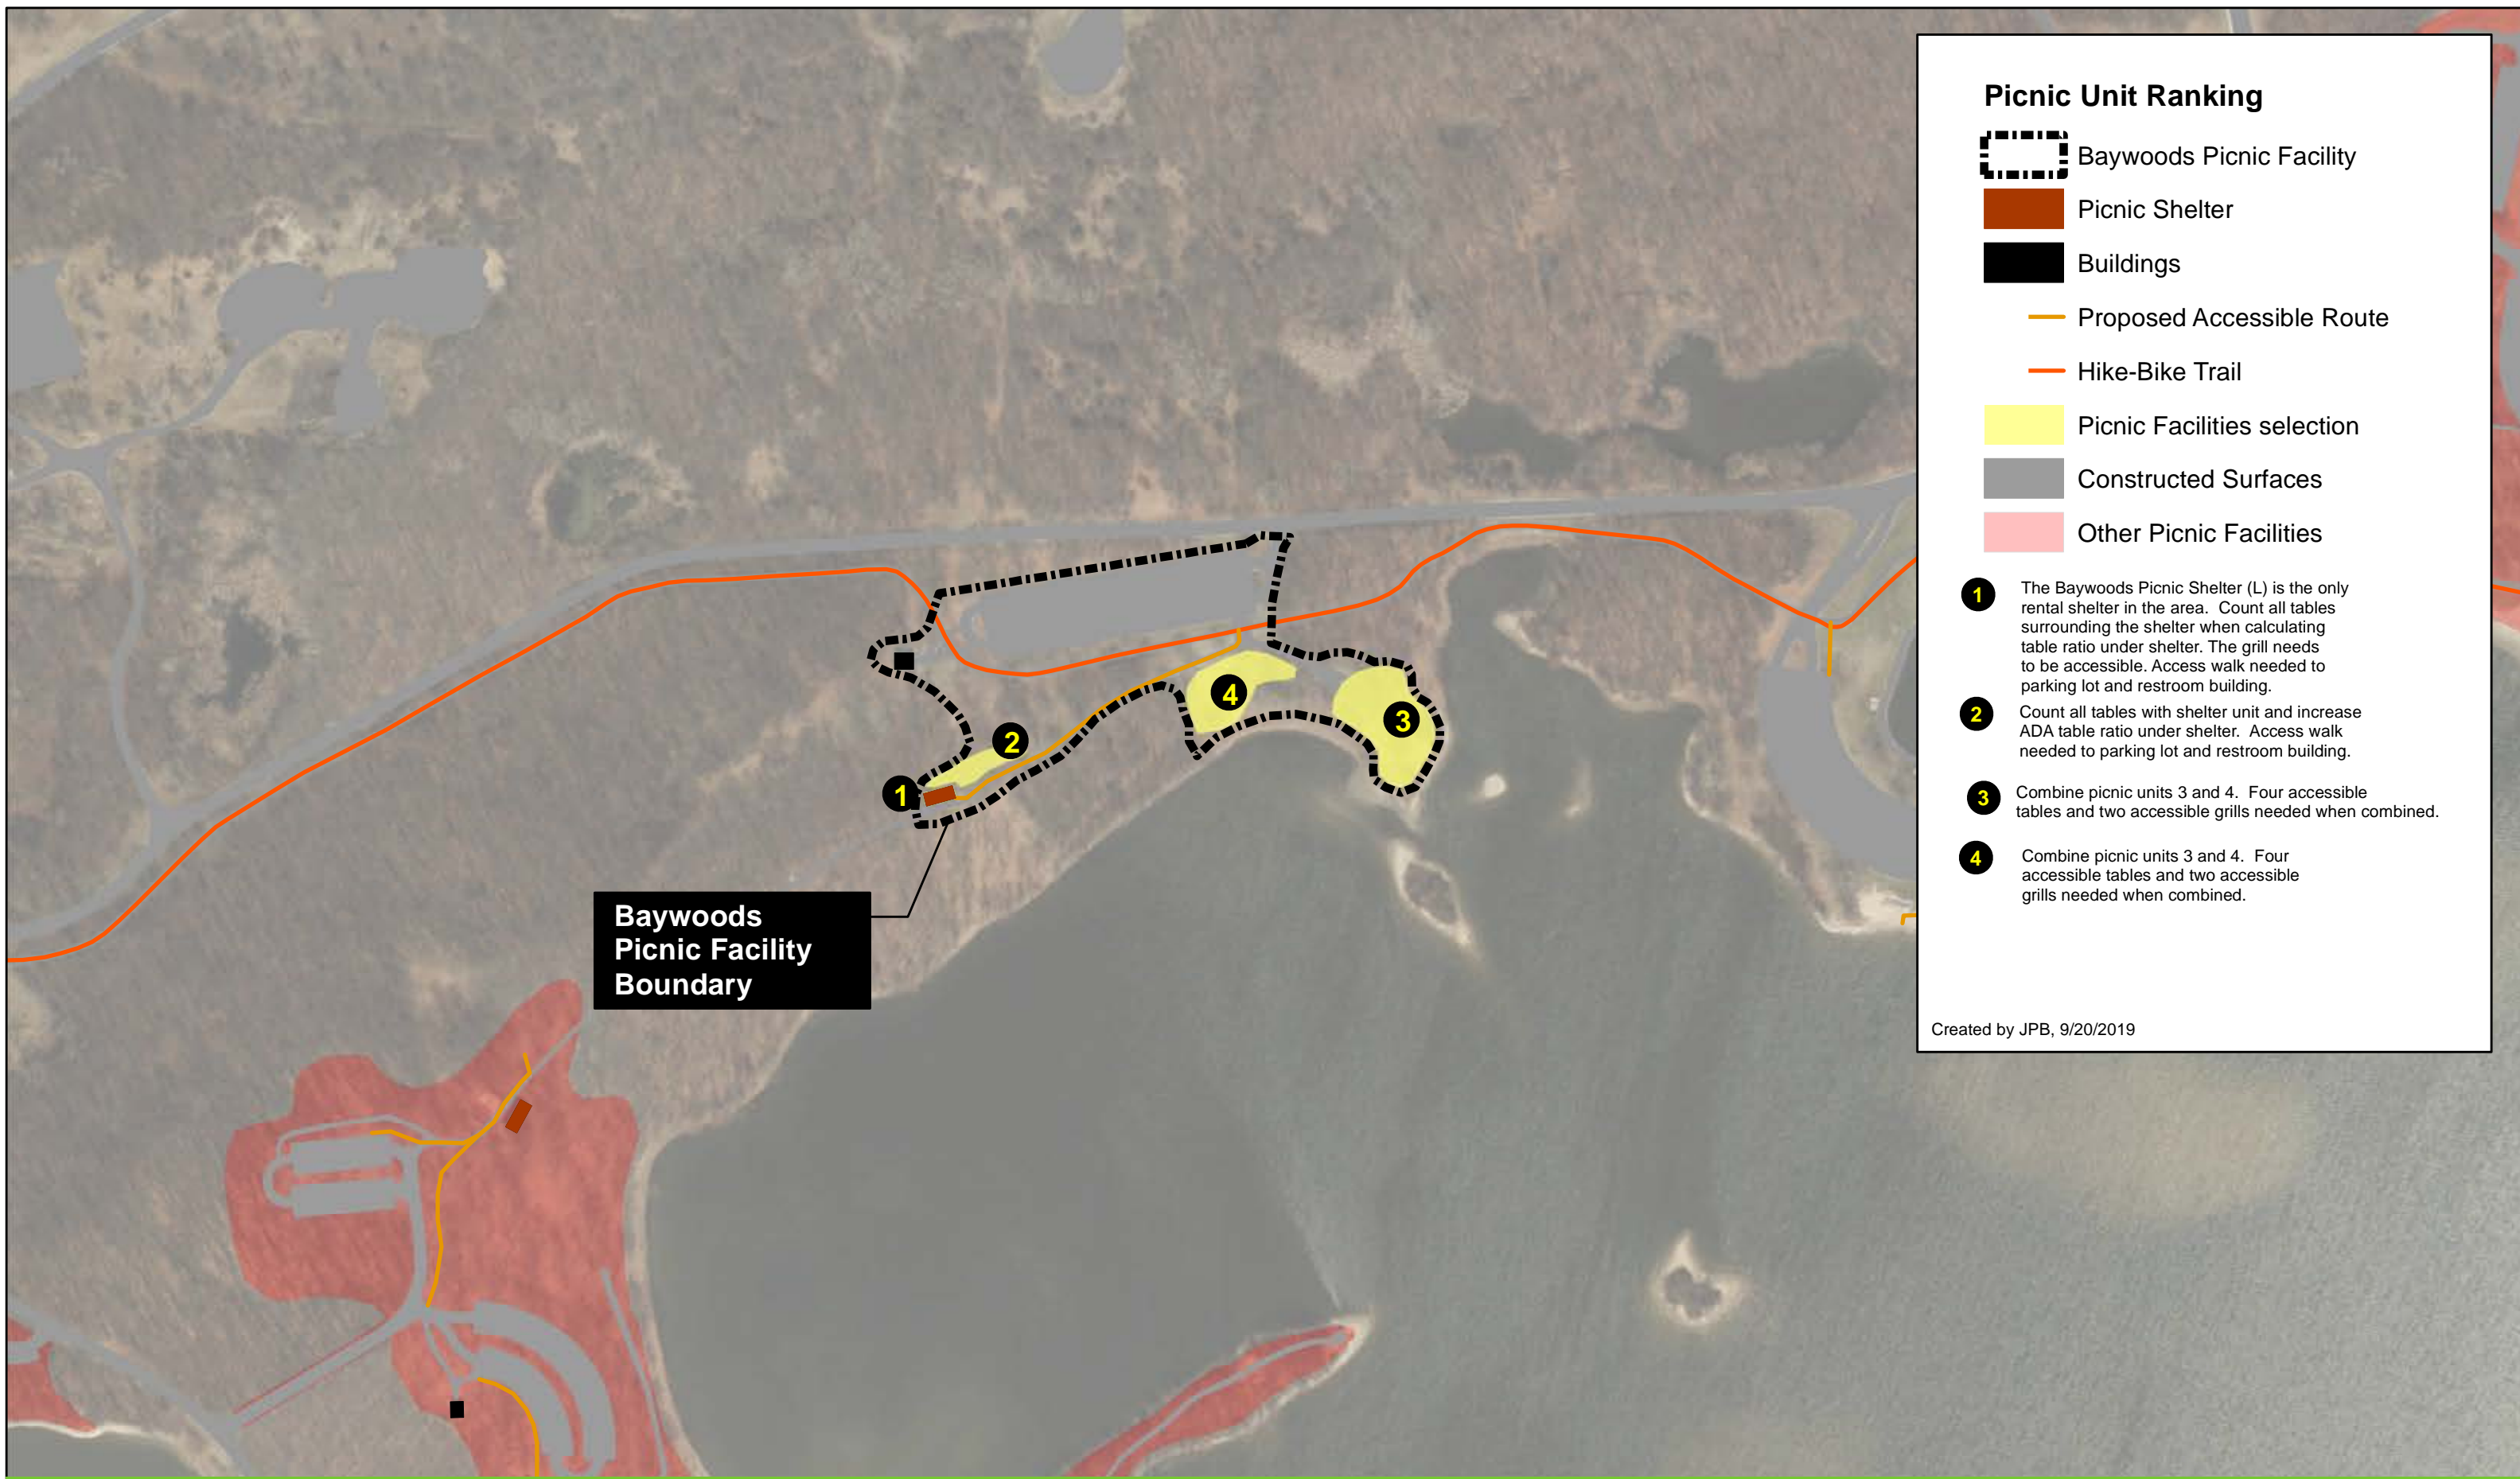
- 1** The Baywoods Picnic Shelter (L) is the only rental shelter in the area. Count all tables surrounding the shelter when calculating table ratio under shelter. The grill needs to be accessible. Access walk needed to parking lot and restroom building.
- 2** Count all tables with shelter unit and increase ADA table ratio under shelter. Access walk needed to parking lot and restroom building.
- 3** Combine picnic units 3 and 4. Four accessible tables and two accessible grills needed when combined.
- 4** Combine picnic units 3 and 4. Four accessible tables and two accessible grills needed when combined.
