APPENDIX 3: PICNIC FACILITIES MAP

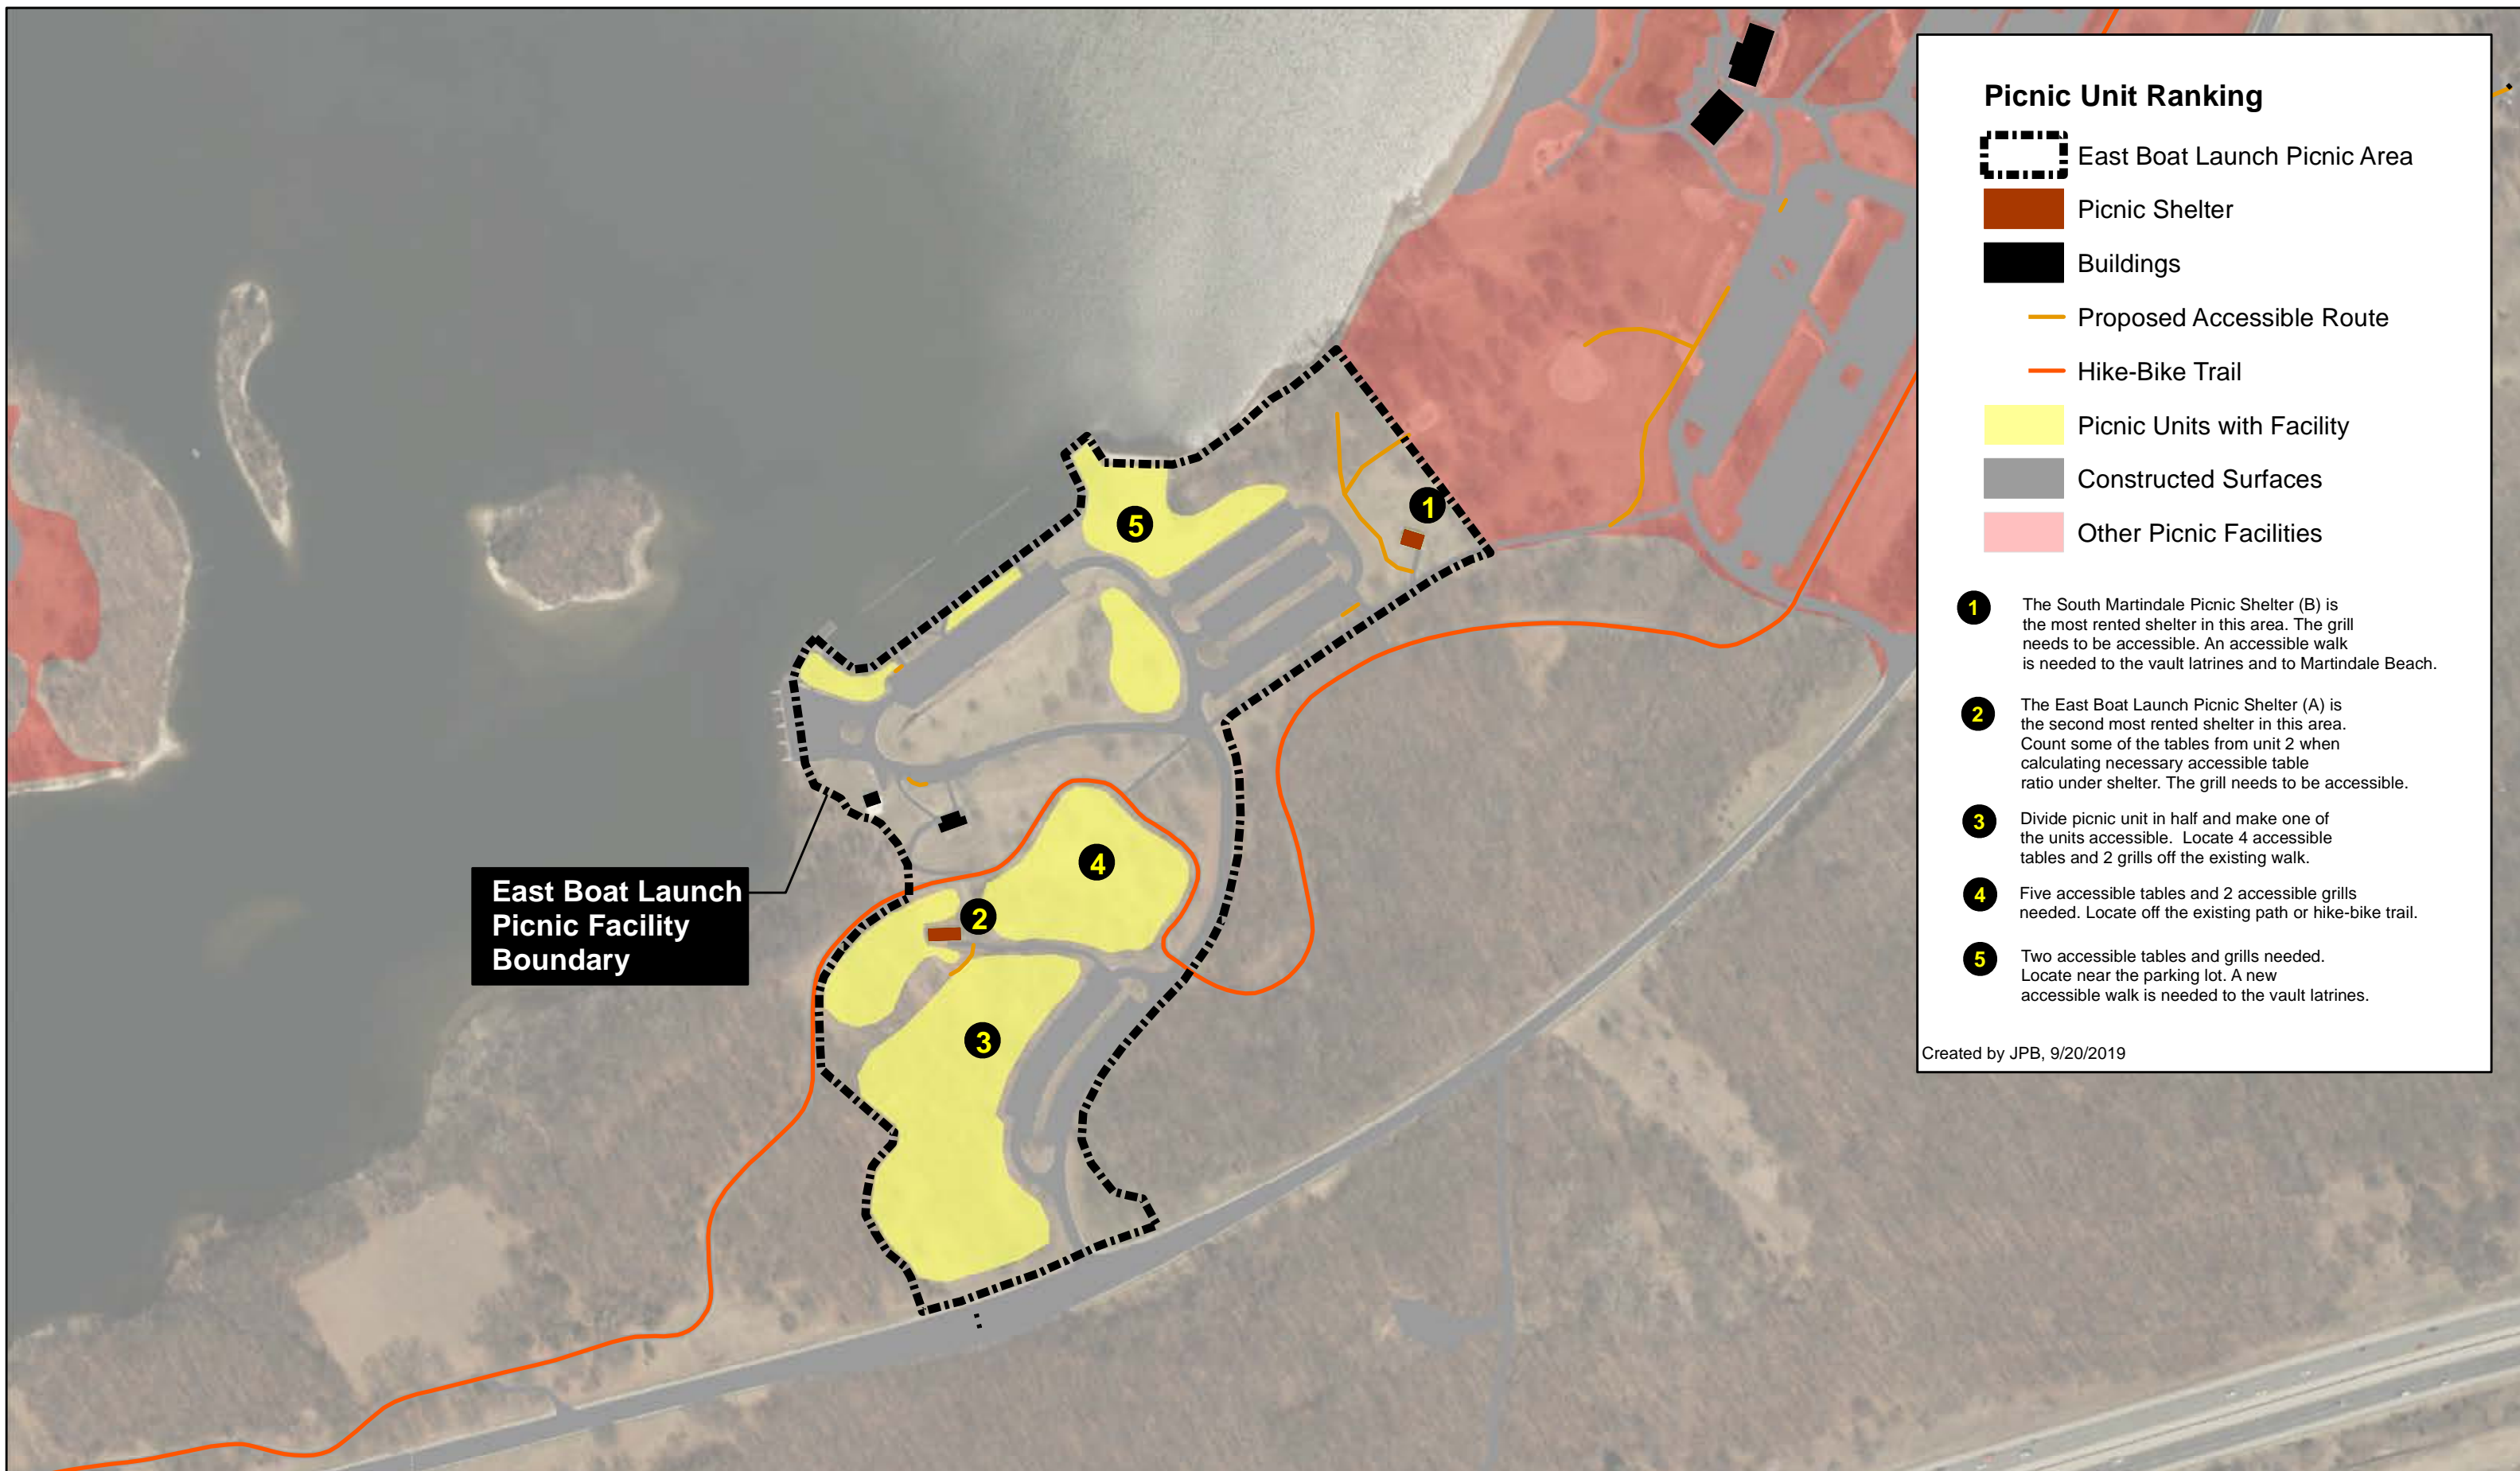
**East Boat Launch
Picnic Facility
Boundary**

- 1** The South Martindale Picnic Shelter (B) is the most rented shelter in this area. The grill needs to be accessible. An accessible walk is needed to the vault latrines and to Martindale Beach.
- 2** The East Boat Launch Picnic Shelter (A) is the second most rented shelter in this area. Count some of the tables from unit 2 when calculating necessary accessible table ratio under shelter. The grill needs to be accessible.
- 3** Divide picnic unit in half and make one of the units accessible. Locate 4 accessible tables and 2 grills off the existing walk.
- 4** Five accessible tables and 2 accessible grills needed. Locate off the existing path or hike-bike trail.
- 5** Two accessible tables and grills needed. Locate near the parking lot. A new accessible walk is needed to the vault latrines.

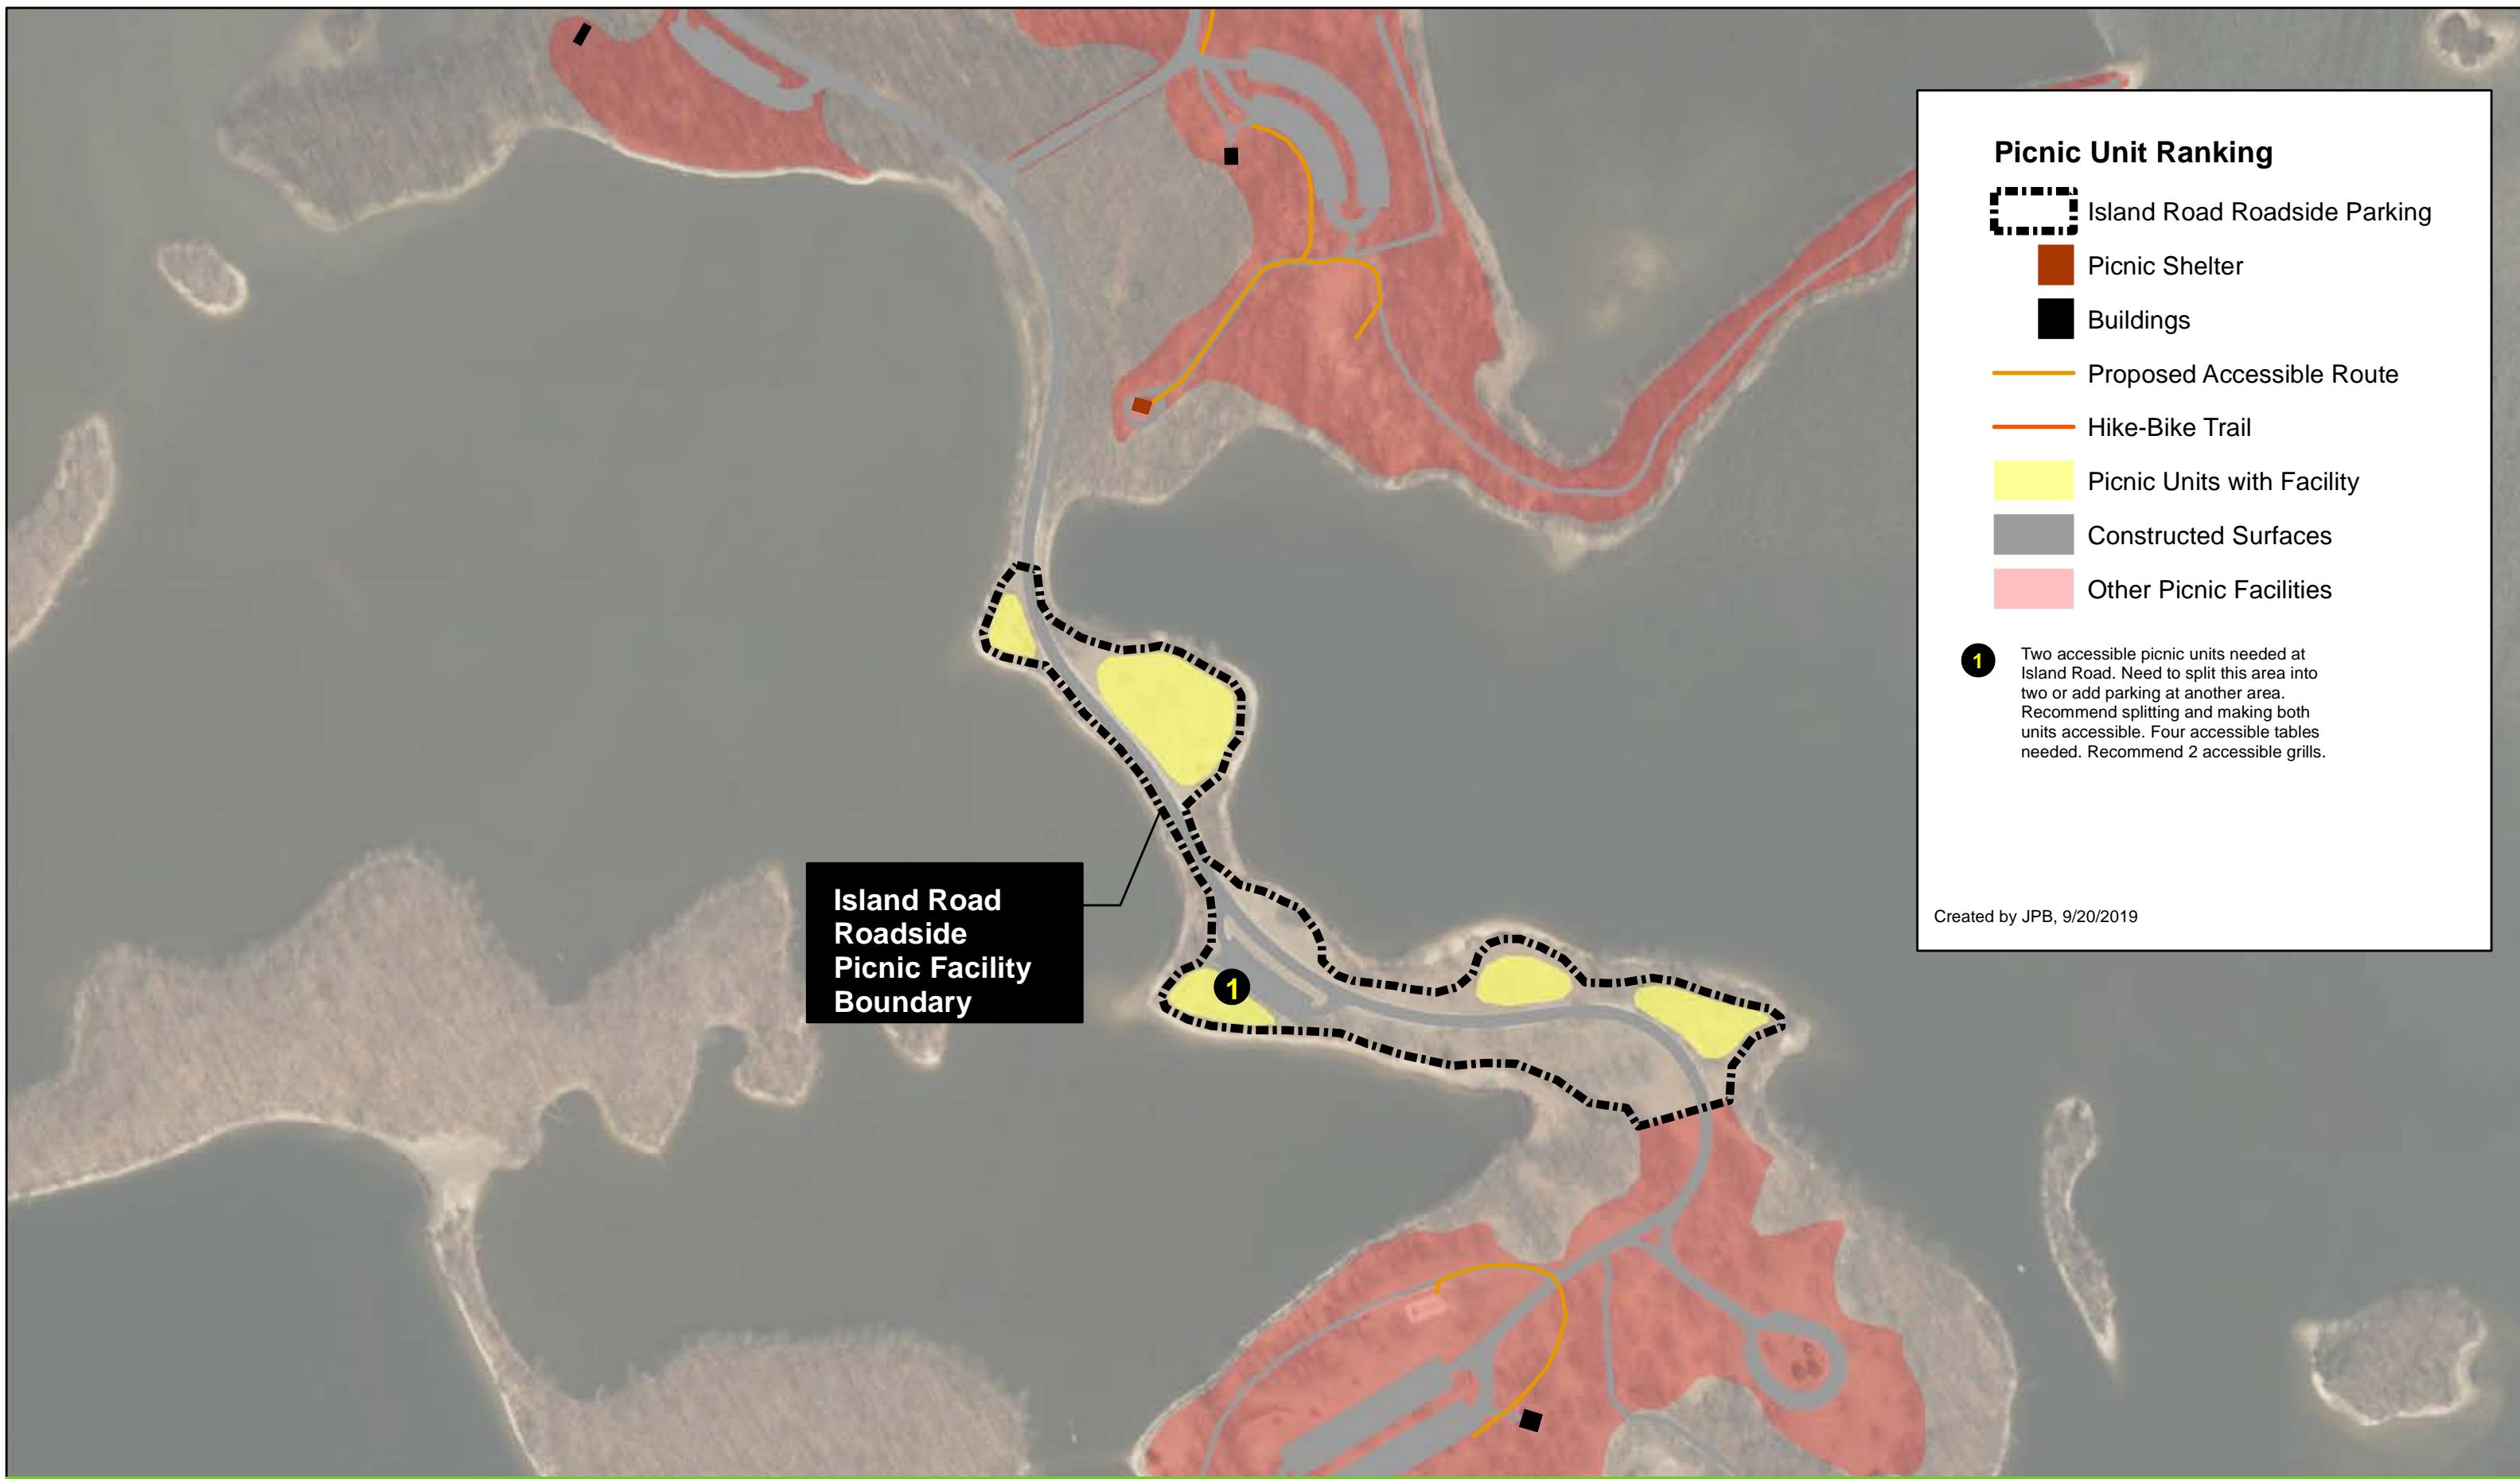
Island Road Roadside Picnic Facility Boundary

1 Two accessible picnic units needed at Island Road. Need to split this area into two or add parking at another area. Recommend splitting and making both units accessible. Four accessible tables needed. Recommend 2 accessible grills.

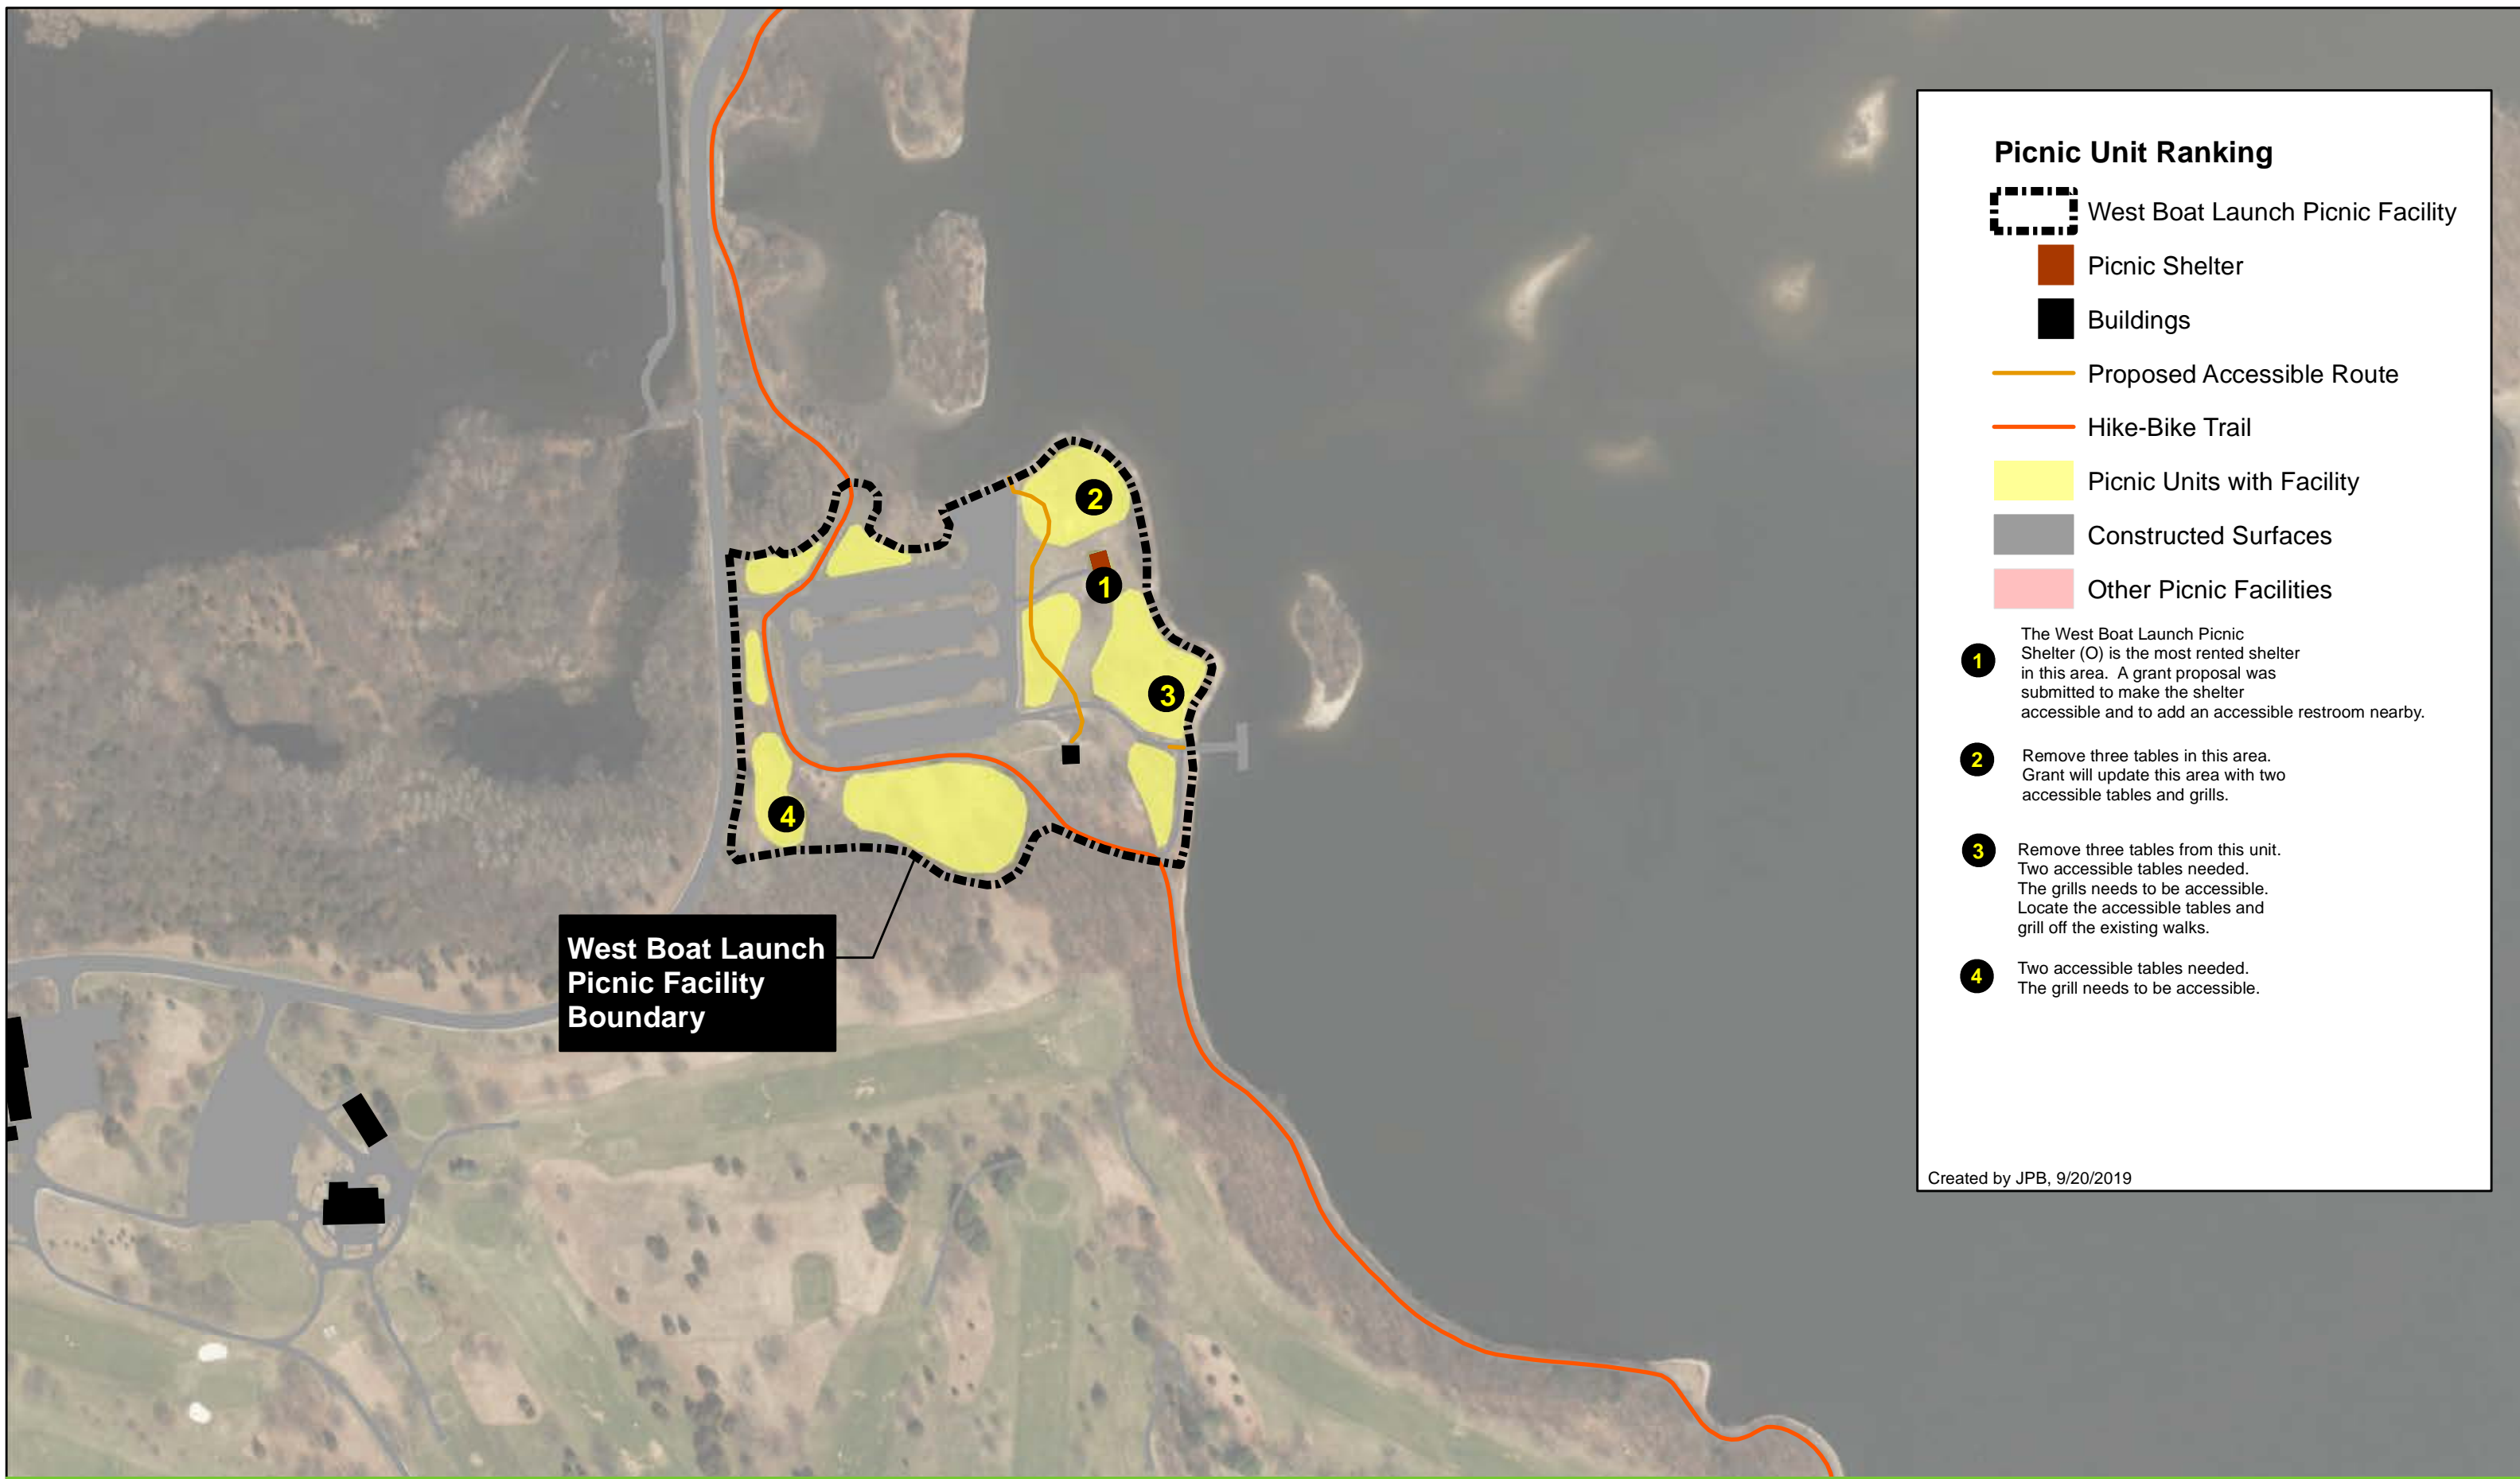
**West Boat Launch
Picnic Facility
Boundary**

- 3** Count some tables w/ shelter unit and increase ADA table ratio at shelter. Meet ratio requirements for ADA tables /grills. Add necessary access routes or locate along existing accessible routes. Two free picnic units recommended at each lot.

- 7** Meet ratio requirements for accessible tables and grills. Add necessary accessible routes. Two free picnic areas recommended at each lot.

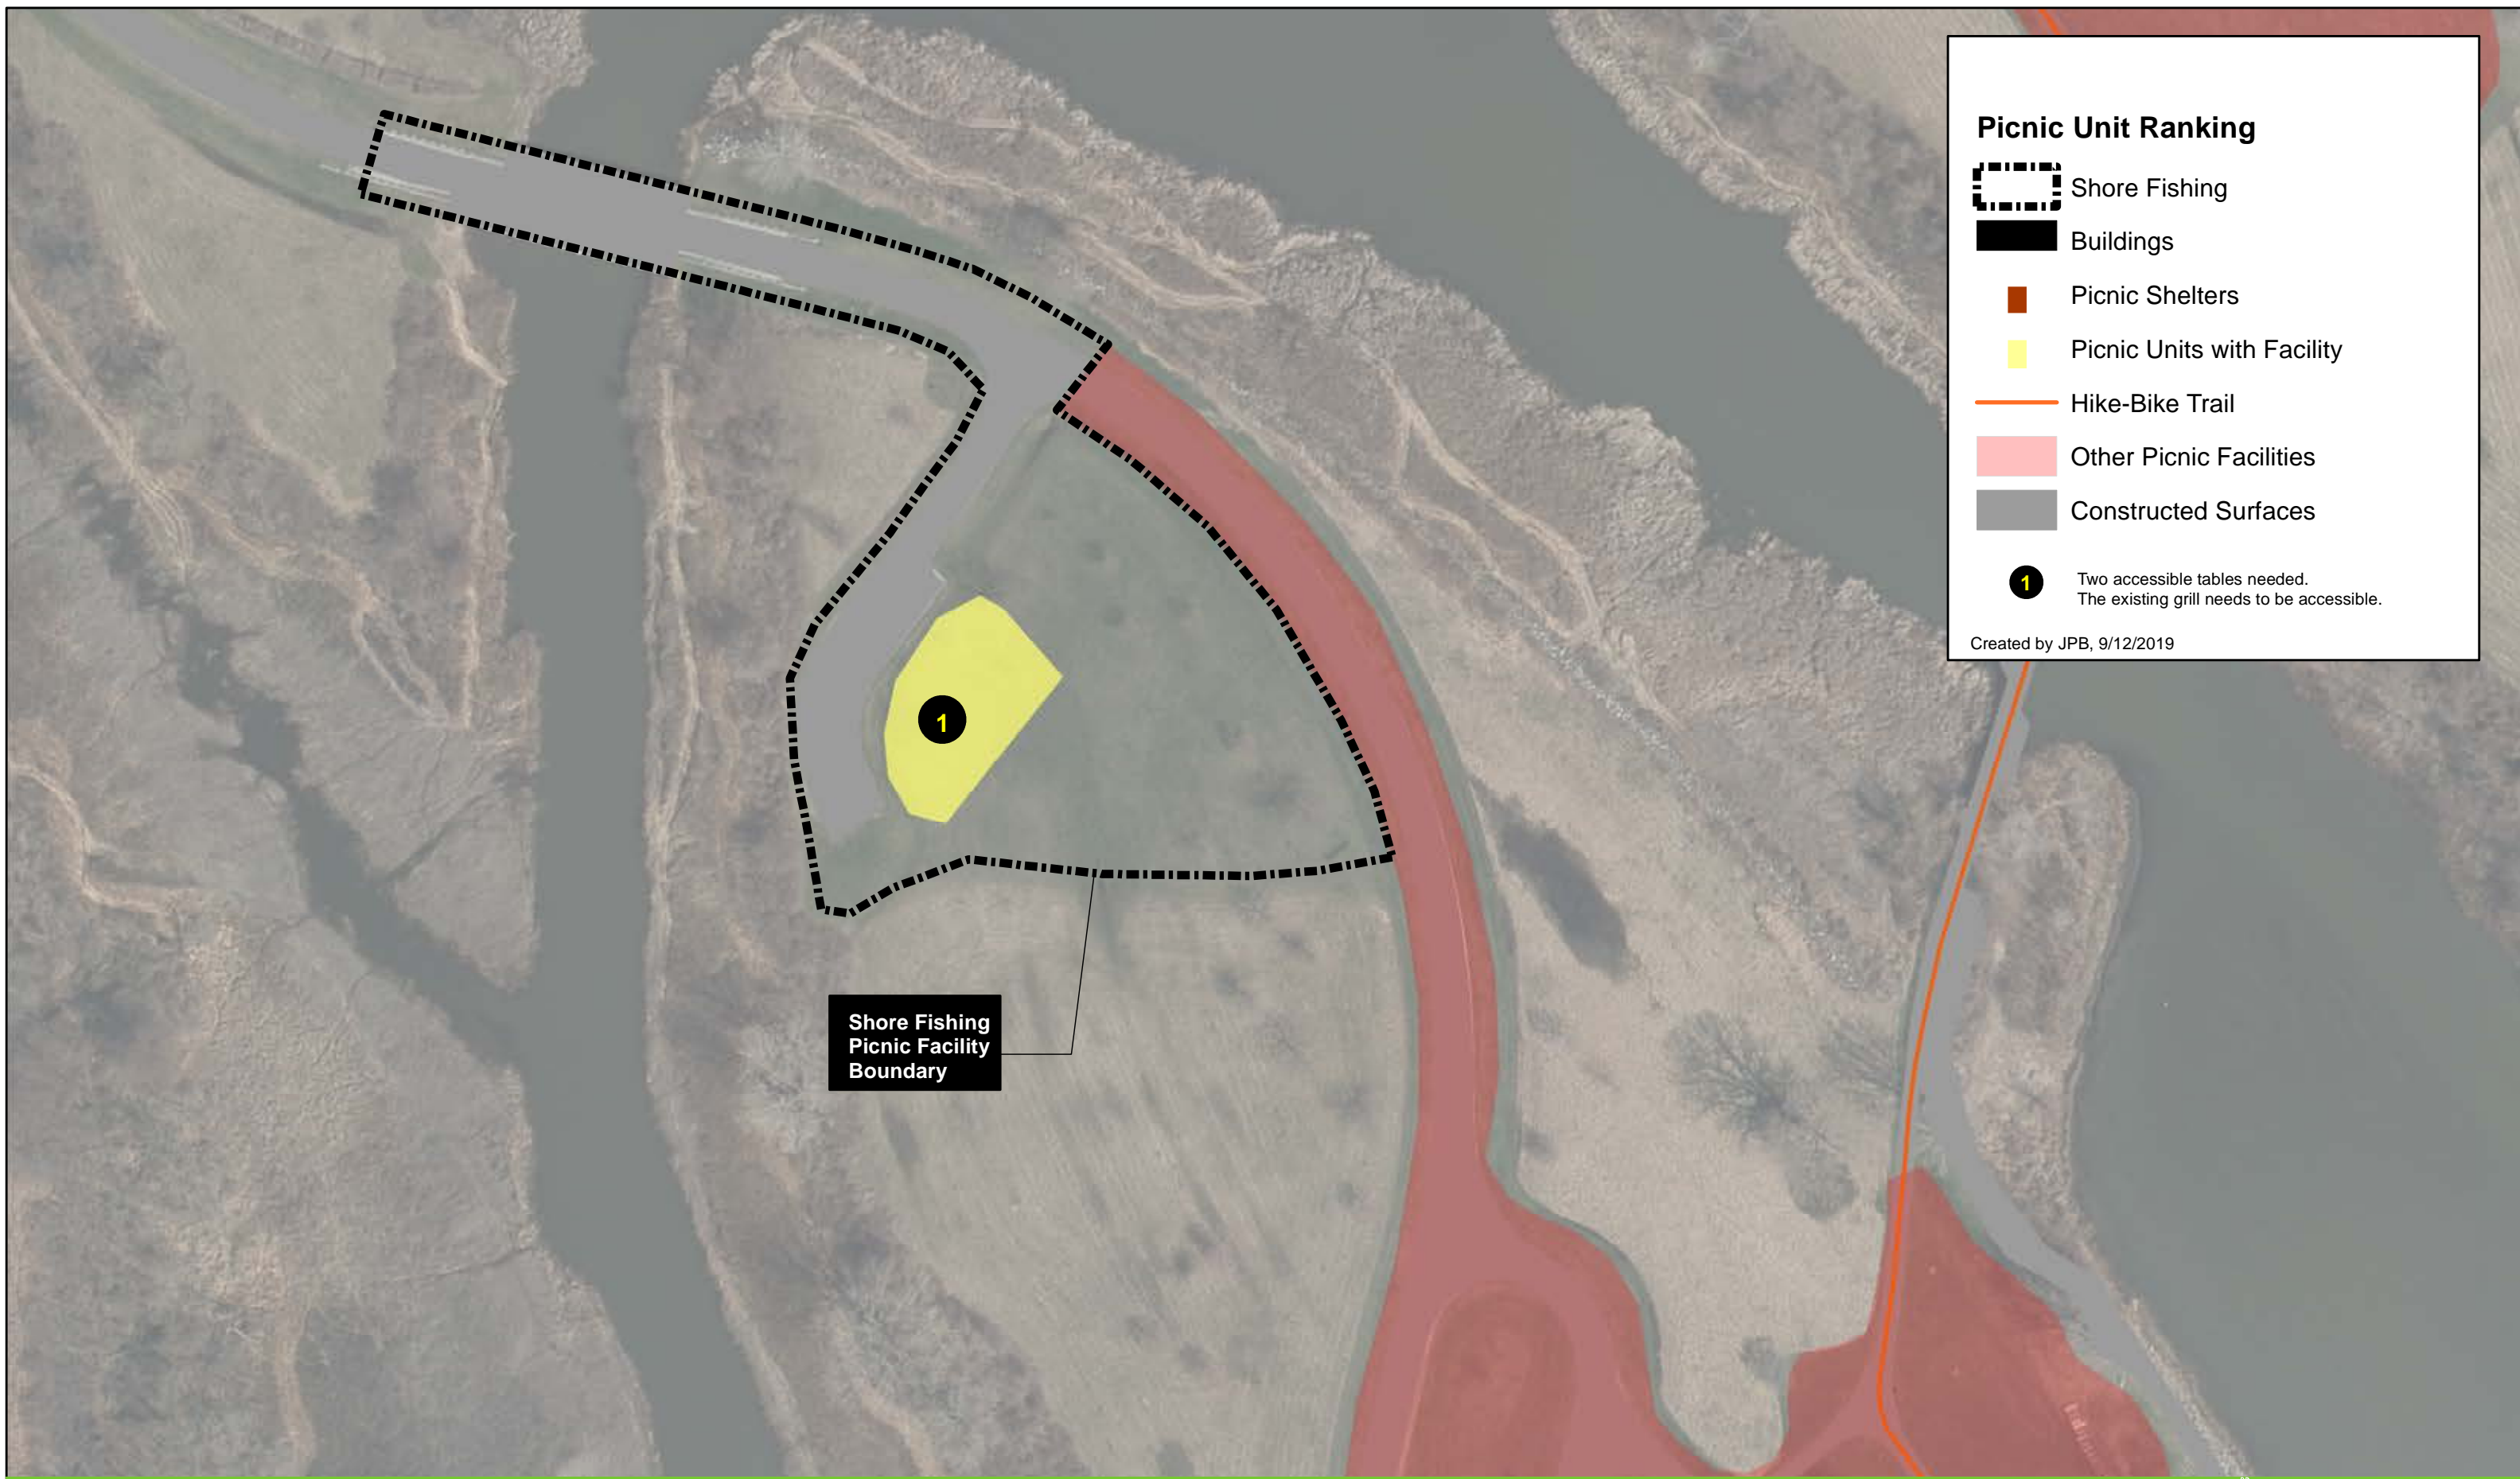
Shore Fishing
Picnic Facility
Boundary

-   Shore Fishing
-   Buildings
-   Picnic Shelters
-   Picnic Units with Facility
-   Hike-Bike Trail
-   Other Picnic Facilities
-   Constructed Surfaces
-   Two accessible tables needed. The existing grill needs to be accessible.

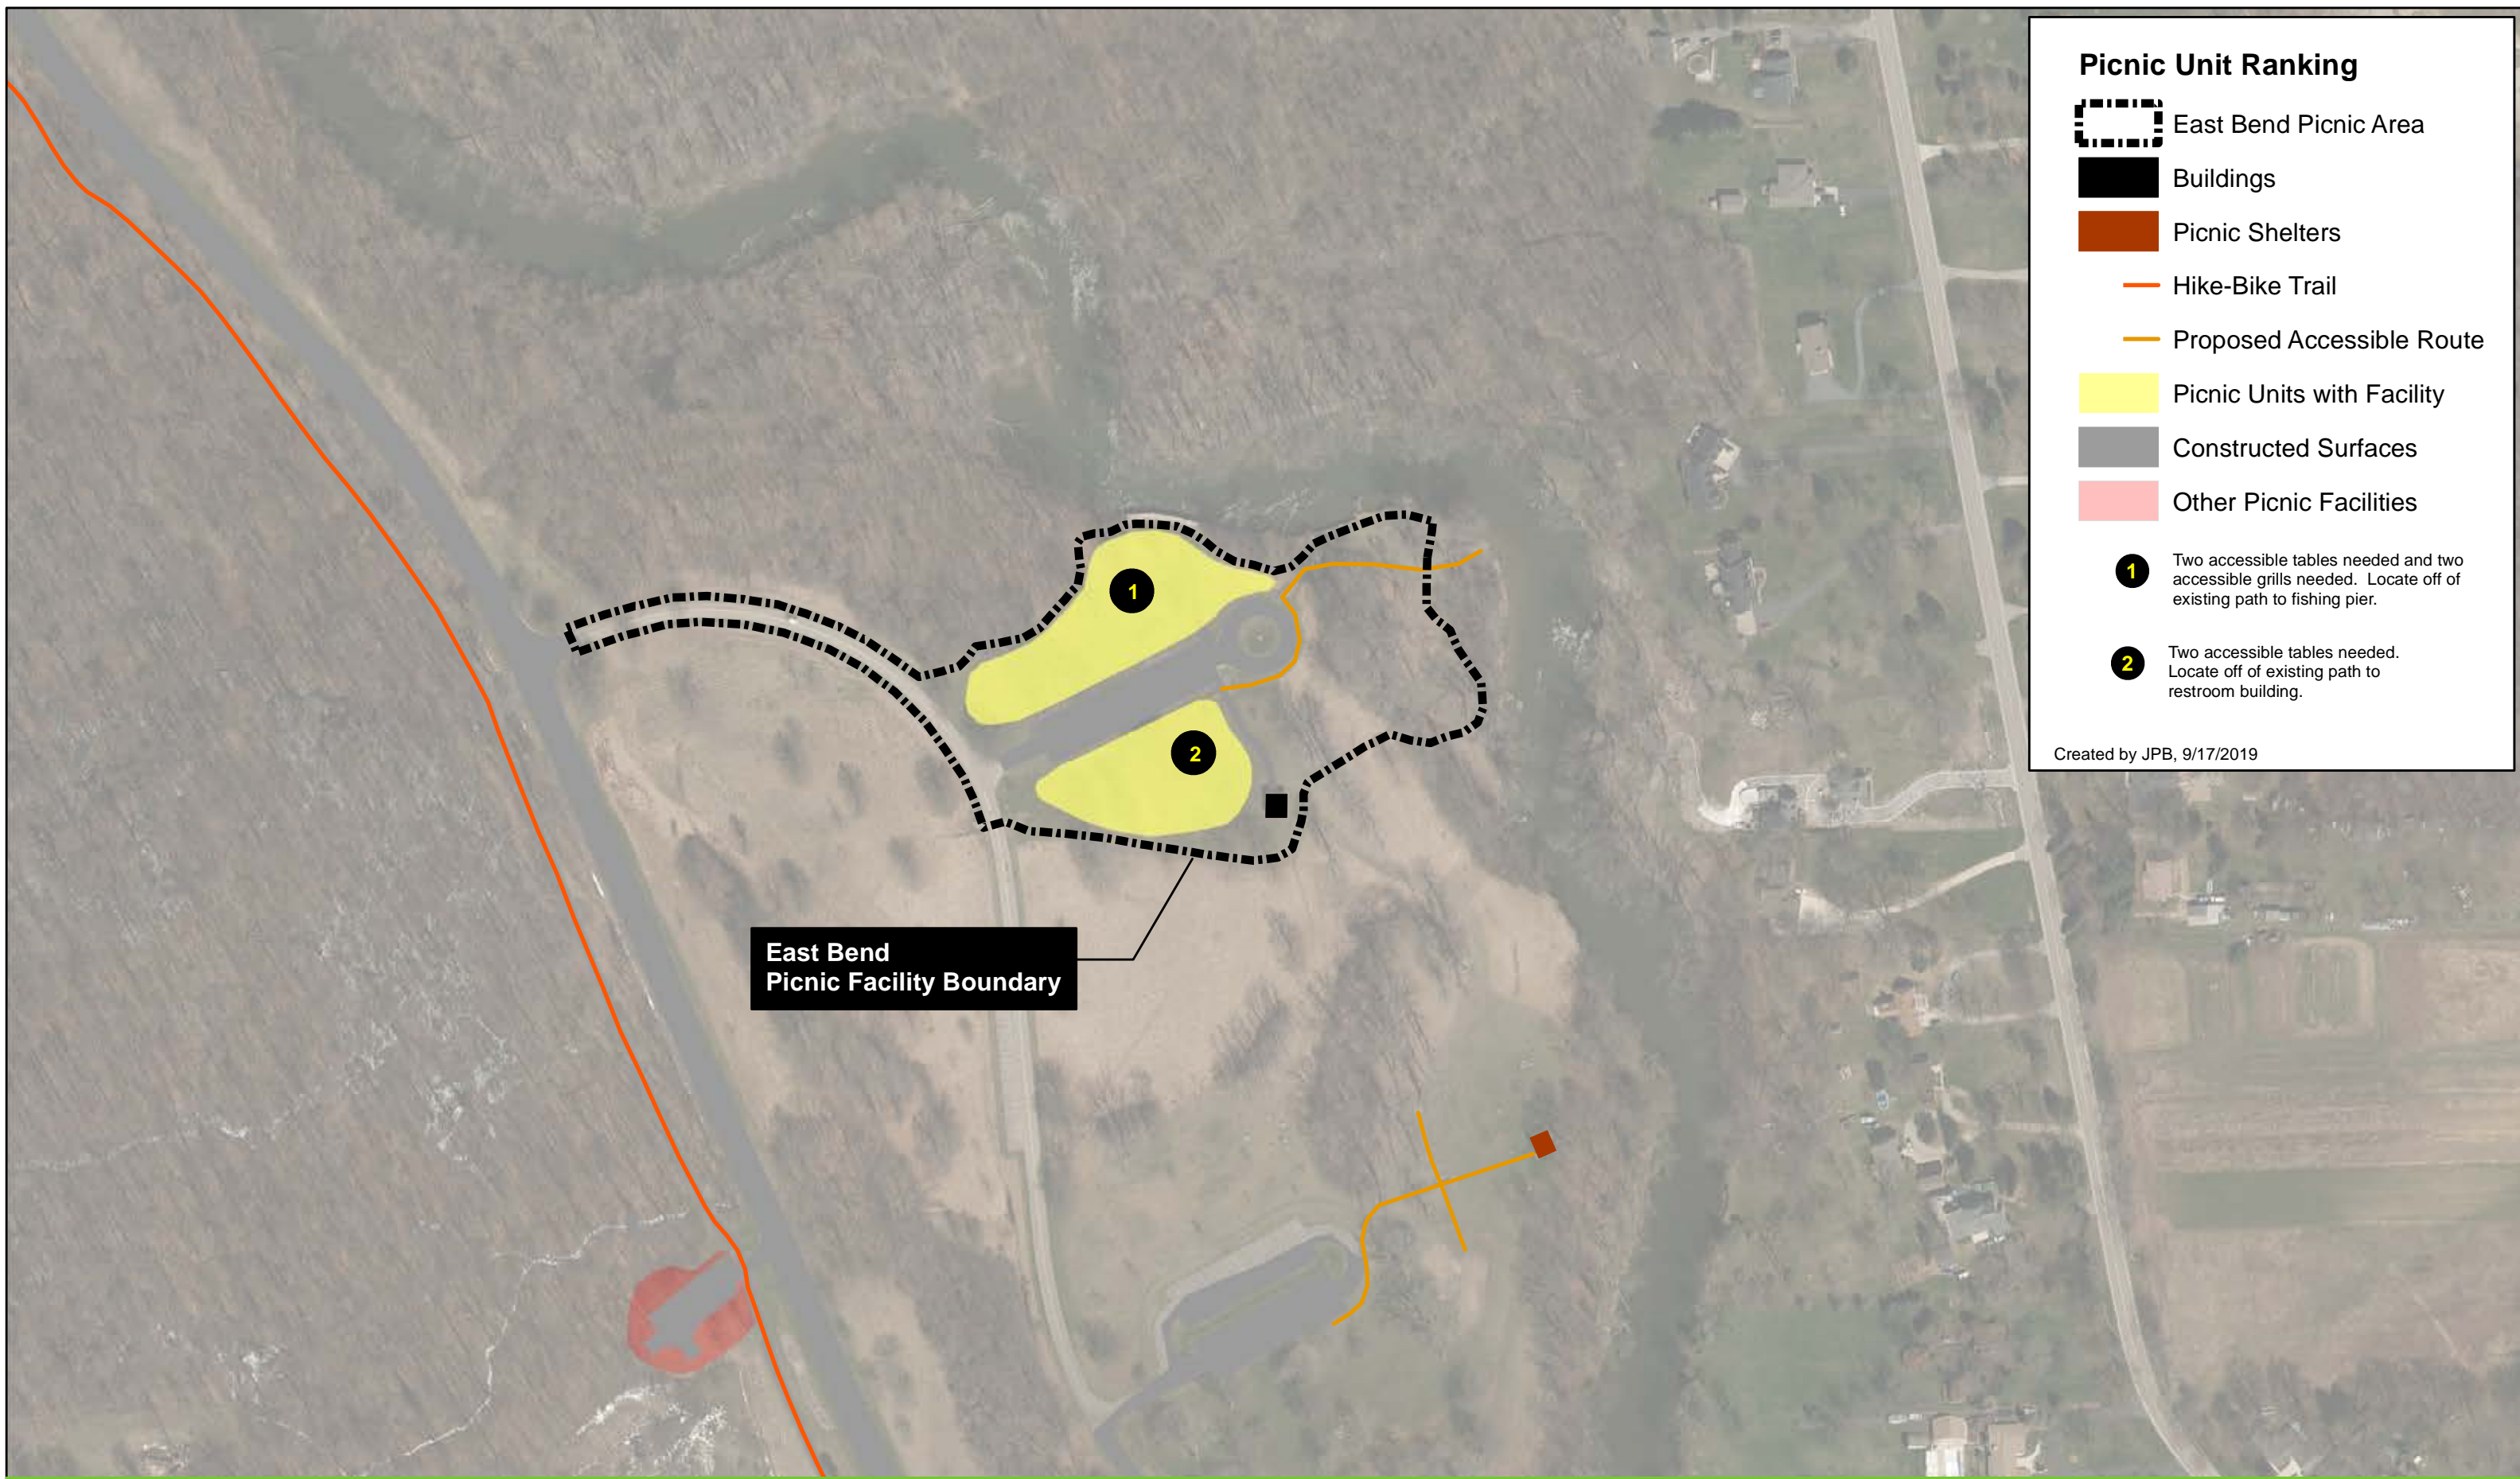
- 6** Two accessible tables needed. Two accessible grills needed. Locate the accessible tables and grills along a new accessible route connecting the parking lot, playground, restroom building, and Turtle Cove.

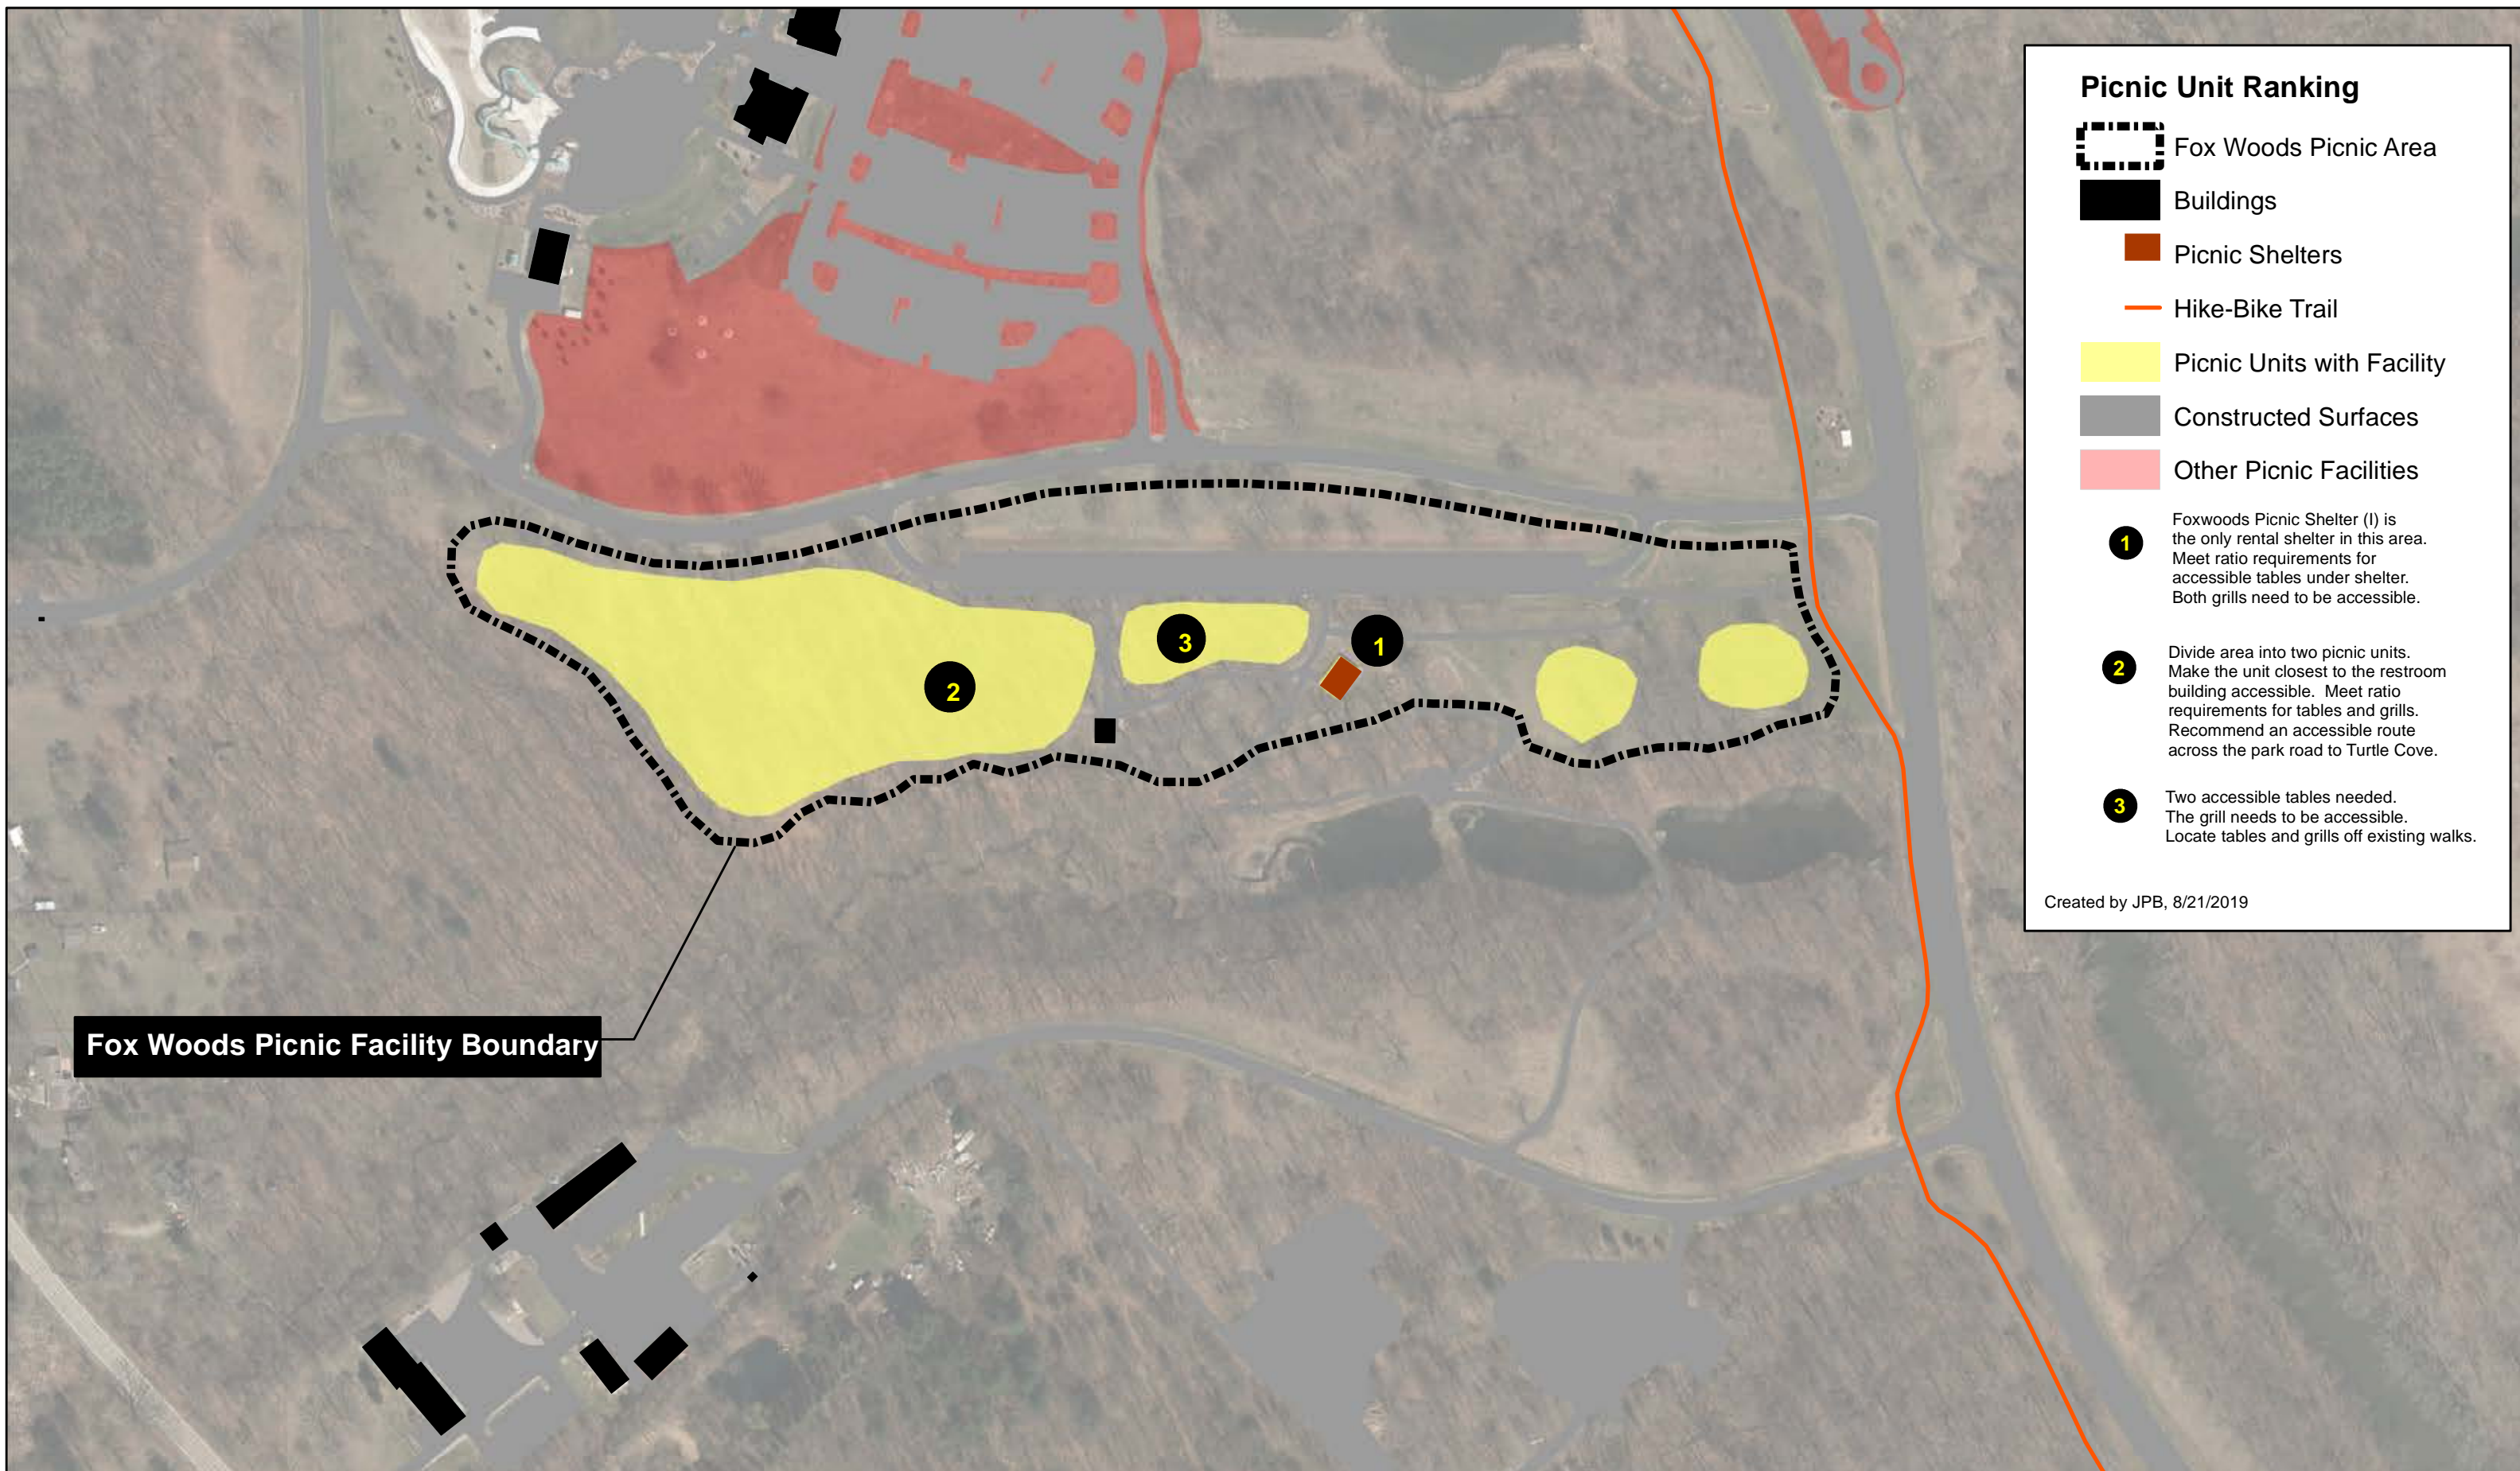
Fox Woods Picnic Facility Boundary

- 1** Foxwoods Picnic Shelter (1) is the only rental shelter in this area. Meet ratio requirements for accessible tables under shelter. Both grills need to be accessible.
- 2** Divide area into two picnic units. Make the unit closest to the restroom building accessible. Meet ratio requirements for tables and grills. Recommend an accessible route across the park road to Turtle Cove.
- 3** Two accessible tables needed. The grill needs to be accessible. Locate tables and grills off existing walks.
