APPENDIX 3: PICNIC FACILITIES MAP

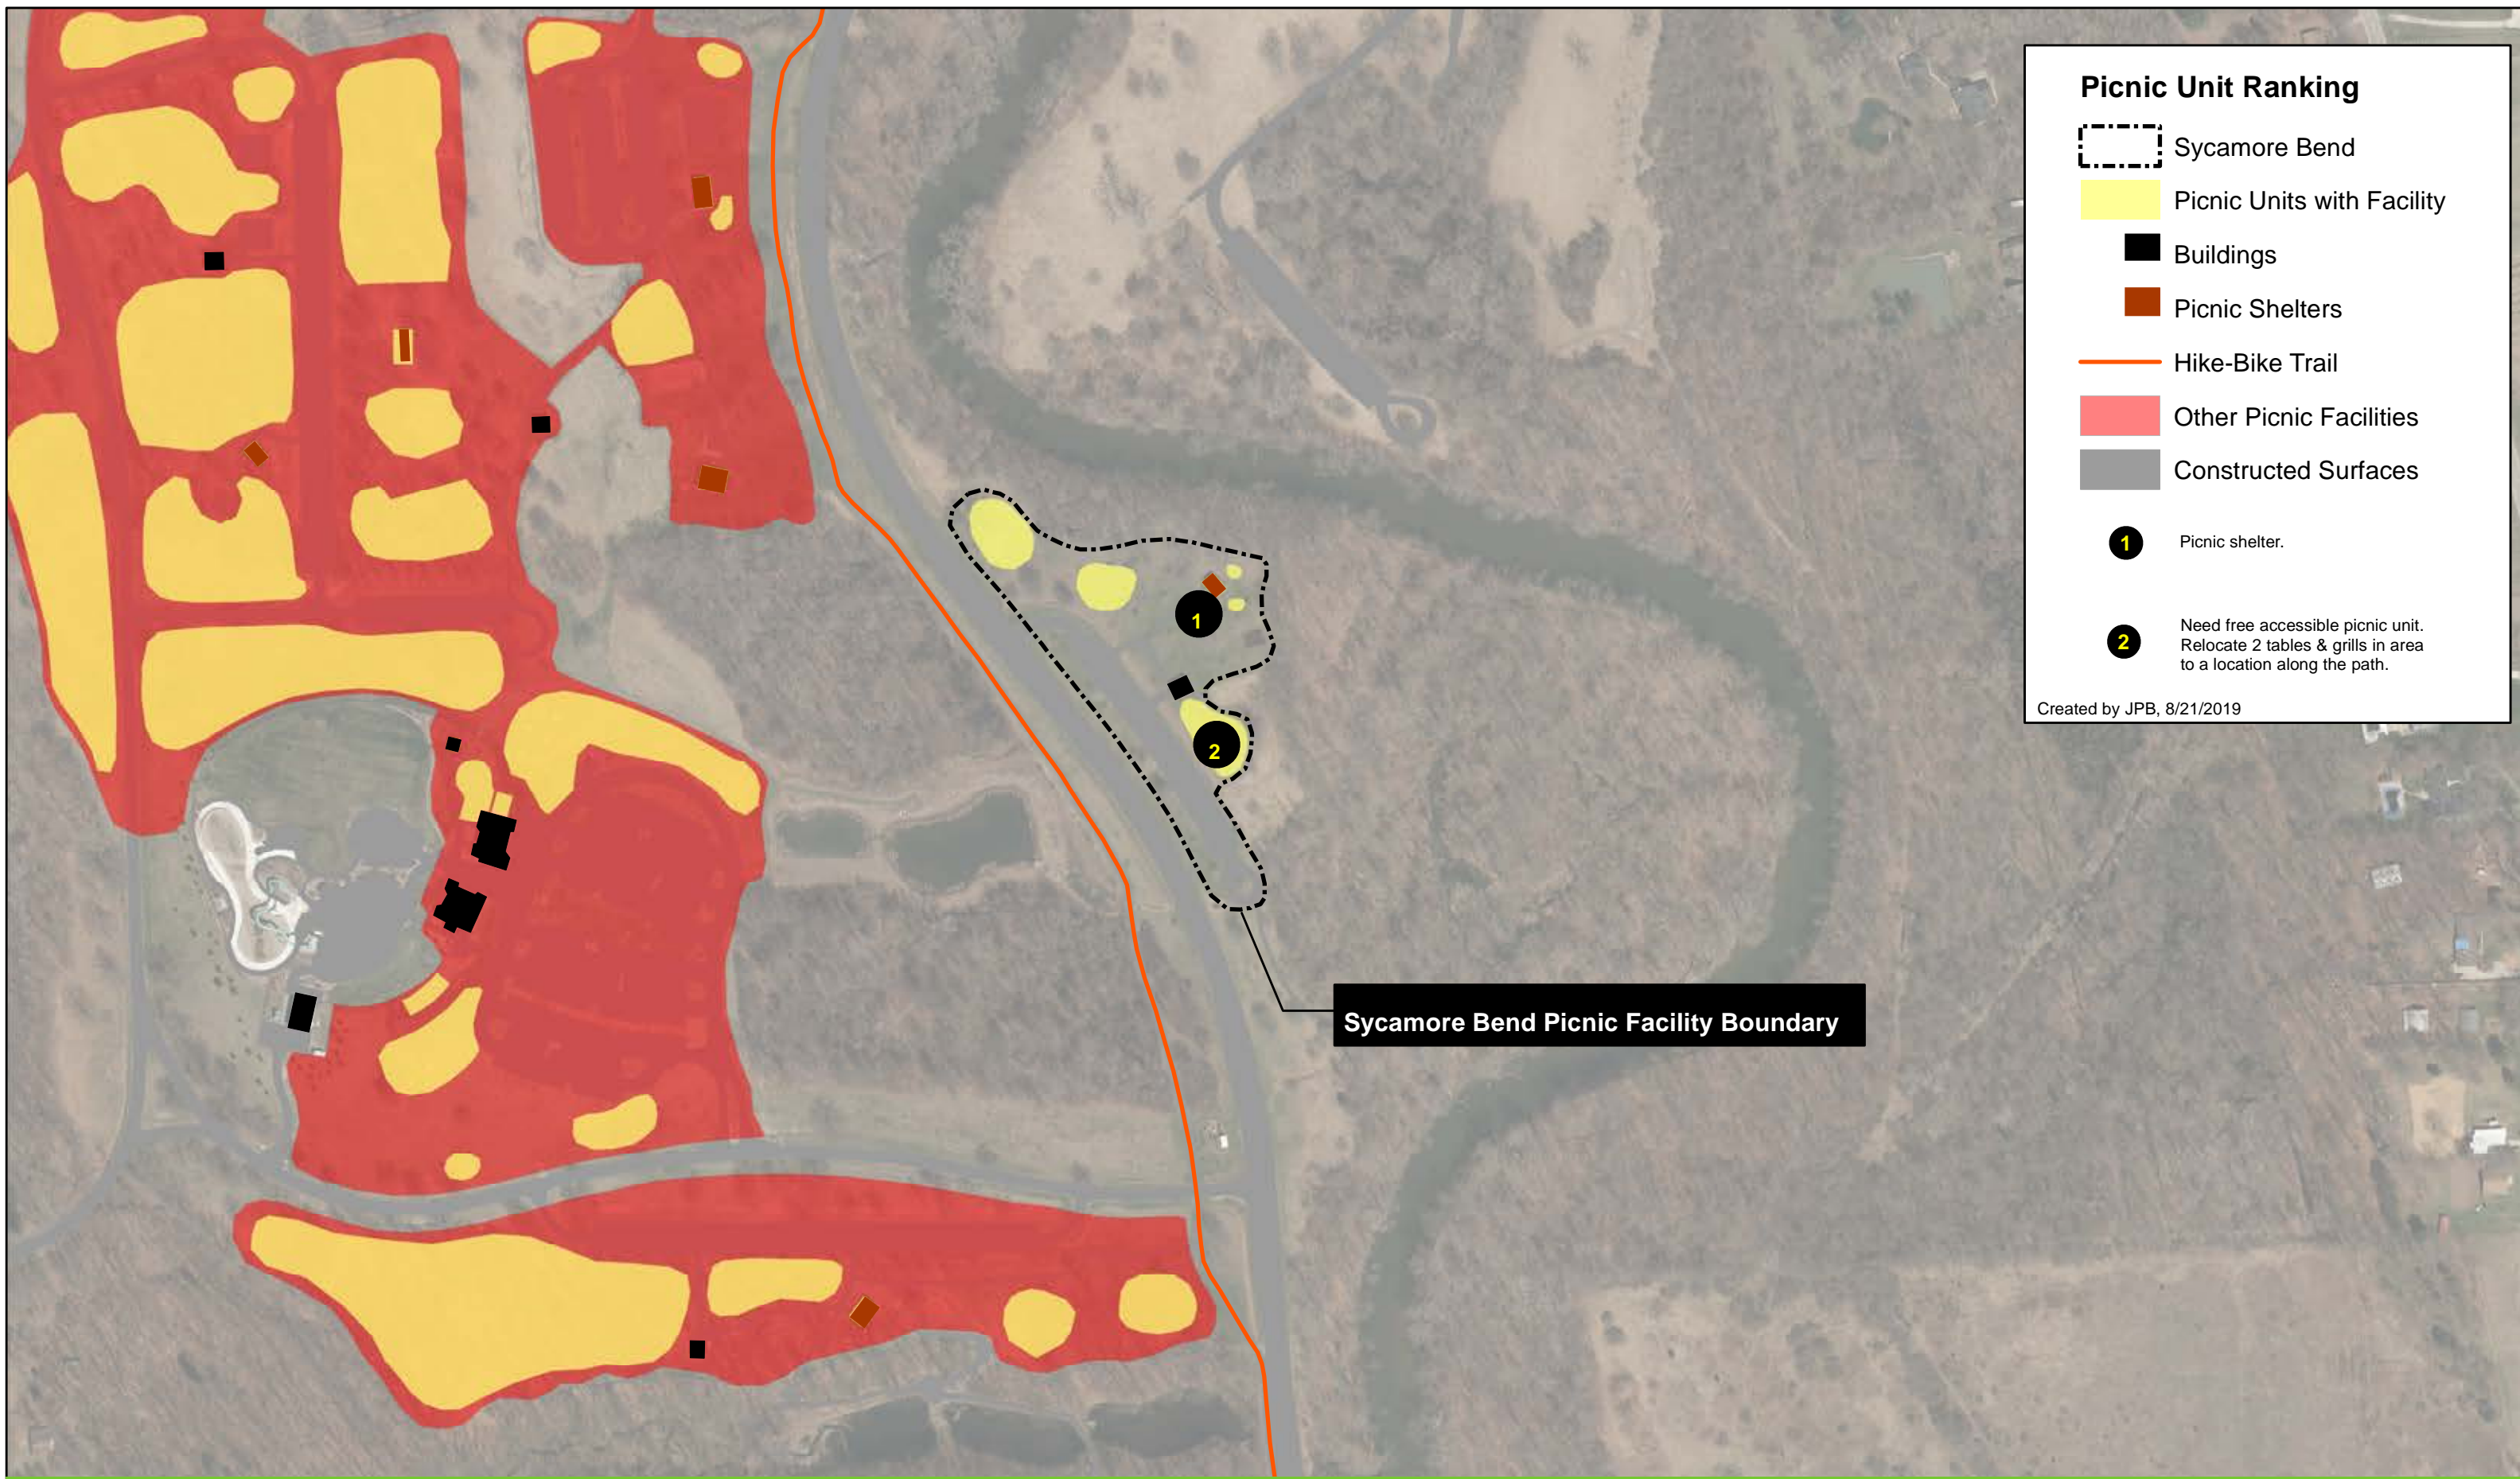
Sycamore Bend Picnic Facility Boundary

-   Sycamore Bend
-   Picnic Units with Facility
-   Buildings
-   Picnic Shelters
-   Hike-Bike Trail
-   Other Picnic Facilities
-   Constructed Surfaces
-   Picnic shelter.
-   Need free accessible picnic unit. Relocate 2 tables & grills in area to a location along the path.

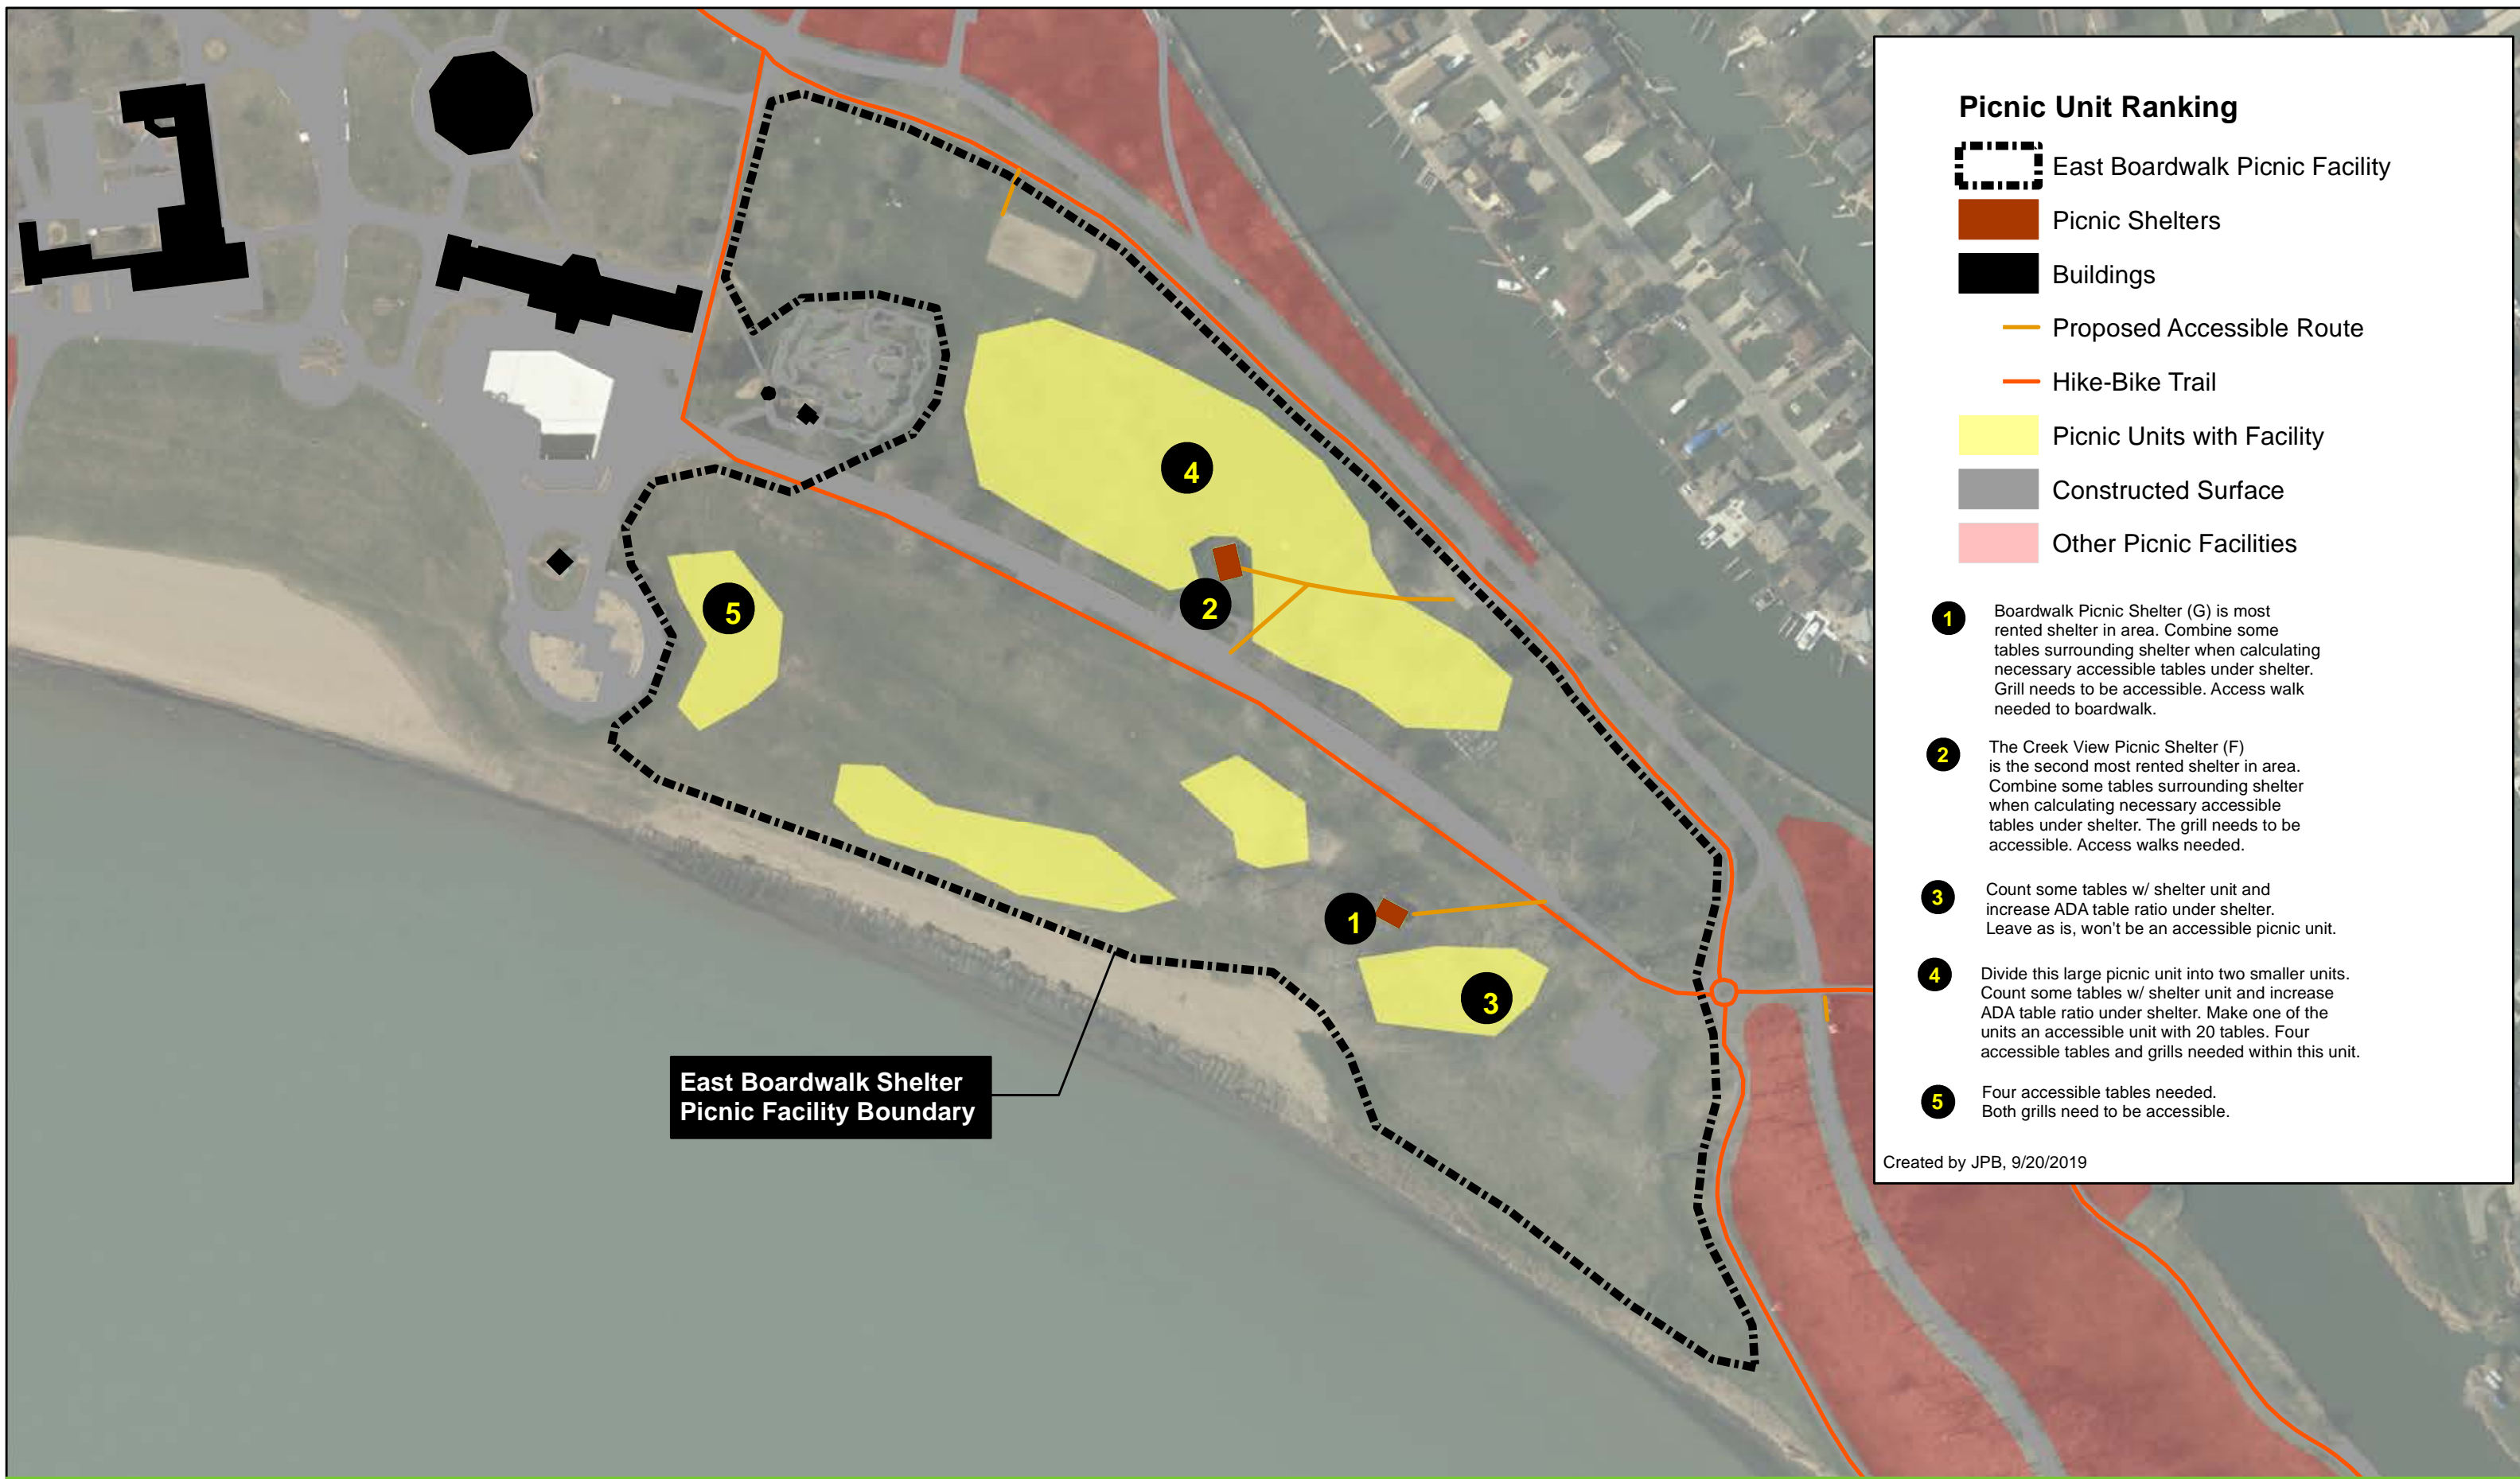
- 5** Four accessible tables needed. Both grills need to be accessible.

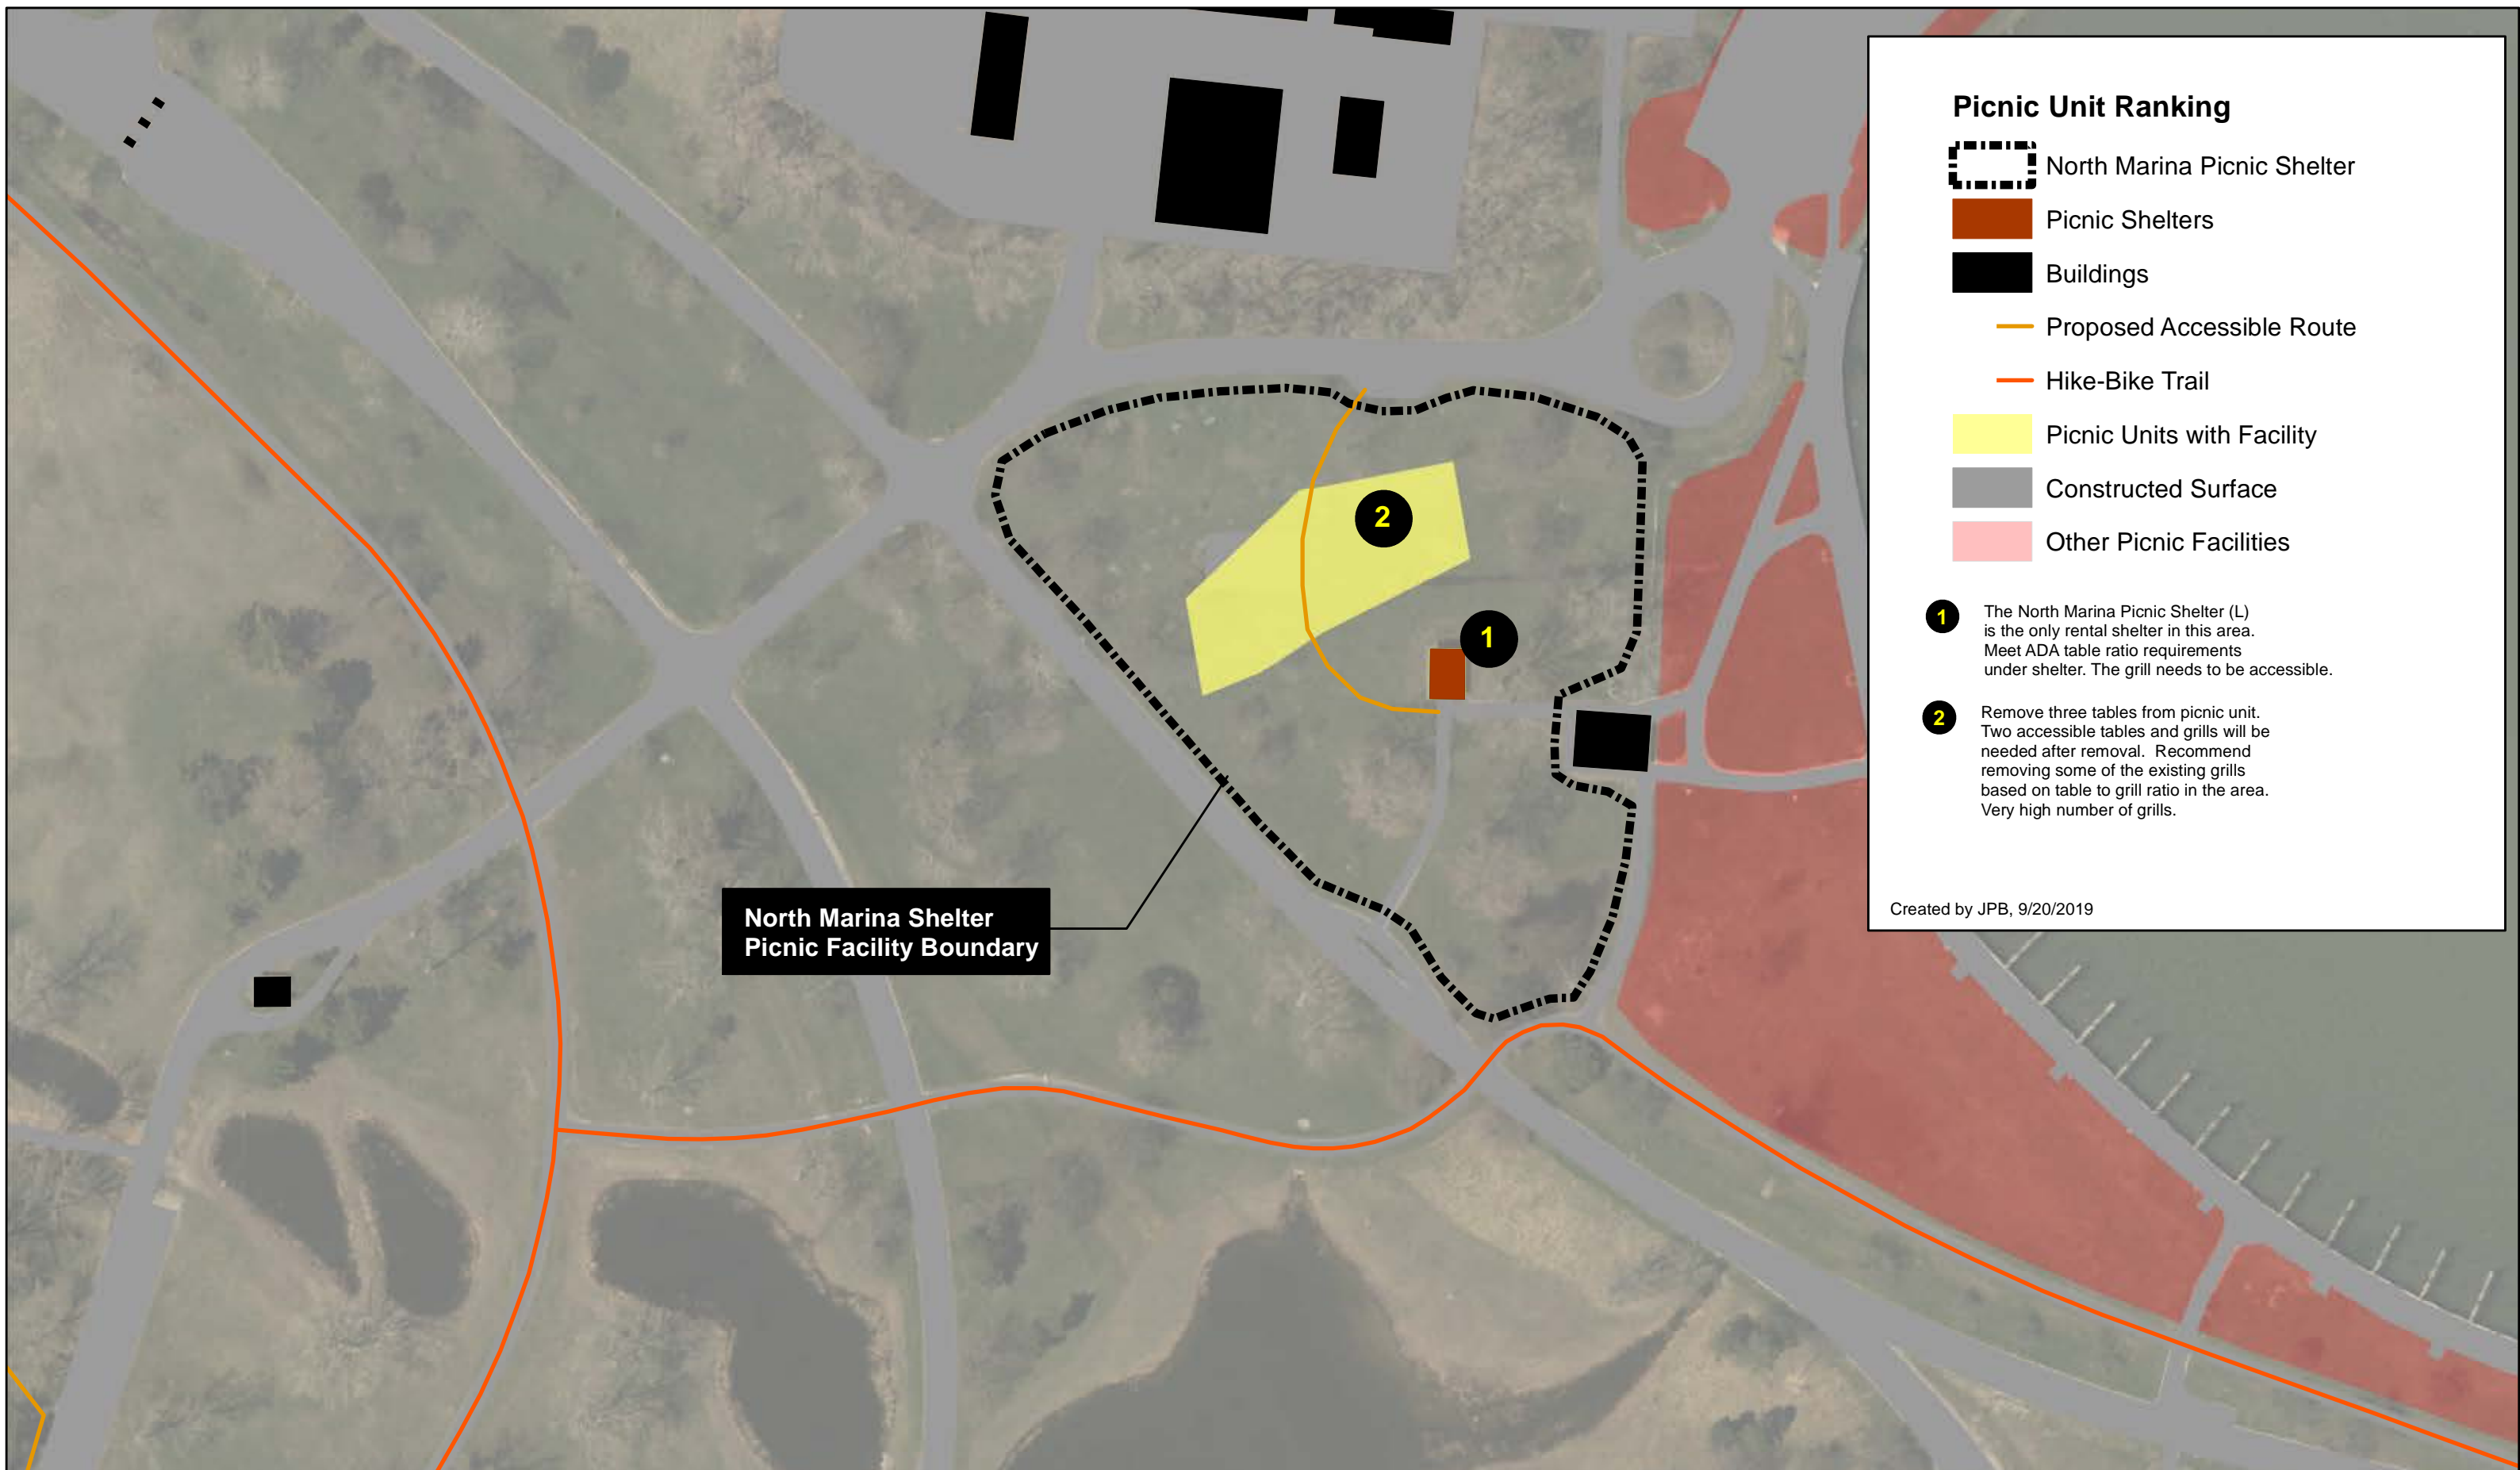
North Marina Shelter
Picnic Facility Boundary

- 1** The North Marina Picnic Shelter (L) is the only rental shelter in this area. Meet ADA table ratio requirements under shelter. The grill needs to be accessible.
- 2** Remove three tables from picnic unit. Two accessible tables and grills will be needed after removal. Recommend removing some of the existing grills based on table to grill ratio in the area. Very high number of grills.

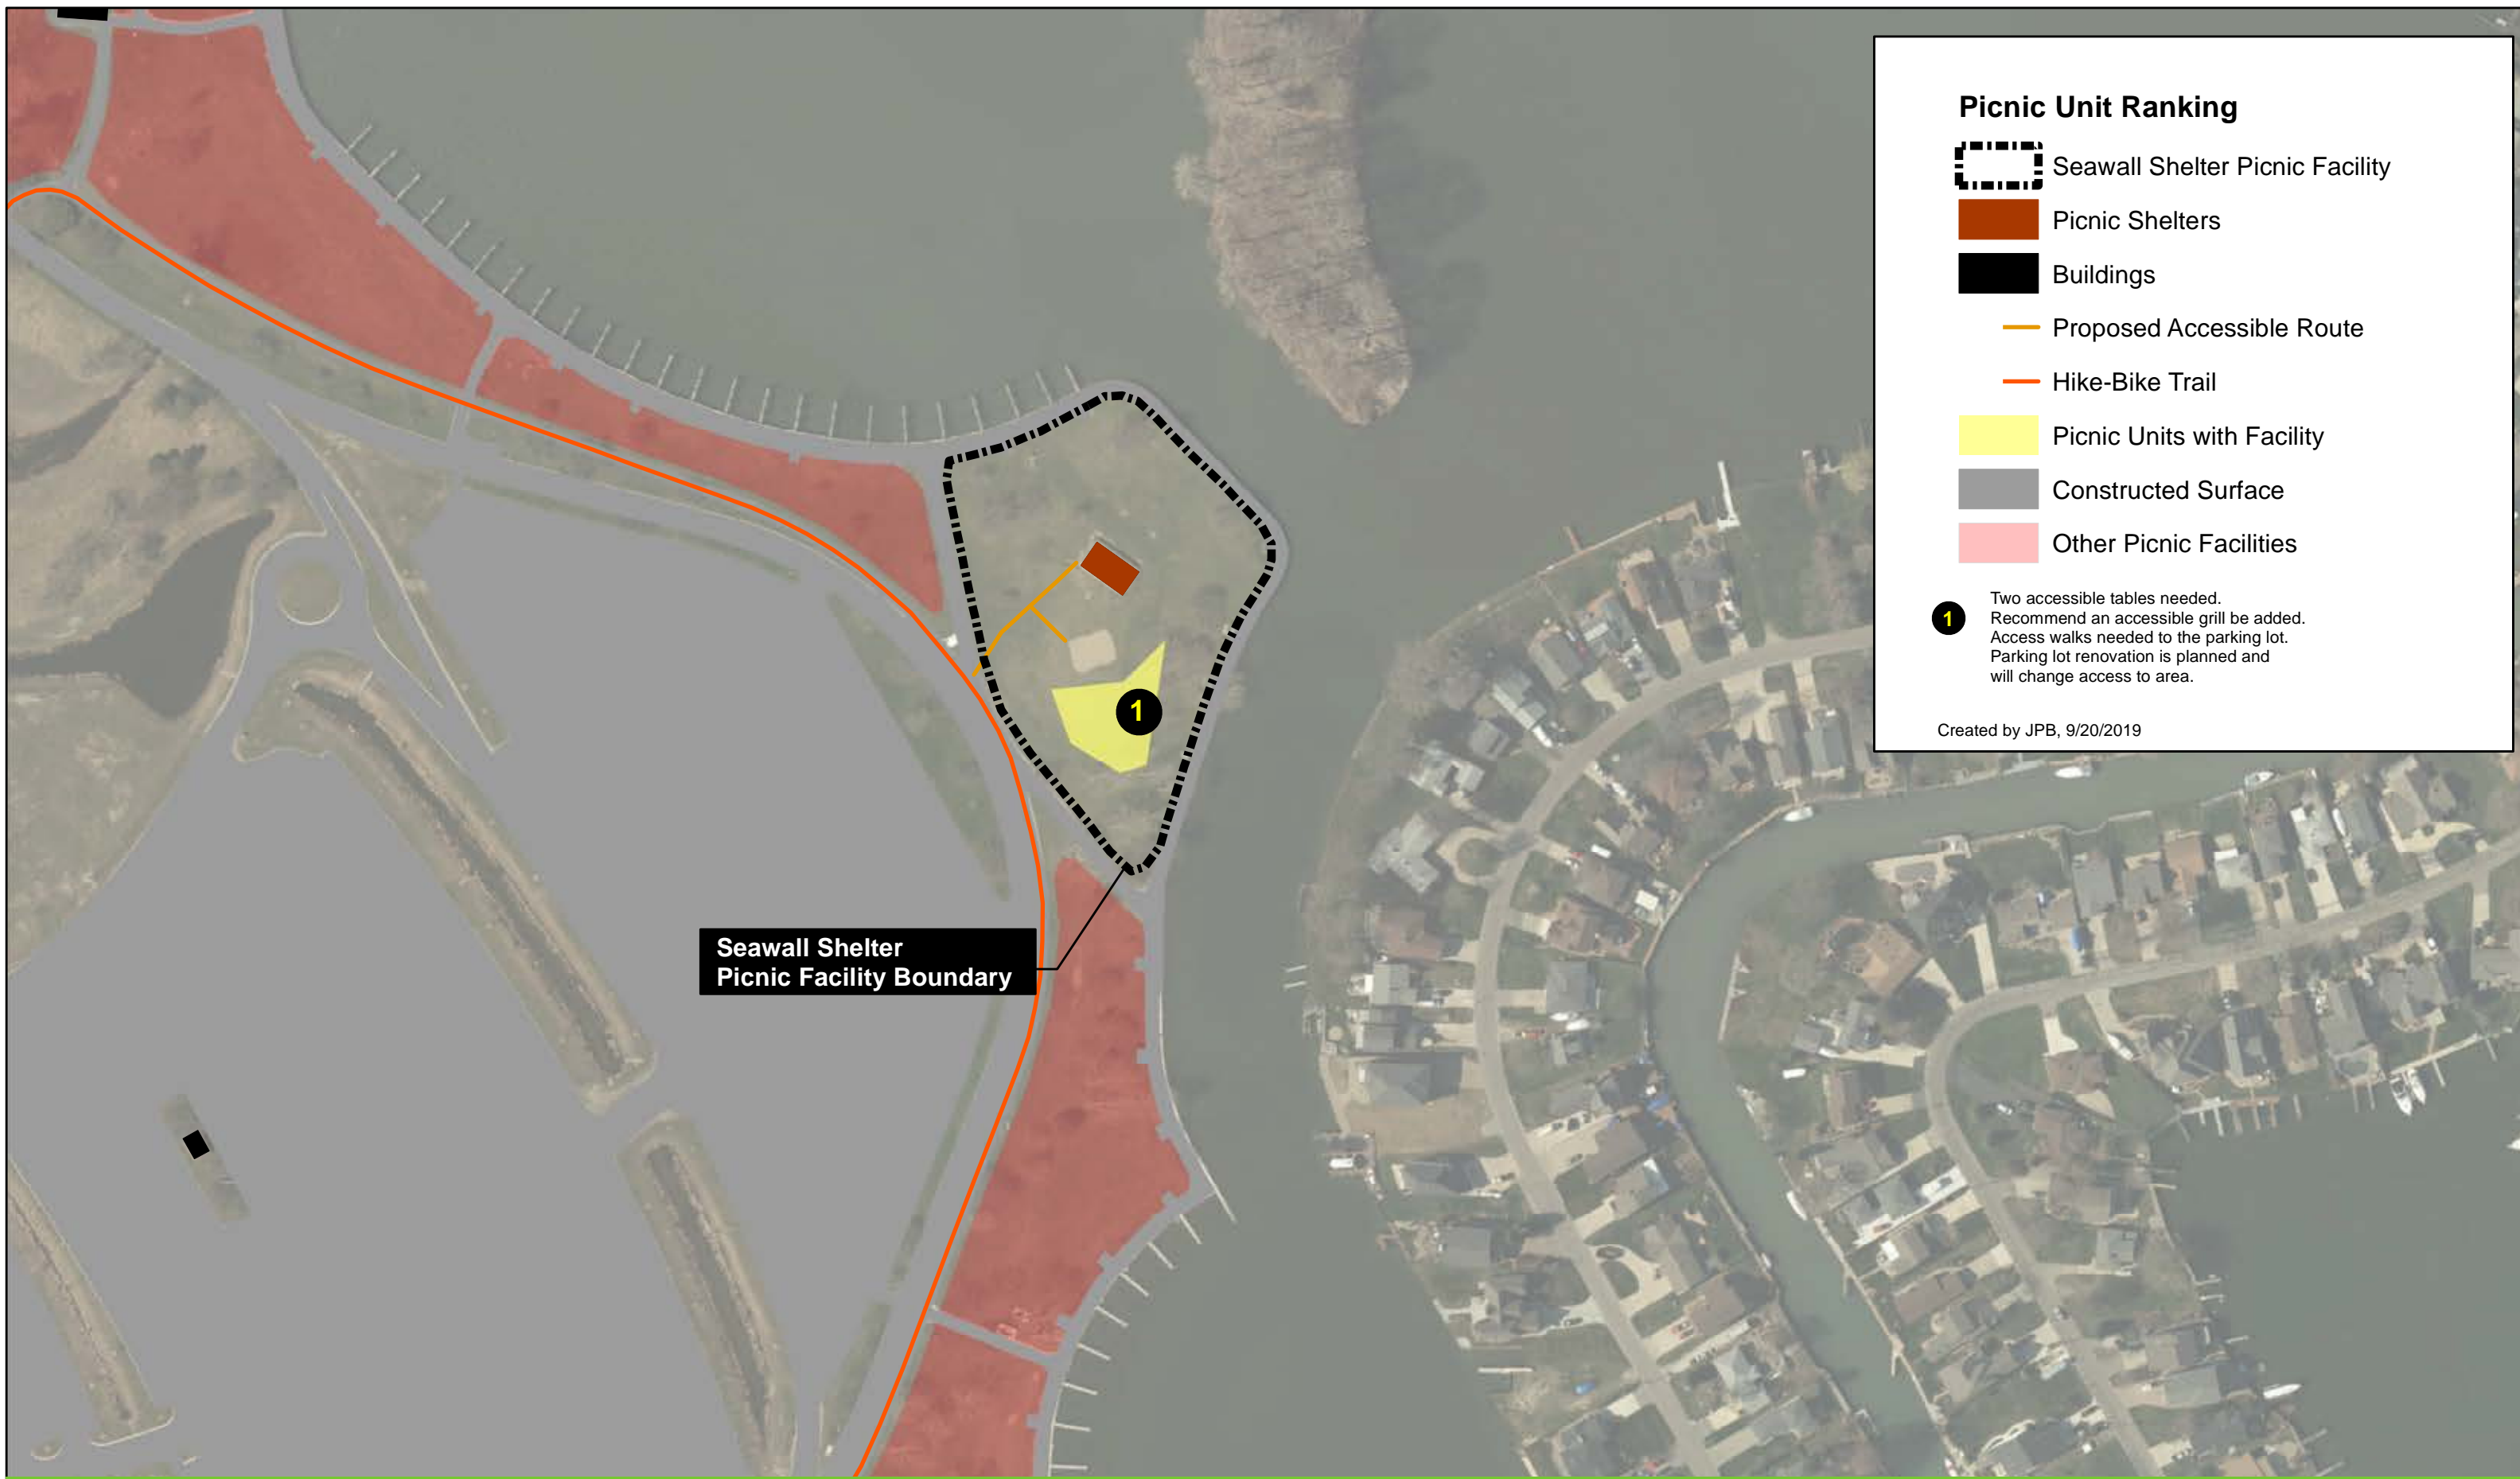
**Seawall Shelter
 Picnic Facility Boundary**

1 Two accessible tables needed.
 Recommend an accessible grill be added.
 Access walks needed to the parking lot.
 Parking lot renovation is planned and
 will change access to area.

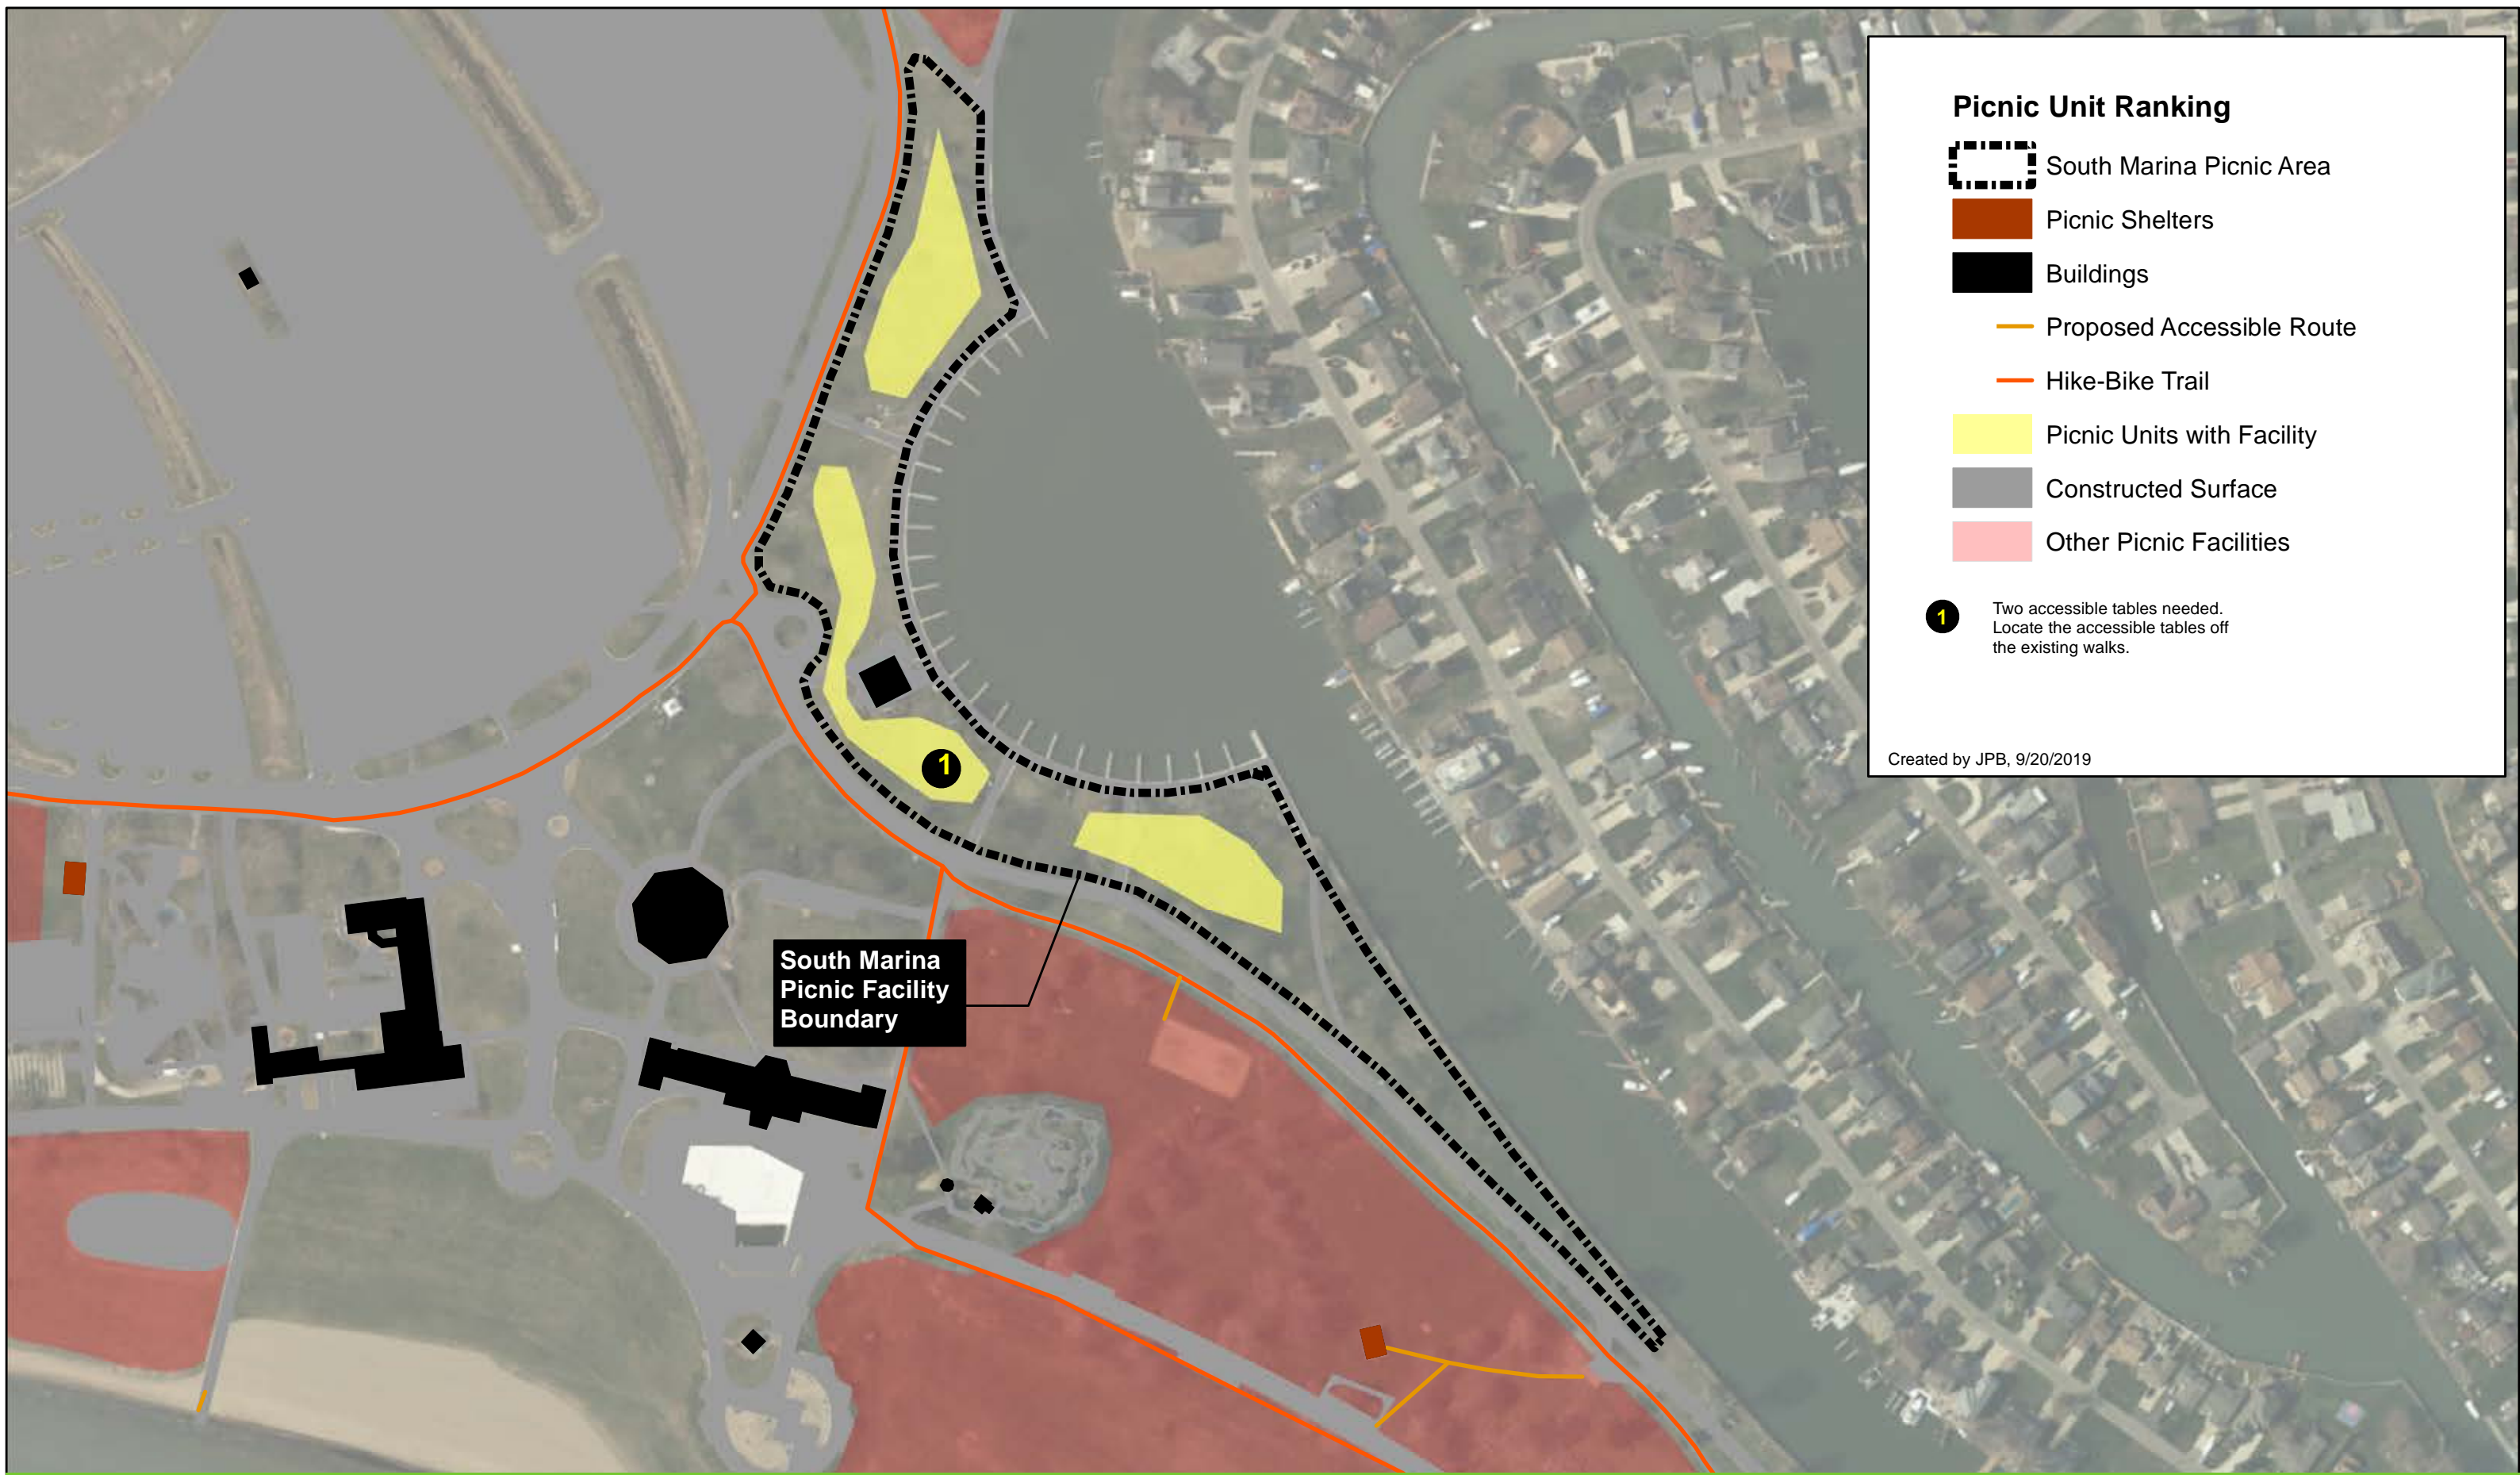
- 1** The West Beach Picnic Shelter (D) is the only rental shelter in area. Combine some tables surrounding the shelter when calculating necessary accessible tables under shelter. The grill need to be accessible. Access walk needed to the boardwalk.
- 2** Count some tables w/ shelter unit and increase ADA table ratio under shelter. Meet ADA requirements for remaining tables. Two accessible grills needed. Locate accessible tables and grills off a new walk between the shelter and boardwalk.

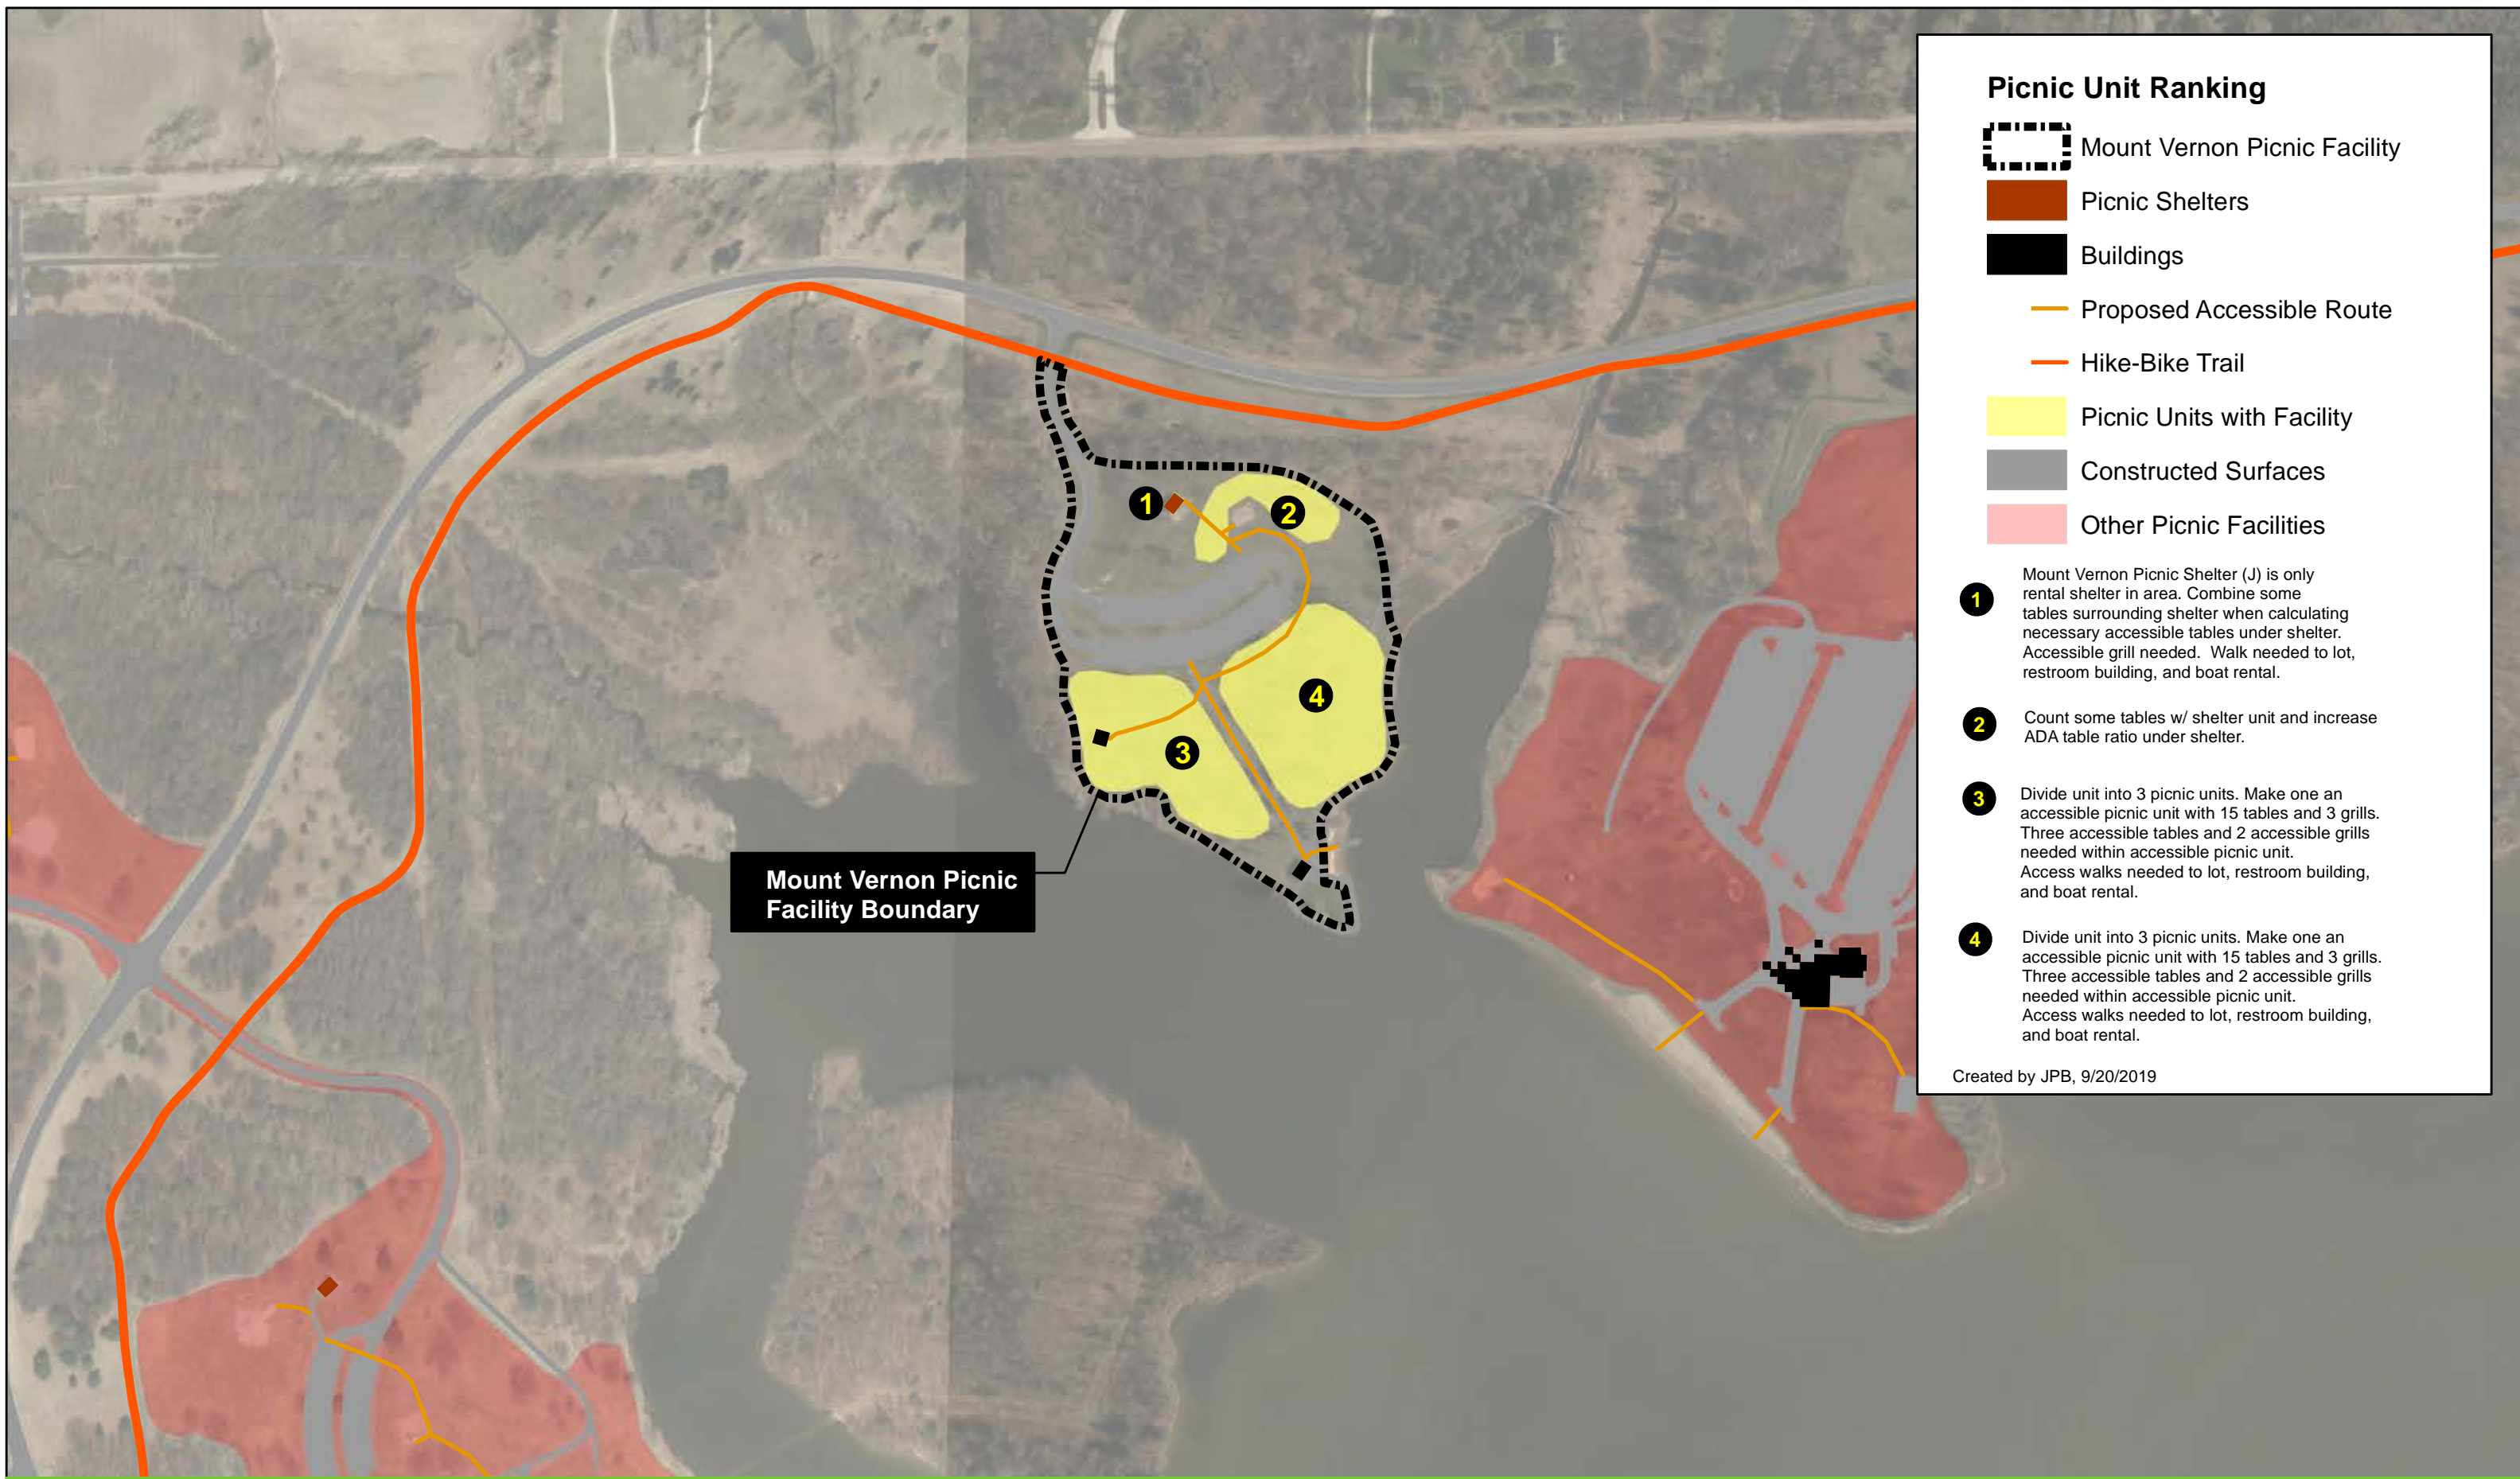
Lakeview Picnic Facility Boundary

- 1** The Lakeview Picnic Shelter (H) is the only rental shelter in this area. Meet ADA accessible table ratio requirements under shelter. The grill needs to be accessible.
- 2** Divide the picnic unit into three units. Make one of the three an accessible unit with two accessible tables and grills. Locate along a new walk that connects to the restroom building.
- 3** Divide the picnic unit into two units. Make the one closest to the play area an accessible unit with two accessible tables and grills. Locate along a new walk that connects to the restroom building.
