APPENDIX 3: PICNIC FACILITIES MAP

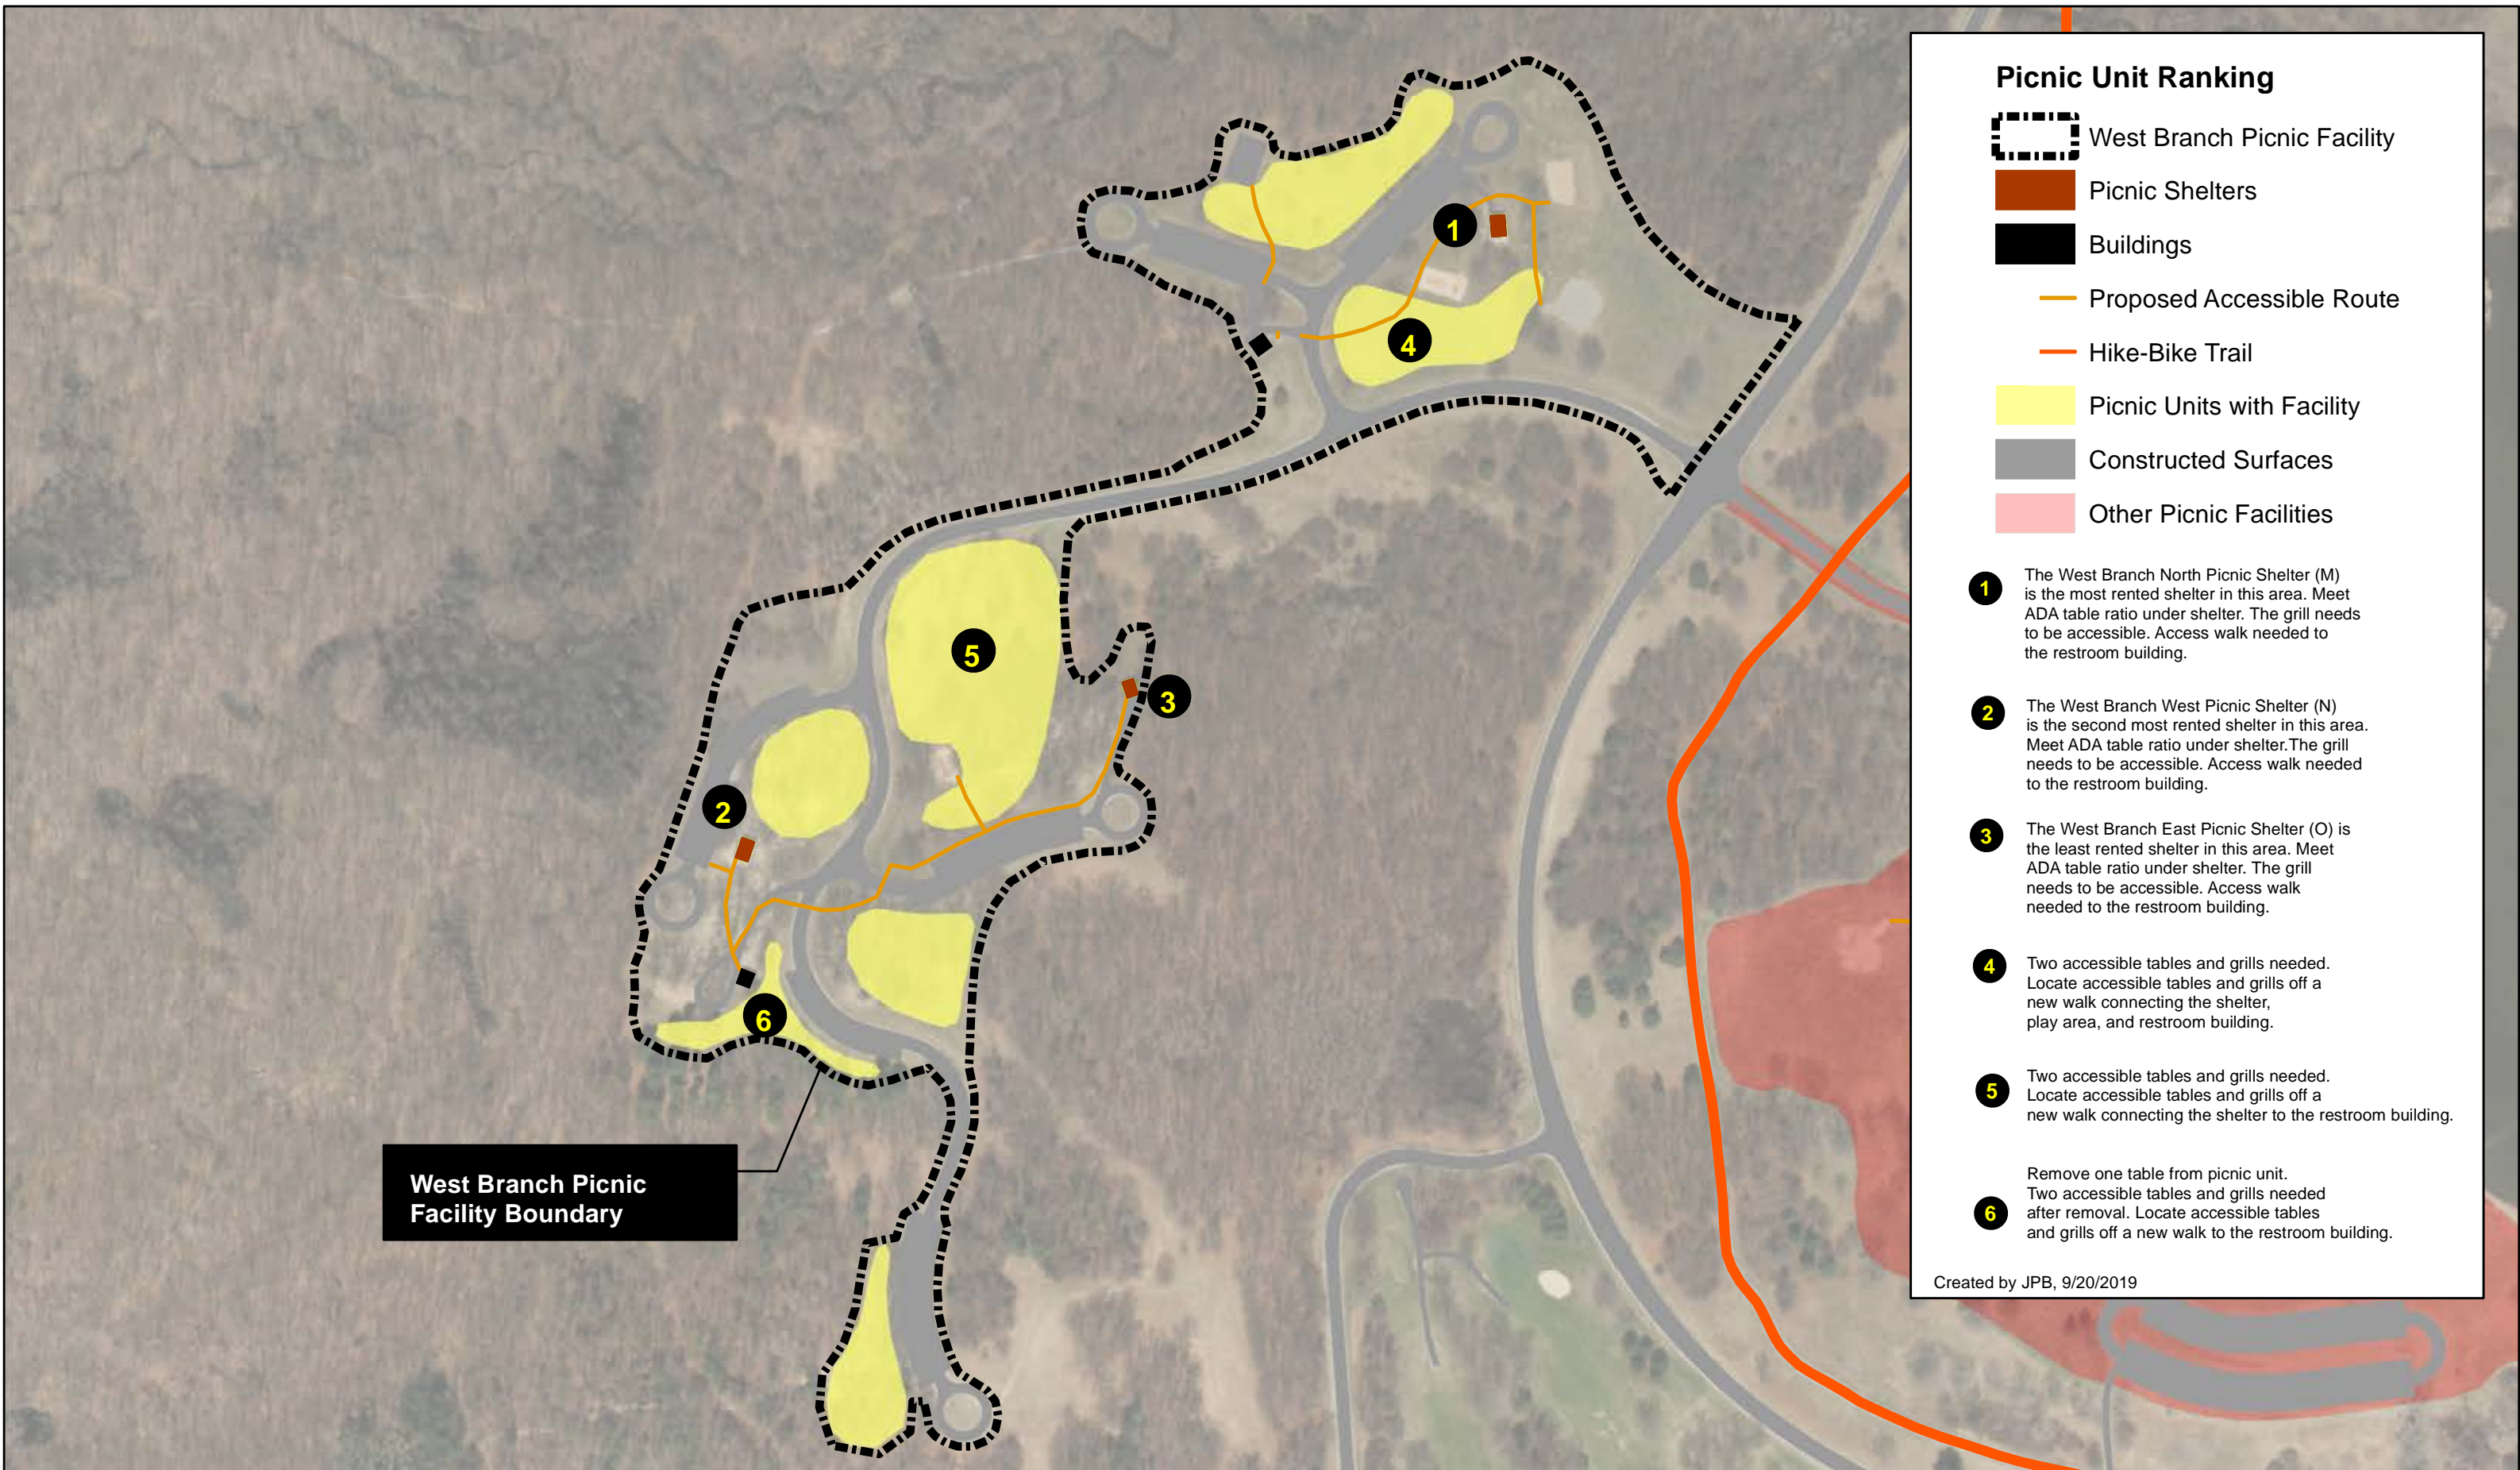
West Branch Picnic Facility Boundary

- 5** Two accessible tables and grills needed. Locate accessible tables and grills off a new walk connecting the shelter to the restroom building.
- 6** Remove one table from picnic unit. Two accessible tables and grills needed after removal. Locate accessible tables and grills off a new walk to the restroom building.

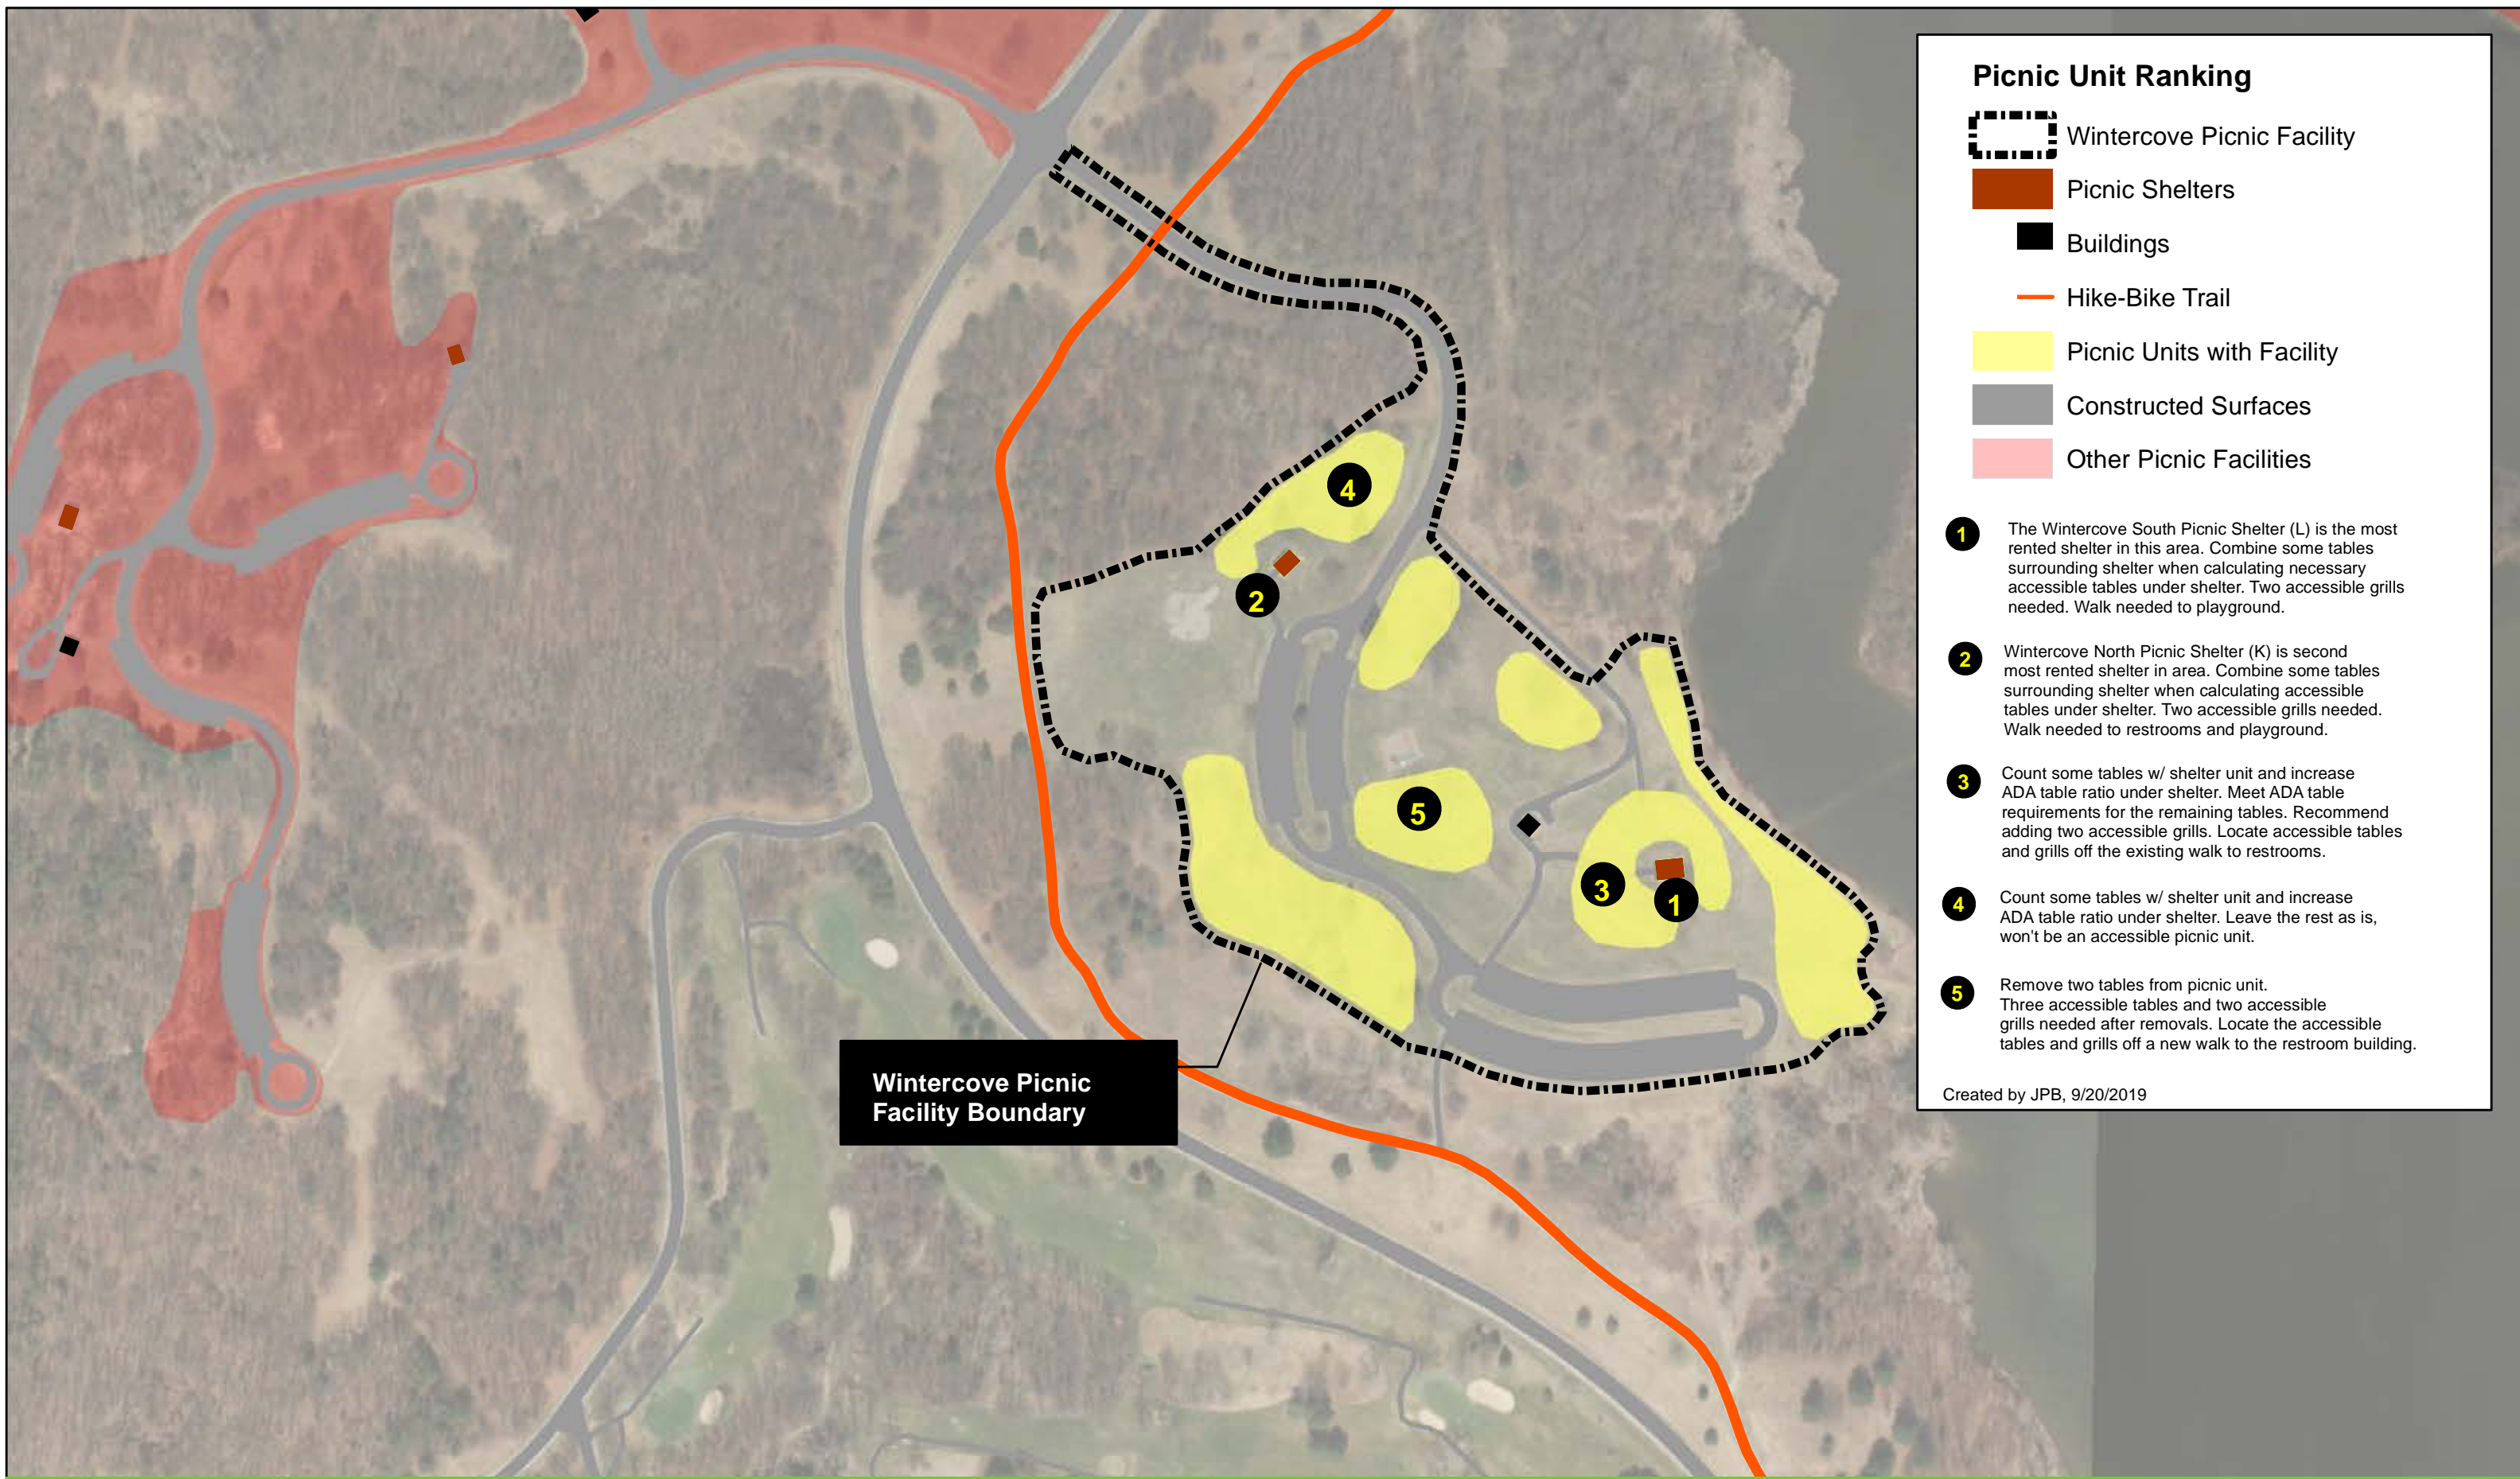
Wintercove Picnic Facility Boundary

- 3** Count some tables w/ shelter unit and increase ADA table ratio under shelter. Meet ADA table requirements for the remaining tables. Recommend adding two accessible grills. Locate accessible tables and grills off the existing walk to restrooms.

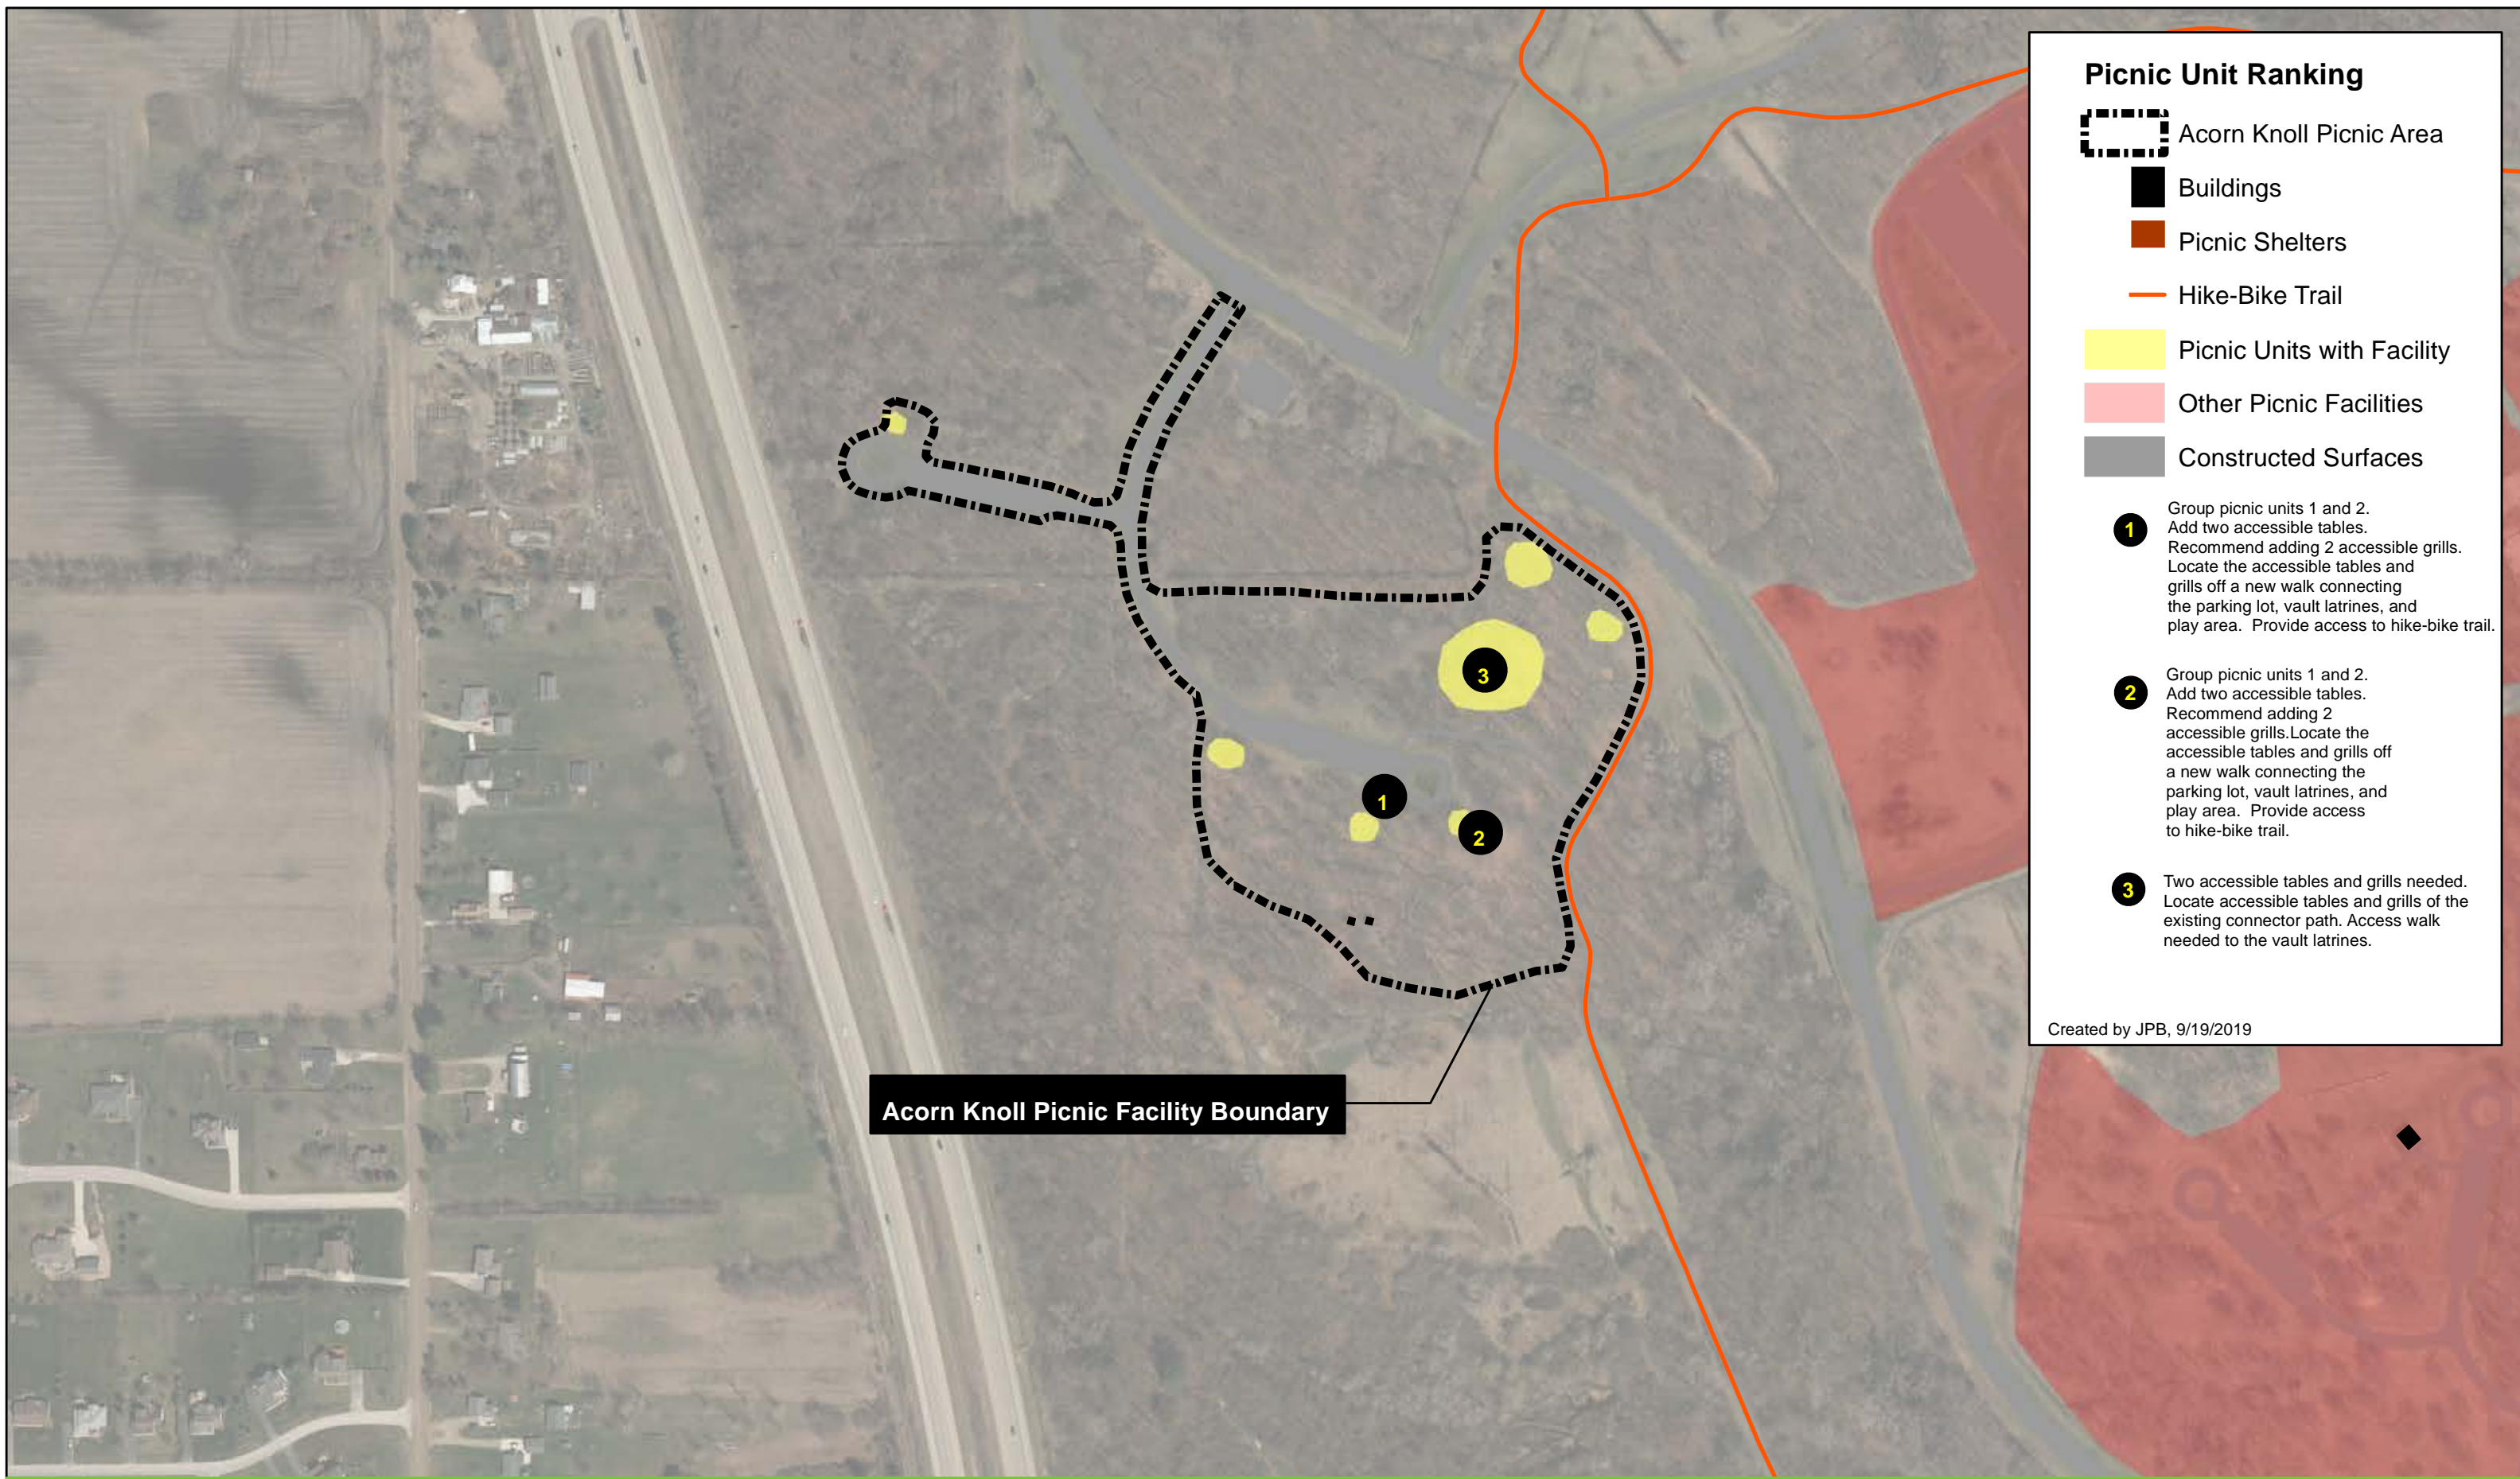
Acorn Knoll Picnic Facility Boundary

1 Group picnic units 1 and 2. Add two accessible tables. Recommend adding 2 accessible grills. Locate the accessible tables and grills off a new walk connecting the parking lot, vault latrines, and play area. Provide access to hike-bike trail.

2 Group picnic units 1 and 2. Add two accessible tables. Recommend adding 2 accessible grills. Locate the accessible tables and grills off a new walk connecting the parking lot, vault latrines, and play area. Provide access to hike-bike trail.
