SUBJECT: Flat Rock Dam, Dam ID No. 556; Wayne County

**DAM SAFETY INSPECTION REPORT  
FLAT ROCK DAM – DAM ID NO. 556  
HURON RIVER  
WAYNE COUNTY – SW 1/4 SECTION 31, T 04S, R 10E**

APPENDIX B – INSPECTION PHOTOS

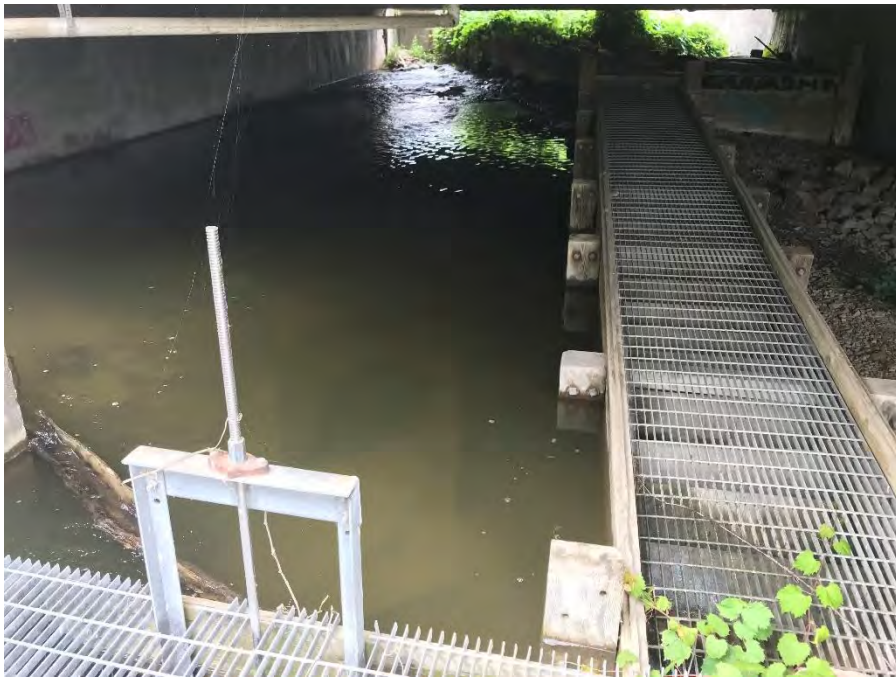
**Photograph 22 – DNR fish ladder under bridge**

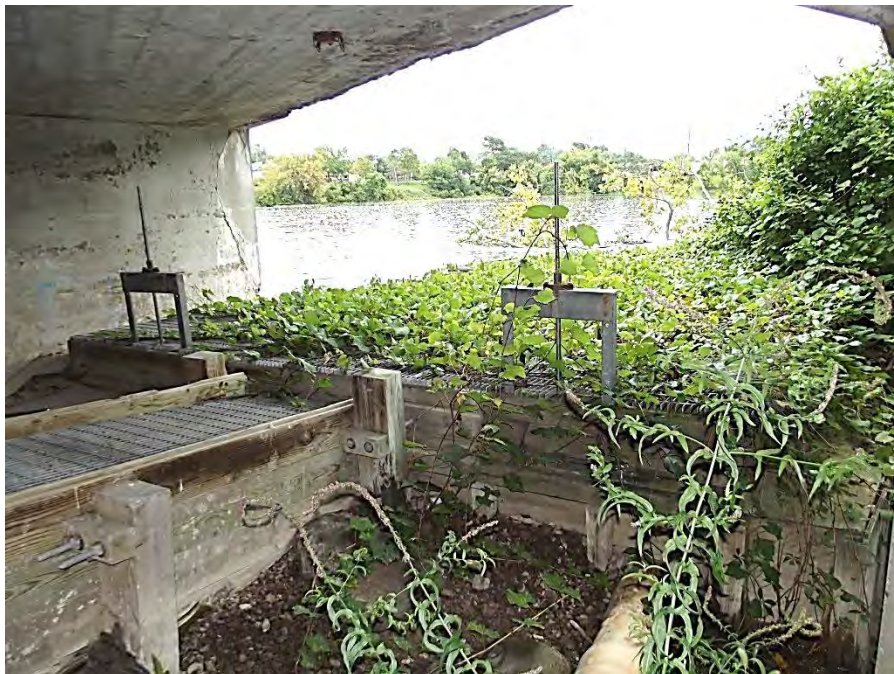
The fish ladder, shown in Photographs 15 through 17, is also in fair condition. No major deterioration was observed. However, leakage between the boards of the wooden structure continues to be an issue. This leakage is not currently causing concern for erosion adjacent to the structure, but as the boards deteriorate; leakage will increase, potentially causing erosion concerns. Therefore, the wooden fish ladder structure should be observed quarterly for significant deterioration and increased leakage. Repairs should be implemented as needed.

**Photograph 16 – Fish ladder as it outlets downstream of the bridge.**
